SteelSeries Arctis Pro Plus GameDAC Headset Mute Button Cap Replacement

This guide shows how to access and replace the mute button located on the SteelSeries Arctis Pro Plus GameDAC headset.

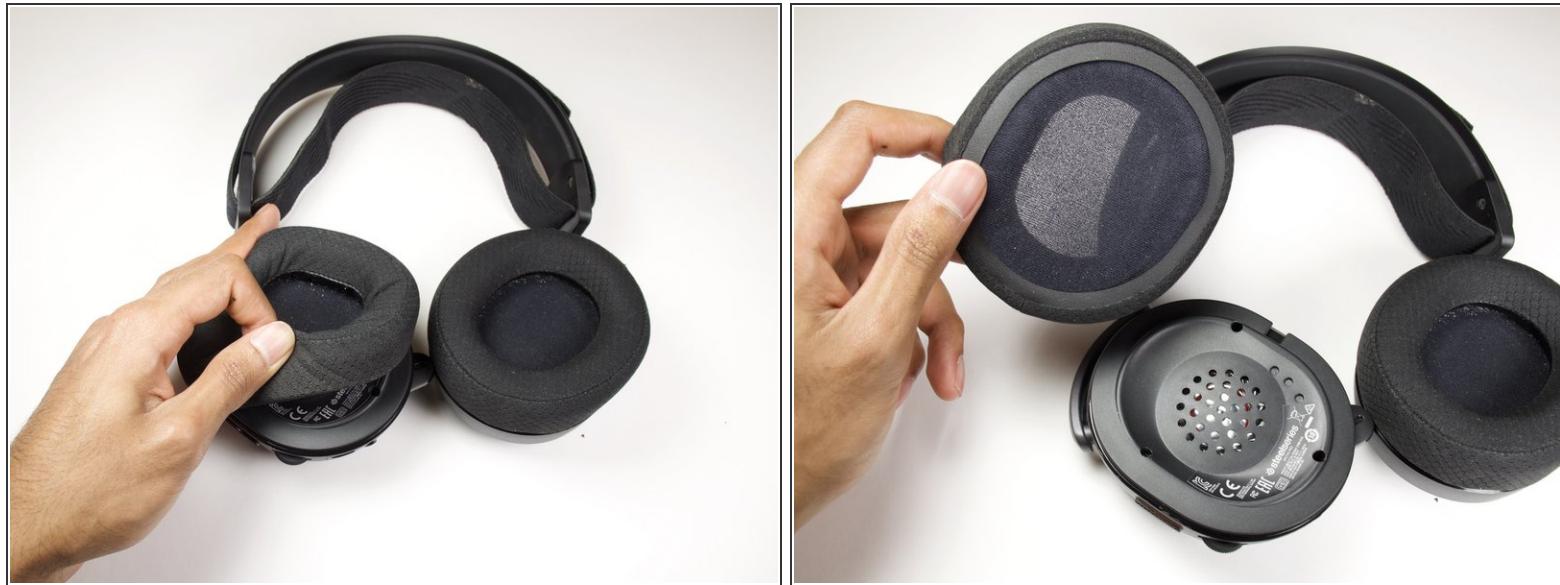
Step 1 — Headset Ear Cushions

- Lift the edge of the cushion and pull out slightly.
- Work your way around the cushion until it comes off completely.
- Repeat for the other cushion.

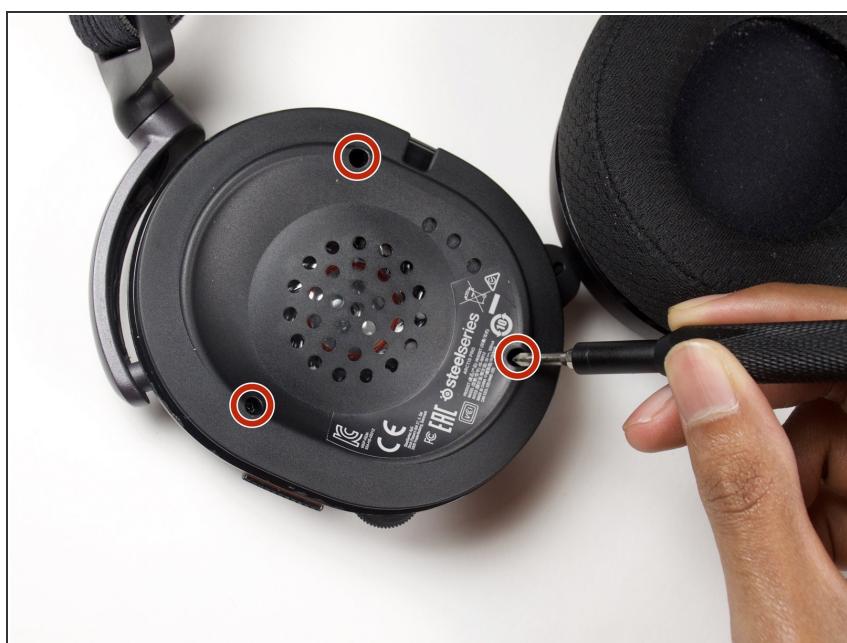
Step 2 — Headset Circuit Board

- Remove the three 5mm screws with a Phillips #0 driver head on the headphone with the microphone.

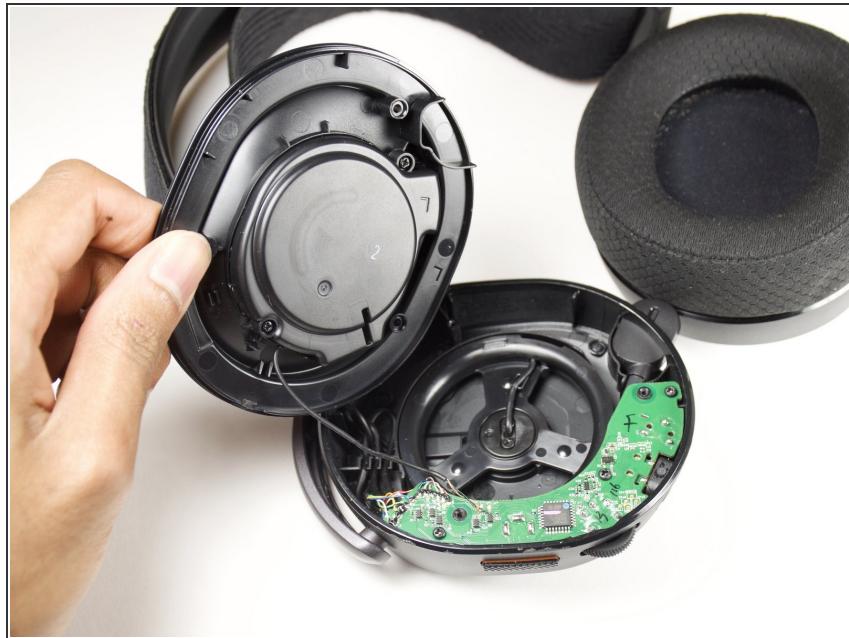
Step 3

- Lift the speaker off the headset to expose the circuit board.

⚠ Be careful not to lift the speaker too quickly or too forcefully to prevent the wires from being pulled out of their connections.

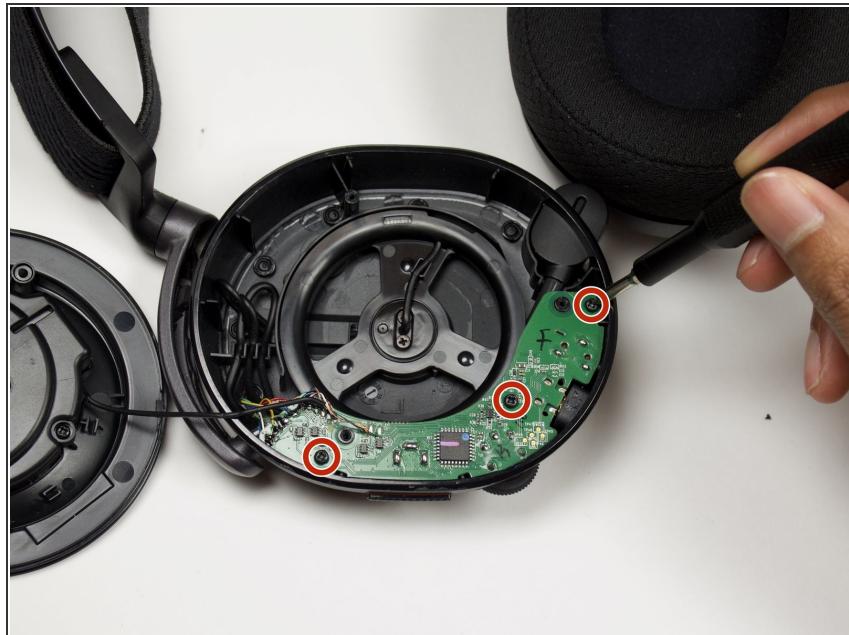
Step 4

- Remove the three 5mm screws using a Phillips #0 driver head.

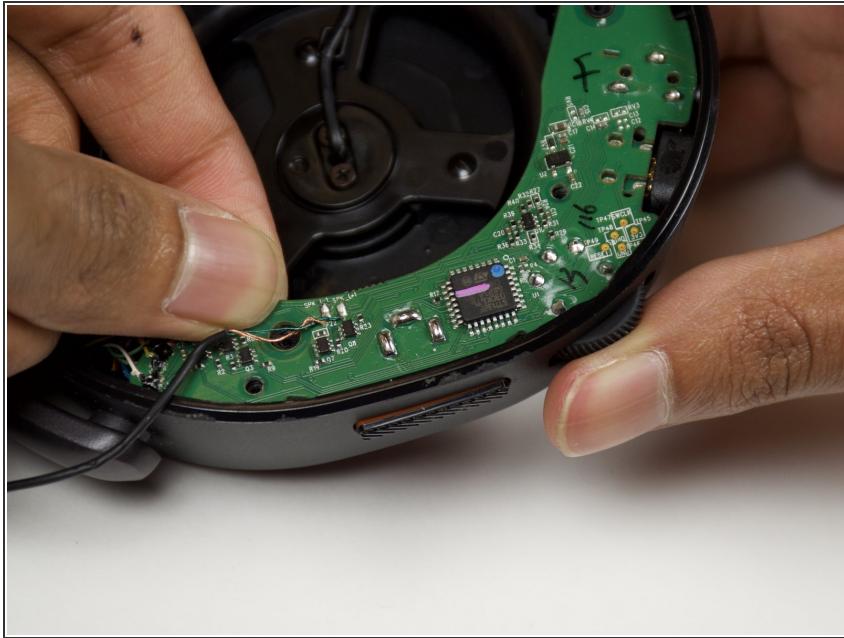
Step 5

- Lift the circuit board out of the plastic housing.

(i) Press in on the volume wheel while pulling on the circuit board to help maneuver the circuit board out of the housing.

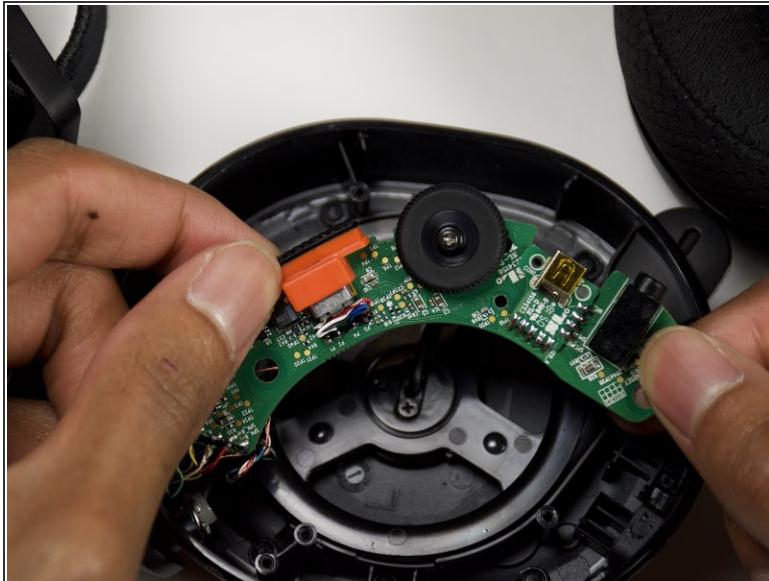
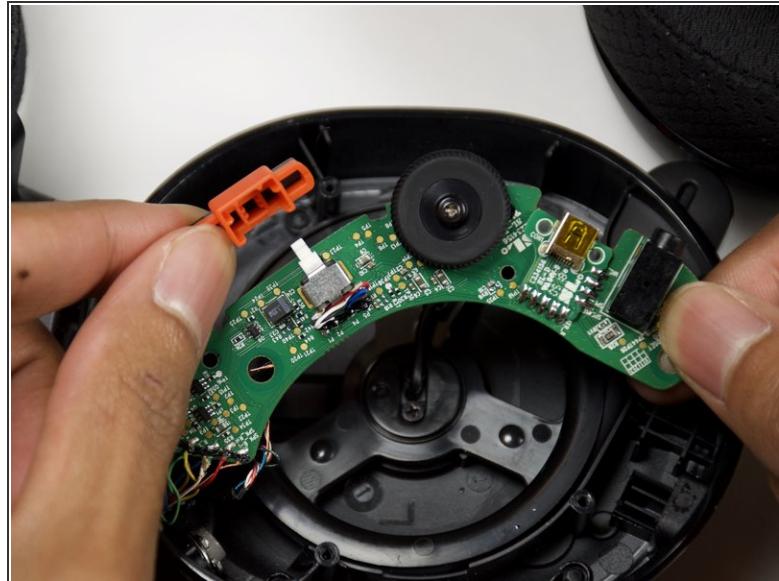
Step 6 — Headset Mute Button Cap

- Flip the circuit board over and remove the keycap by pulling on it.

To reassemble your device, follow these instructions in reverse order.
