Texas Instruments TI-5130 Printer Unit Replacement

Follow this guide to remove and replace the printing unit in the TI-5130 electronic calculator.

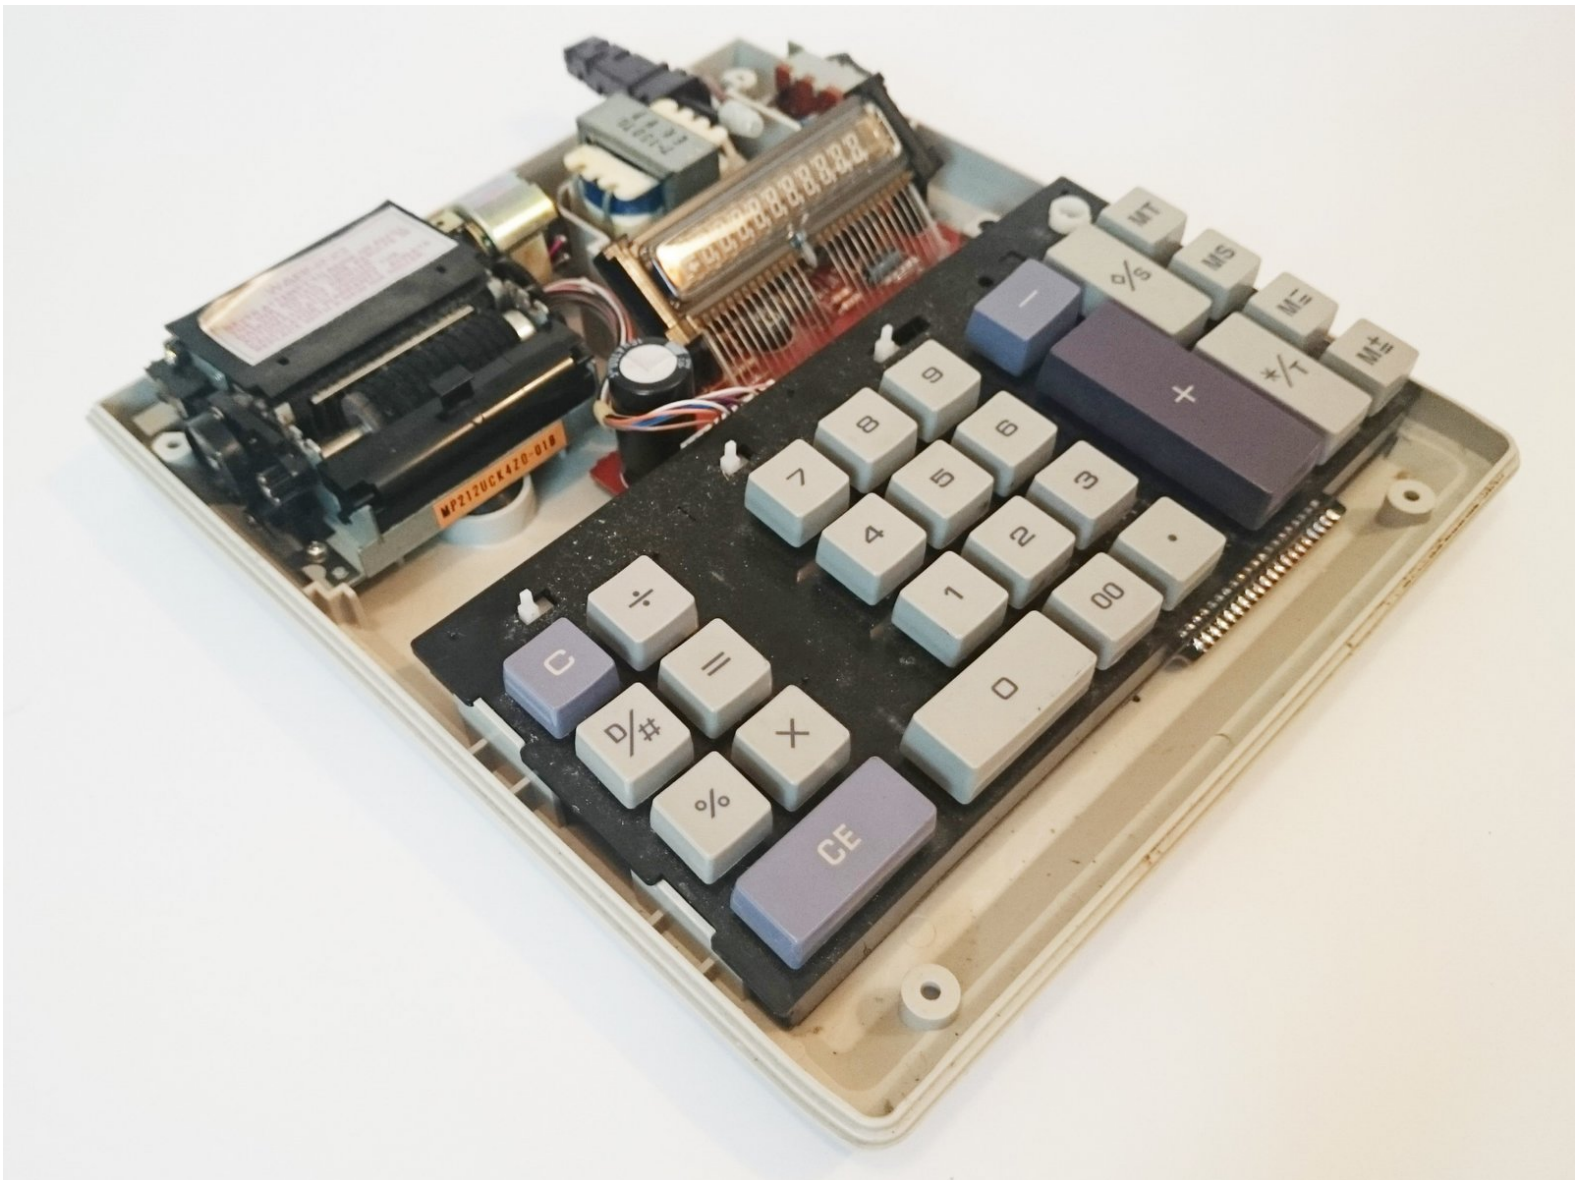
If your calculator has stopped printing and/or will not feed paper you may need to replace the printing unit, shown here.
