# TomTom One 310 LCD and Touchscreen Replacement

Older model TomTom that is well used. Replacement LCD and digitizer purchased as one assembly. Total cost \$20 for the repair.

Written By: oldturkey03

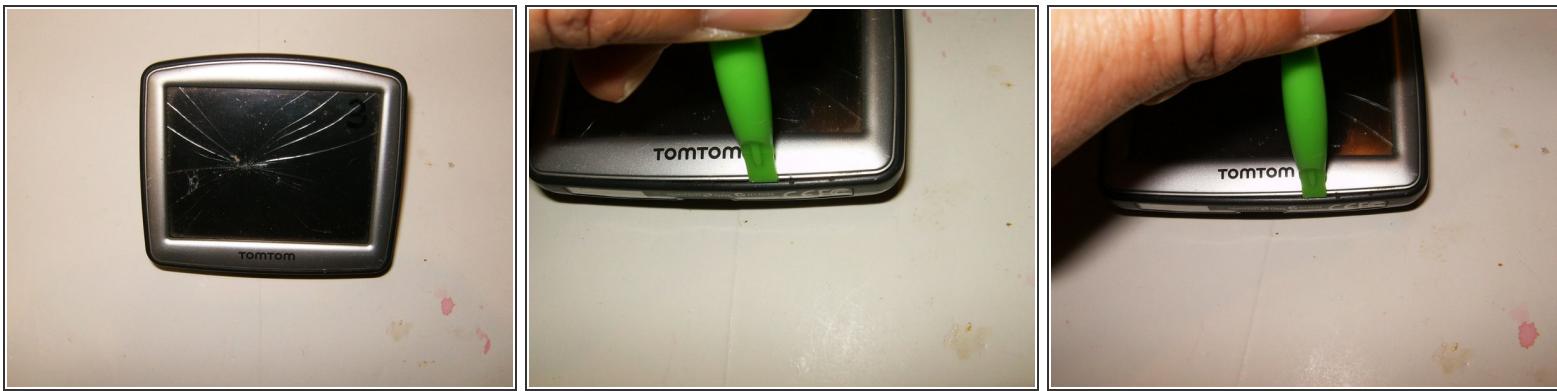
## Step 1 — LCD and Touchscreen

- Here is the TomTom with a clearly visible damage. The LCD did work, but for obvious reasons the digitizer did not.
- Use a plastic opening tool and insert it between the outside of the bezel and the plastic case. It will need some effort, but the plastic of the case does have enough give to make it possible.
- Continue to work the tool around the bezel. There are multiple plastic tabs that need to be released

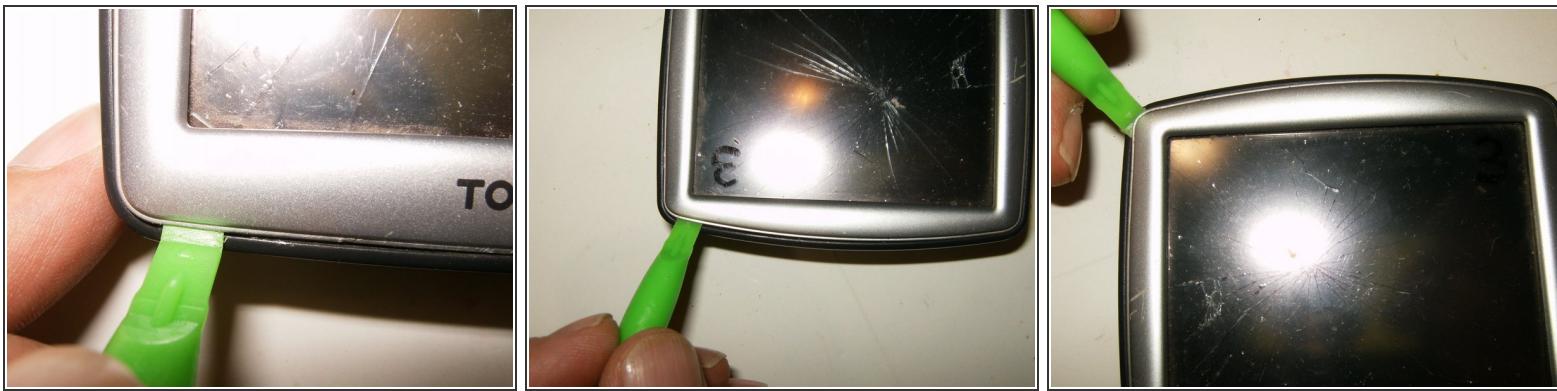
## Step 2

- Continue to move the tool to the outside edges,
- then along the sides
- and finally the top.

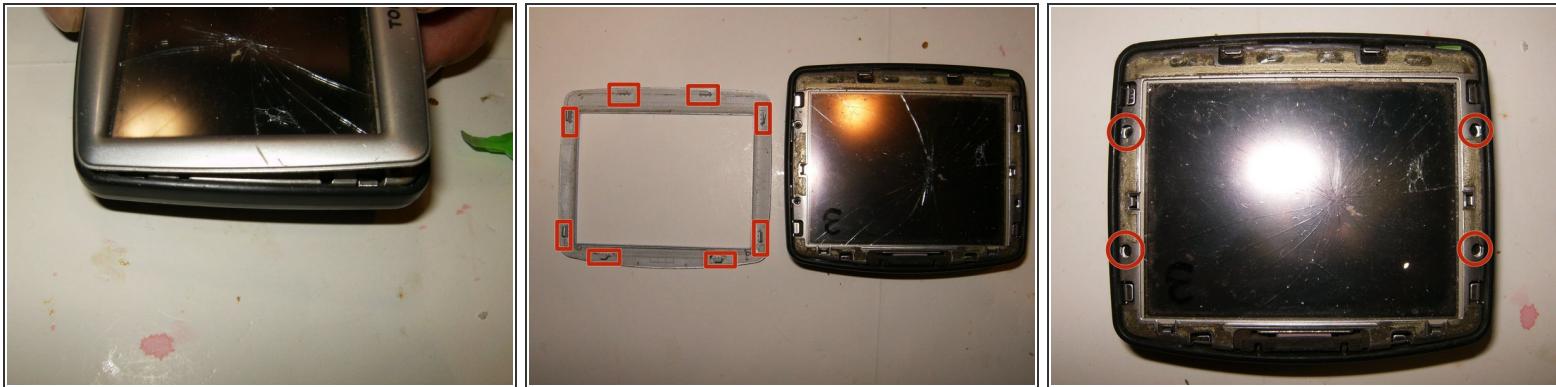
## Step 3

- Once all the tabs are released, carefully lift the bezel up and remove it.
- Now the 8 holding tabs are visible
- Remove the 4 Phillips screws that connect the LCD holder

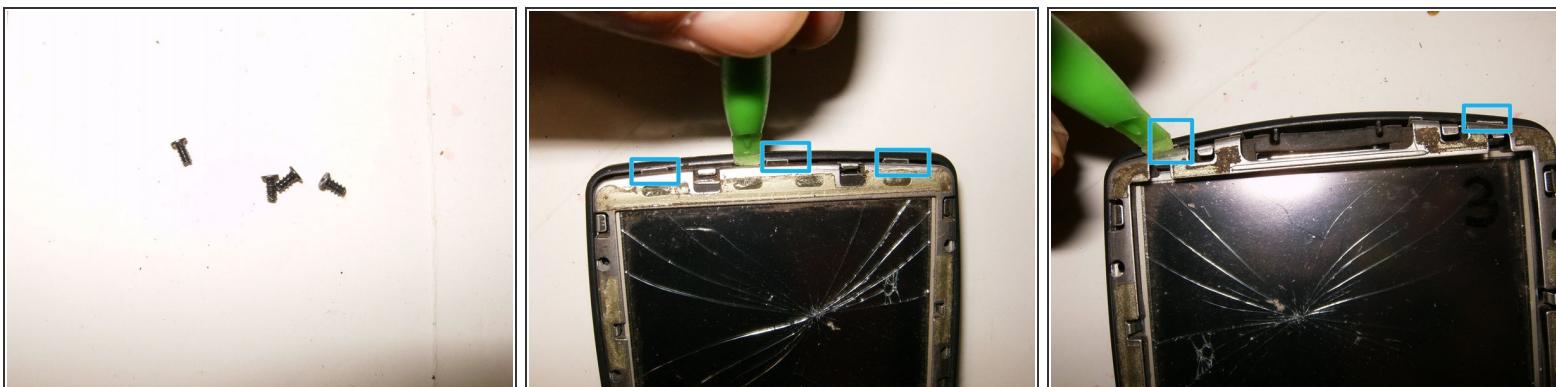
## Step 4

- Here are the four coarse threaded 3mm long screws.
- The LCD holder shows three metal tabs on the bottom that hold it to the plastic case. Use the plastic opening tool to clear those tabs.
- There are two metal tabs at the top that hold it to the plastic case. Use the plastic opening tool to clear those tabs.

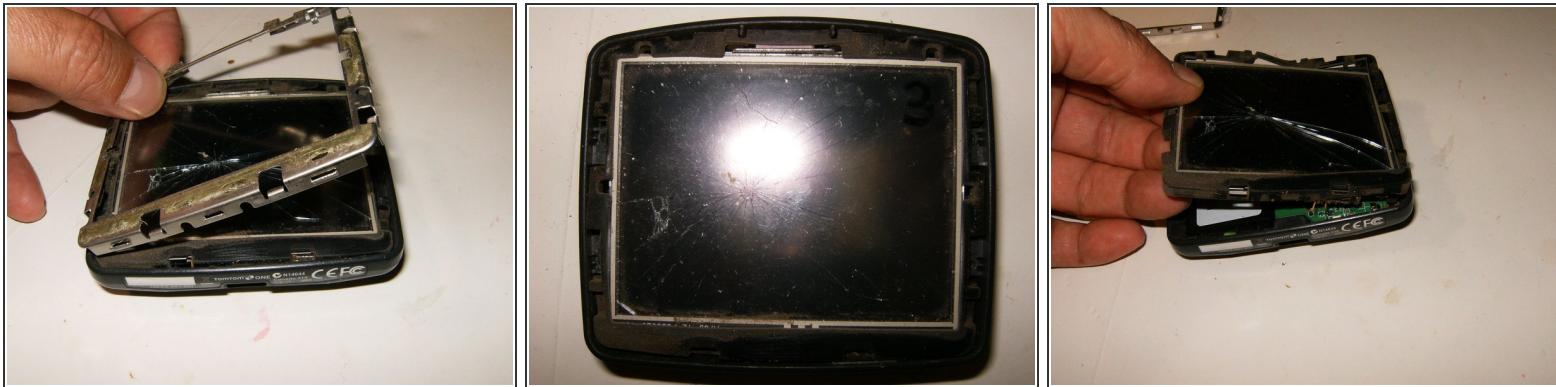
## Step 5

- Remove the LCD holder
- Here is the LCD without the holder. There is a rubber gasket placed around the outside of the LCD. Note its position
- Lift the LCD gently out of the plastic case and fold it toward the bottom of the case. The display cable is still connected and may tear if this is done in either the wrong direction or to forceful.

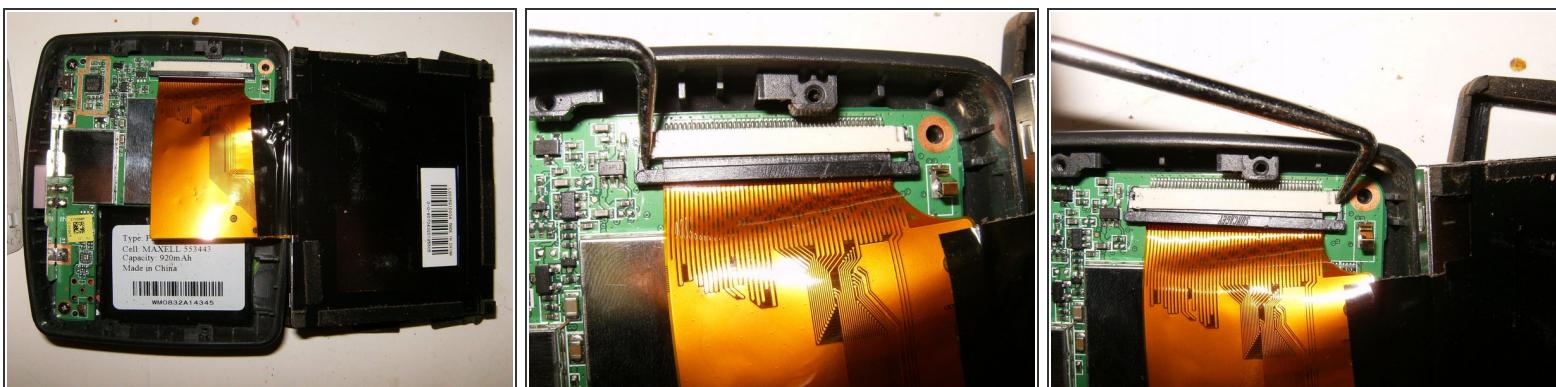
## Step 6

- LCD flipped toward the bottom of the case. The display cable is still connected.
- Use a pick or similar tool to gently move the locking tab. First the bottom,
- Then the top until the locking tab is released and the display cable can be removed.

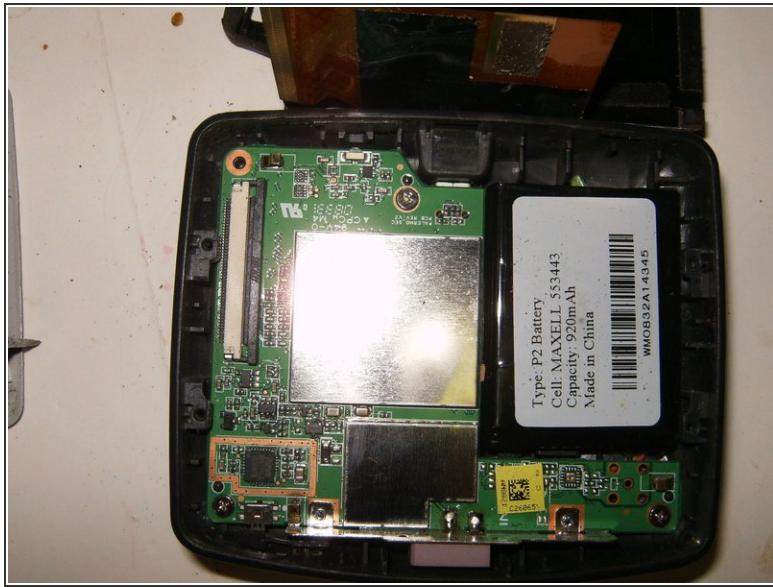
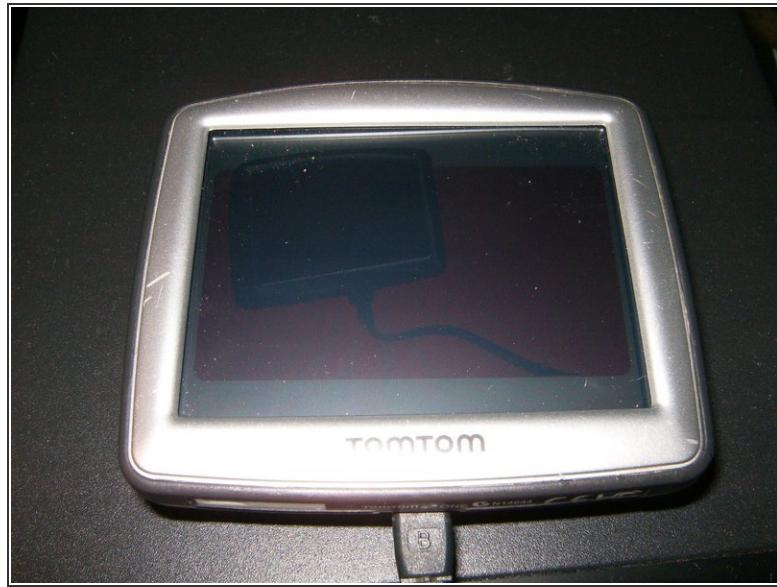
## Step 7

- Remove the display assembly. A new display assembly can now be installed.
- Final result is a refreshed looking and working TomTom

To reassemble your device, follow these instructions in reverse order.
