# Toshiba CB35-3350 Chromebook 2 Bluetooth Chip Replacement

Use this guide to replace your Bluetooth Chip in your Toshiba CB35-3350 Chromebook 2.

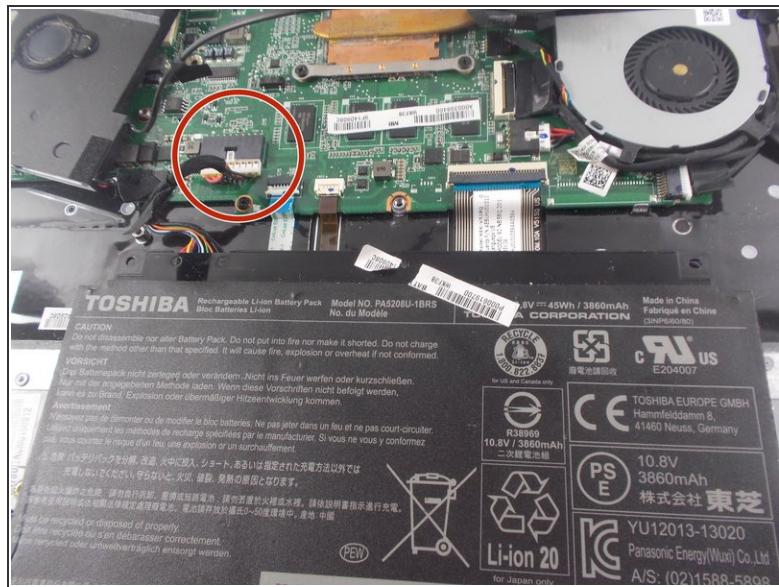
## Step 1 — Bluetooth Chip

- Remove the Phillips #0 screws from the back of the laptop.
- Use your hands and an iFixit opening tool to remove the back of the laptop.
