Toshiba Satellite C55Dt-A5306 DC Power Jack Replacement

Replace DC power jack on Toshiba Satellite Laptop that is unable to conduct charge.

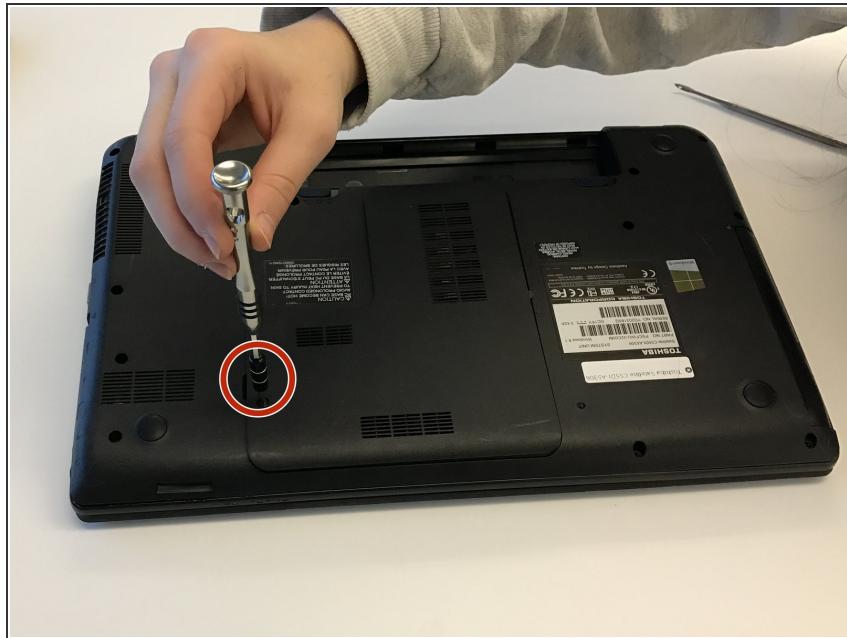
Step 1 — Back Cover

- Using the Phillips Head #0 Screwdriver, remove one 3mm Phillips #0 screw as indicated.

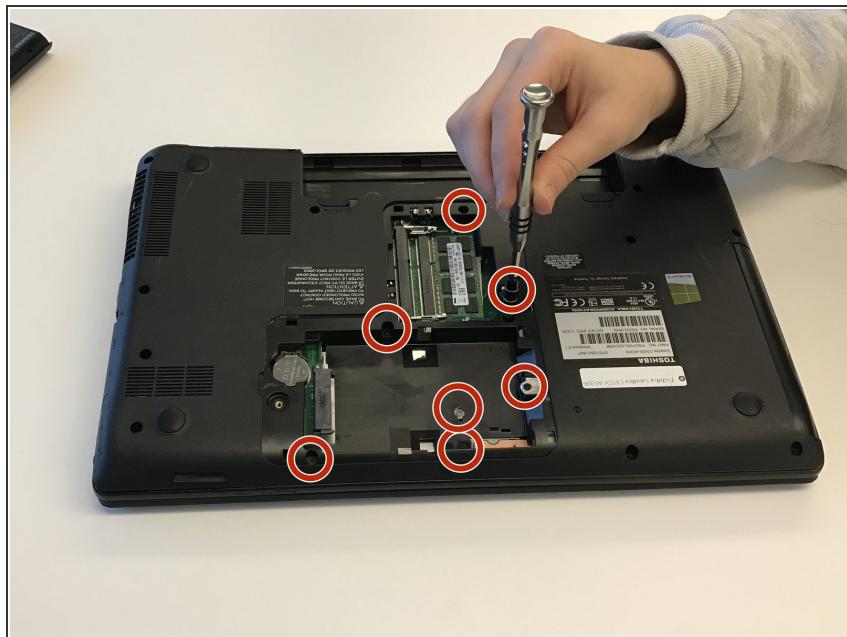
Step 2

- Remove hard drive cover. Using the Phillips Head #0 Screwdriver, remove seven 3mm Phillips #0 screws as indicated.

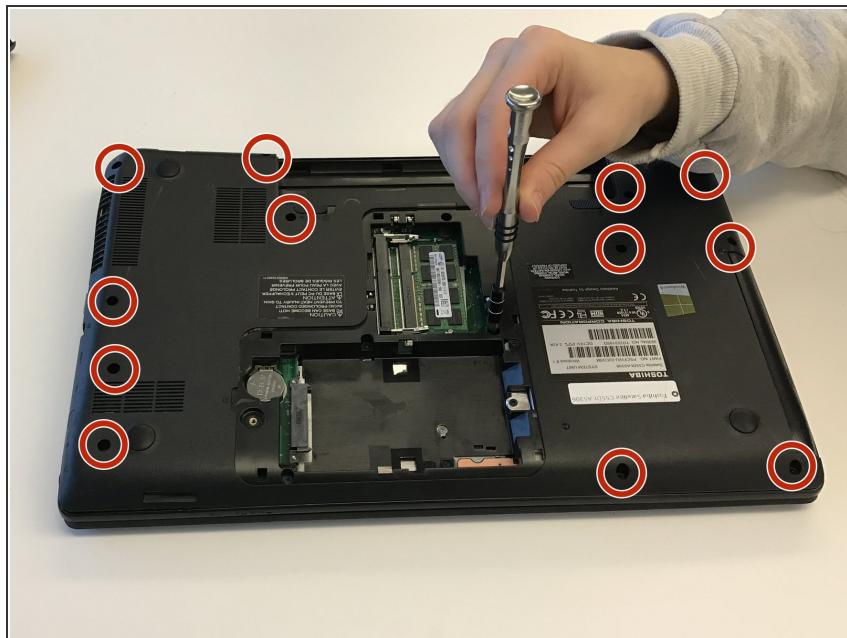
Step 3

- Using the Phillips Head #0 Screwdriver, remove twelve 3mm Phillips #0 screw as indicated.

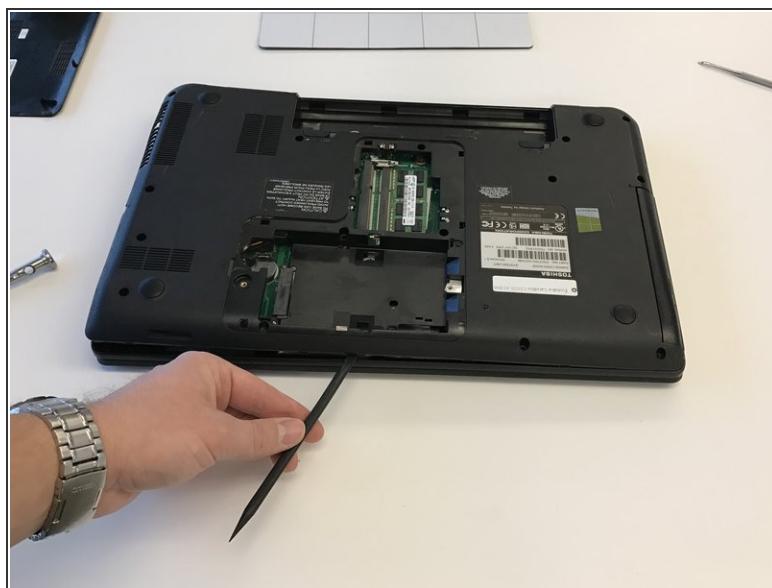
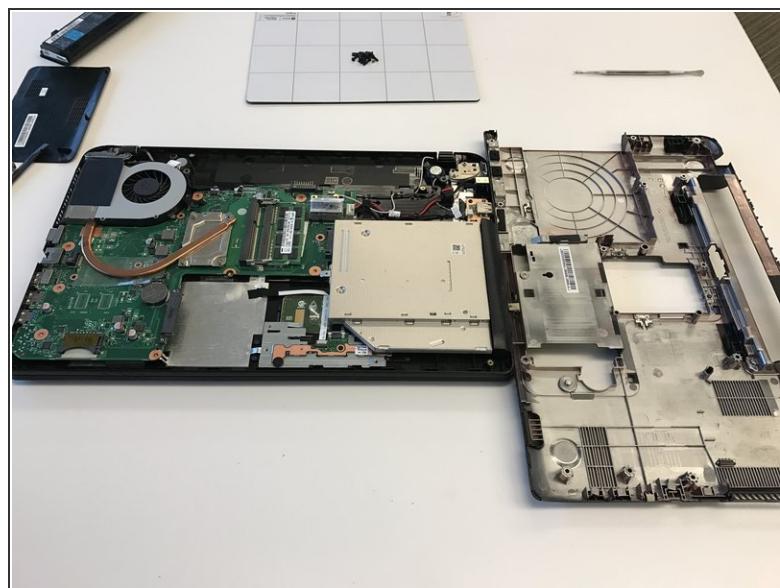
Step 4

- Using the plastic spudger, pry the back off along the periphery of the laptop.

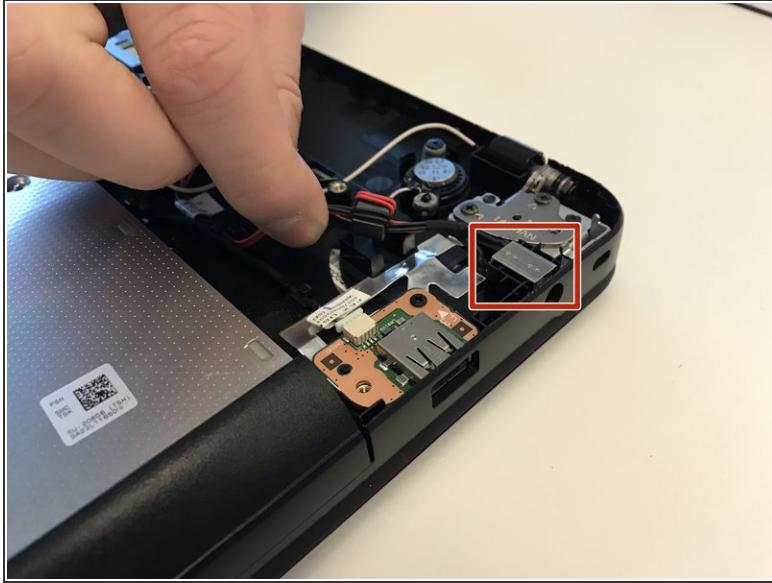
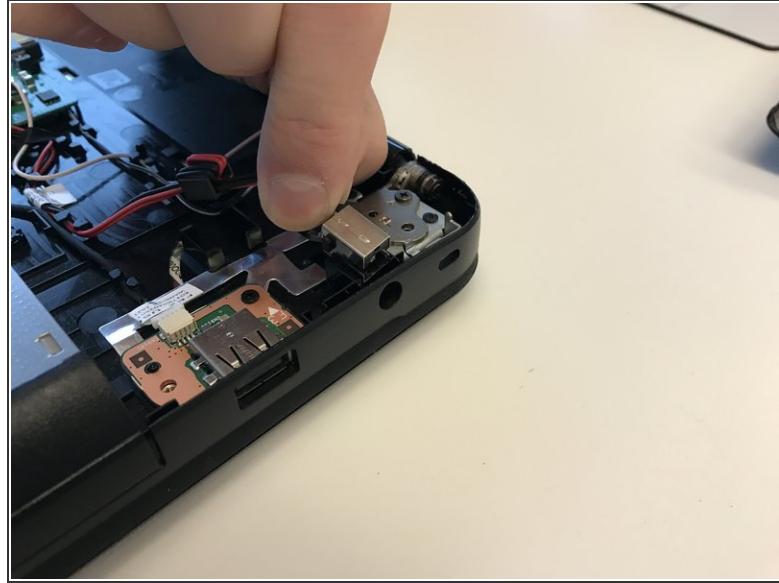
Step 5 — DC Power Jack

- Remove the DC power jack from its plastic retaining piece, just inside of the charger inlet.

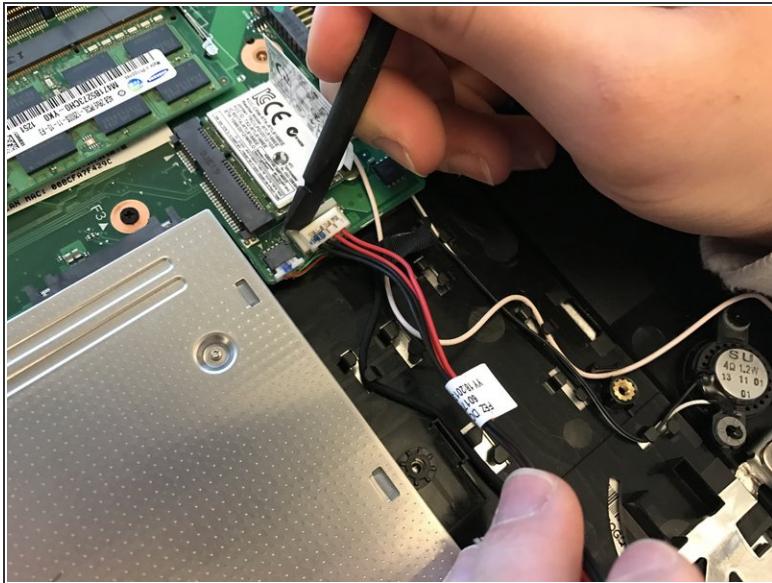
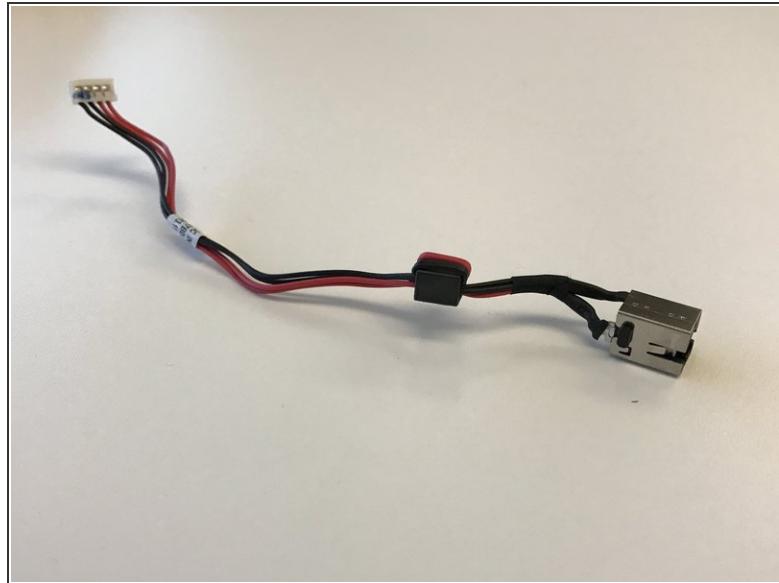
Step 6

- Use the nylon spudger to remove the connecting wires from the motherboard. Insert the spudger between the terminal plastic piece of the wire and its retaining clip on the mother board. The wire should release without much force.
