Wahl Lithium Ion Trimmer Metal Razor Arms Replacement

If these parts experience a mechanical failure or the razor is dropped hard enough to be offset, it is useful to realign or replace these arms.

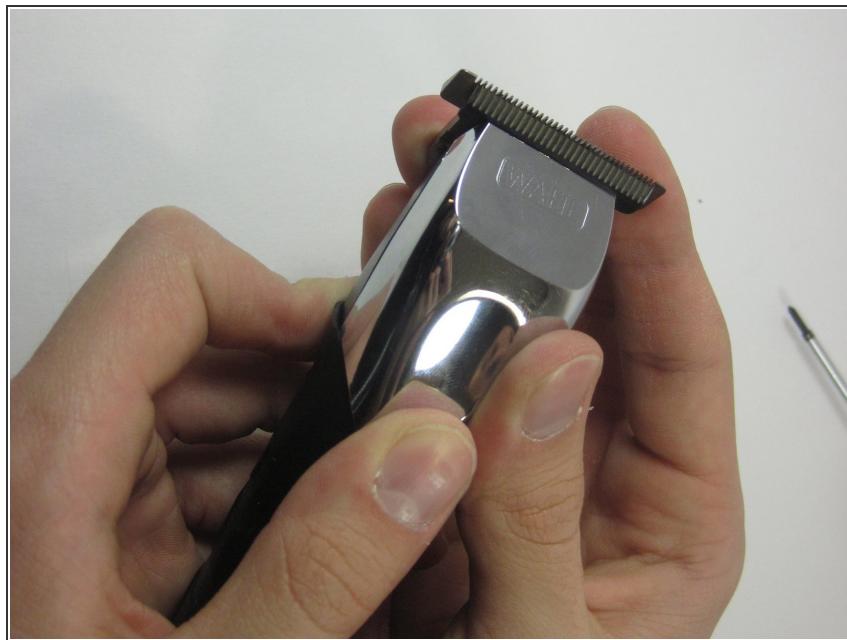
Step 1 — Metal Razor Arms

- Start with examining the razor, looking to see if the blades are jammed or moving.

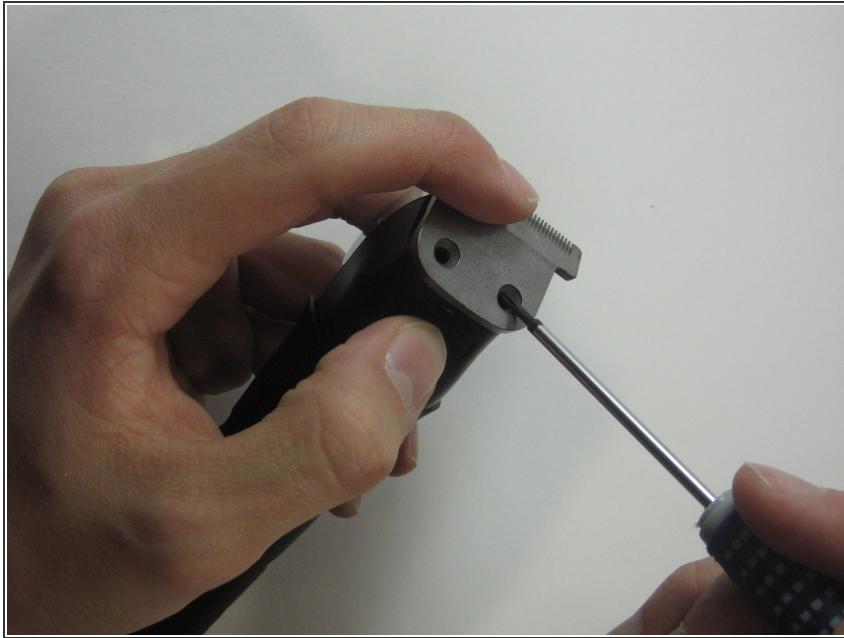
Step 2

- By now you've realized that the blades are broken and need to replace them. Unscrew the top two screws with a Philips head screwdriver.

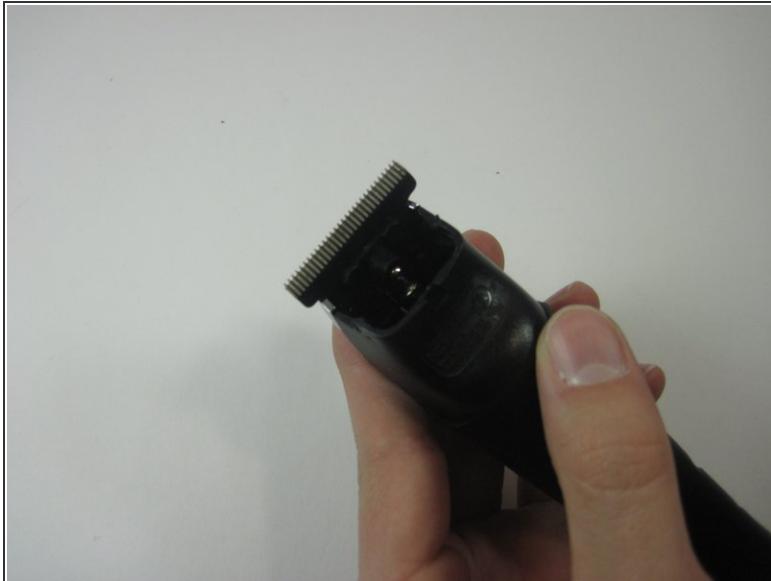
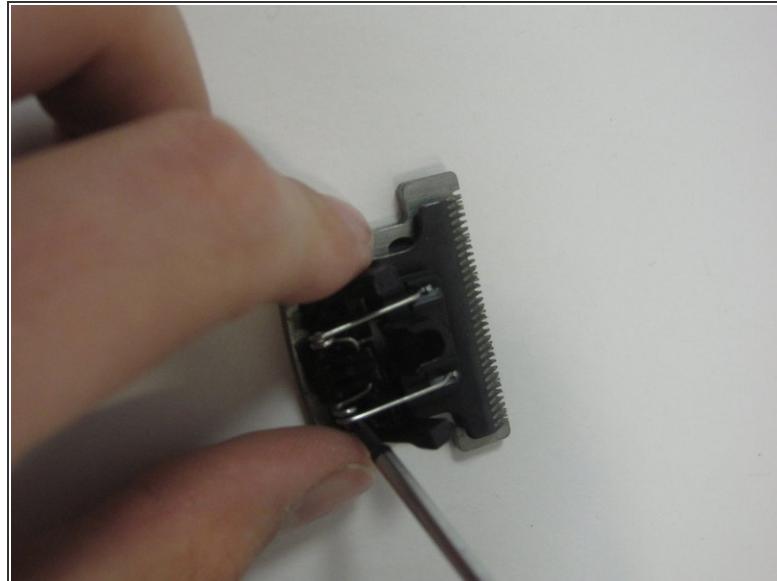
Step 3

- Apply pressure to the back side of the blades and remove the blades.

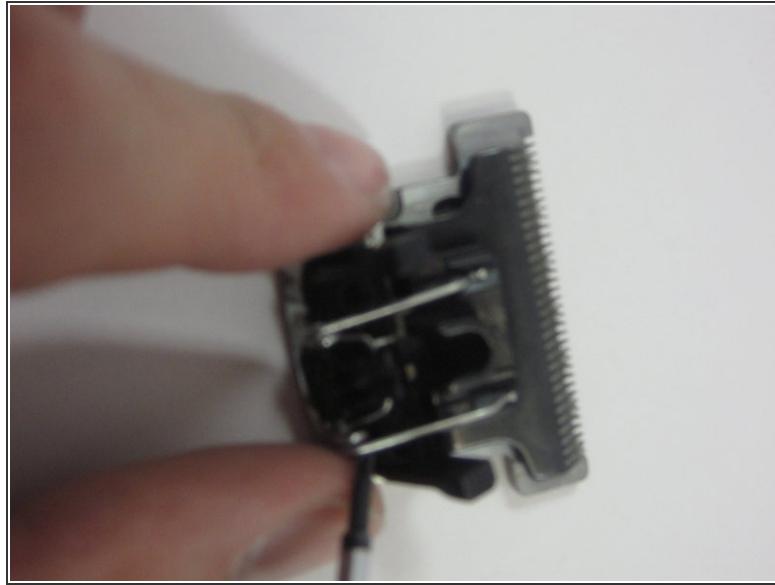
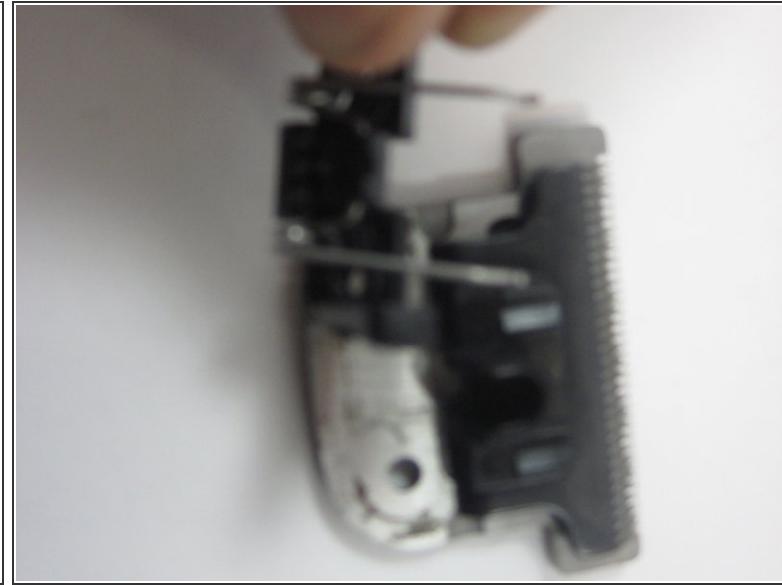
Step 4

- In this step remove metal clip by using either a flat head or Philips head screwdriver.

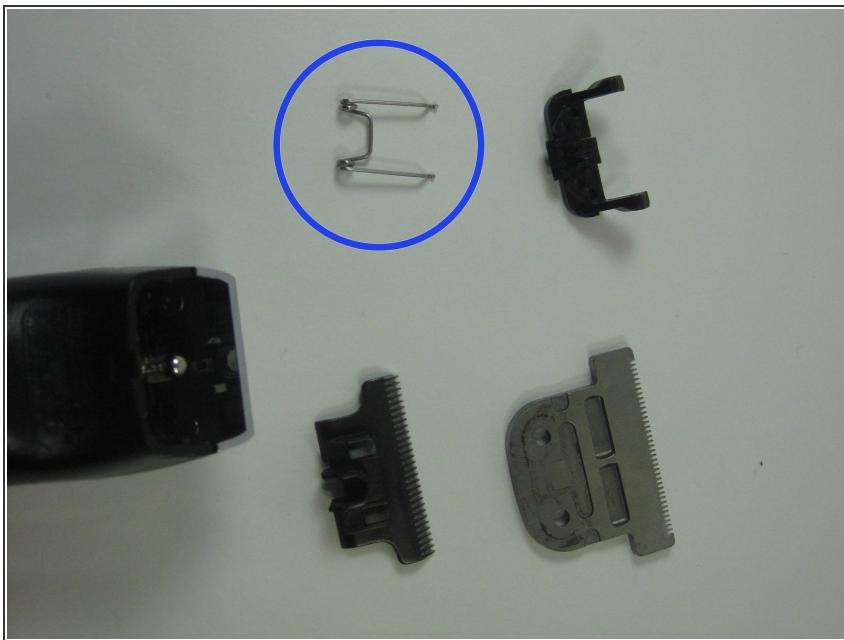
Step 5

- Once taken completely apart this is what you will be looking at. What you need to replace is the metal clip shown in the picture. Once replacing the clip, reassemble the razor and the problem is now solved.

To reassemble your device, follow these instructions in reverse order.
