Weed Whacker Line Replacement

How to replace the line in a self-feeding weed whacker bump head.

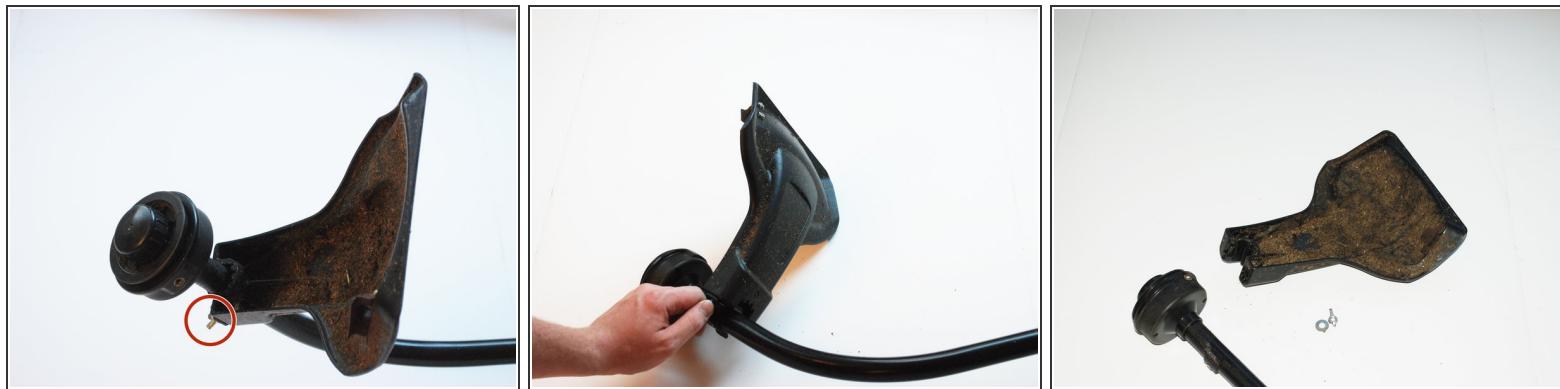
Step 1 — Line

- Remove cutting line guard from weed whacker. This is usually attached by a wing-nut or a bolt and nut, so it can be removed either by hand or with the correct sized wrench.

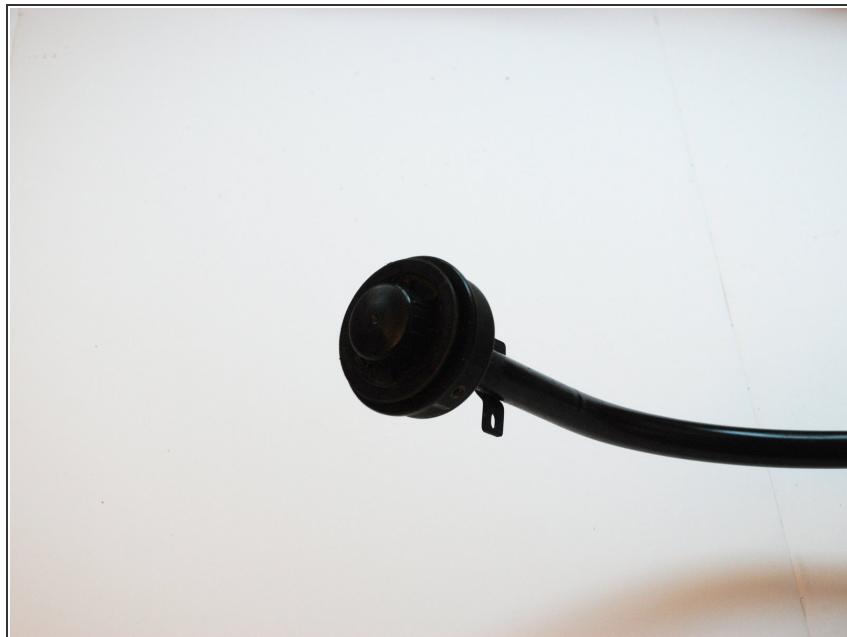
Step 2

- Flip weed whacker upside down so that bottom of cutting piece is facing up.

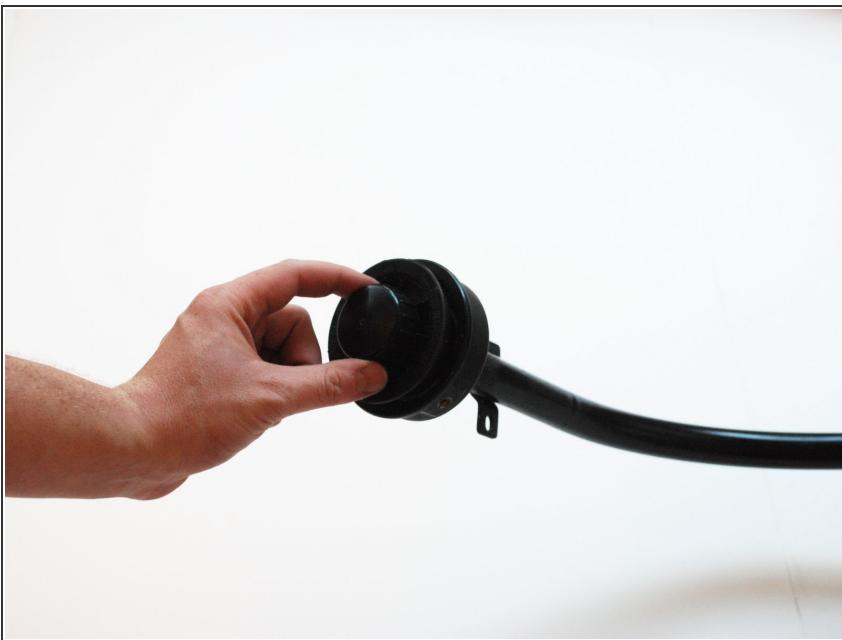
Step 3

- There will be a bottom cap of the rotor setup that needs to be removed. In some models this will be held on with a nut and bolt fixture, but in many models there will be a circular cap that can be rotated counter clockwise for removal. Remove this piece in the manner necessary.

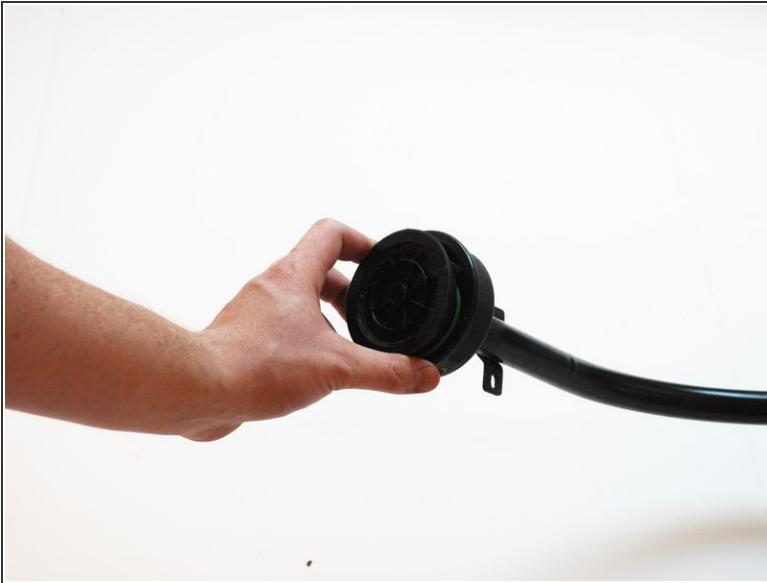
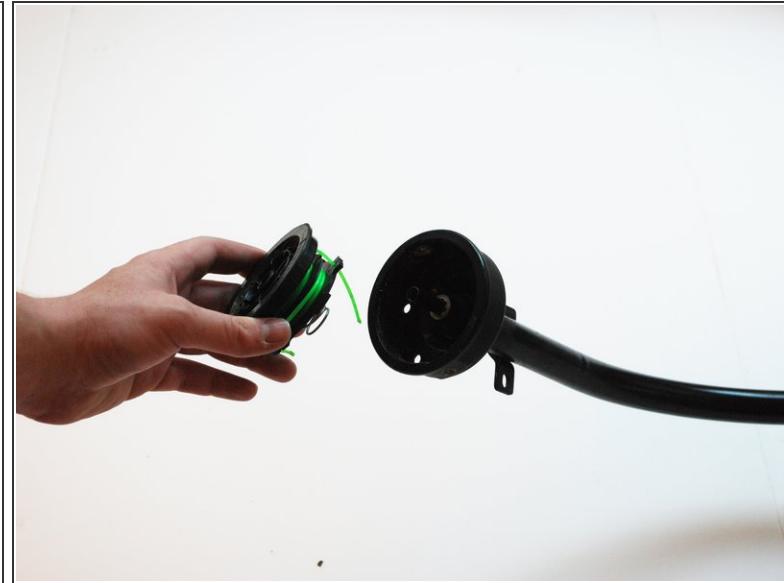
Step 4

- Once the bottom piece is removed, there will be another circular piece that may or may not have cutting line coiled around it. Remove this piece from the weed whacker.

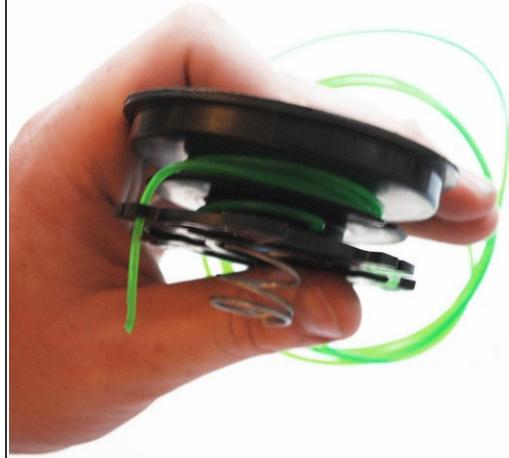
Step 5

- There should be slots to coil cutting line around, with a hole in each for line to be anchored. If no line is coiled around the part, insert the end of about three feet of cutting line into each of the holes, and coil the cutting line snugly around the part, making sure that there are no tangles in the line.

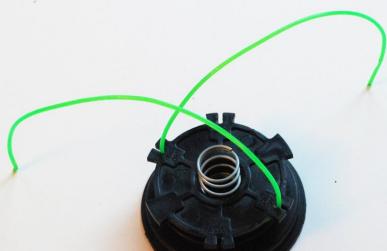
Step 6

- If there are plastic tabs on the plastic part to hold the cutting line, insert each line into one of these tabs. Leave approximately a foot of each line hanging out from the coils.

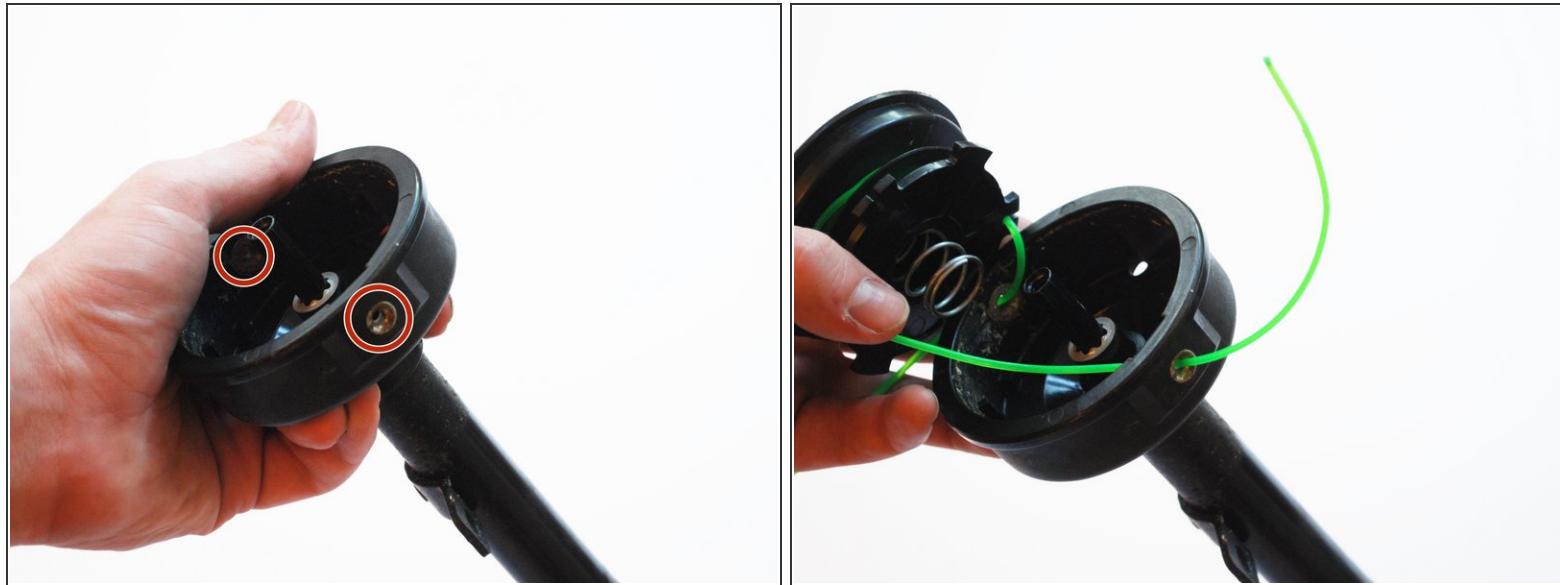
Step 7

- On the weed whacker rotor, there will be eyelets for the cutting line to be fed through. Feed each line through each of these eyelets, being careful not to let the line come uncoiled.

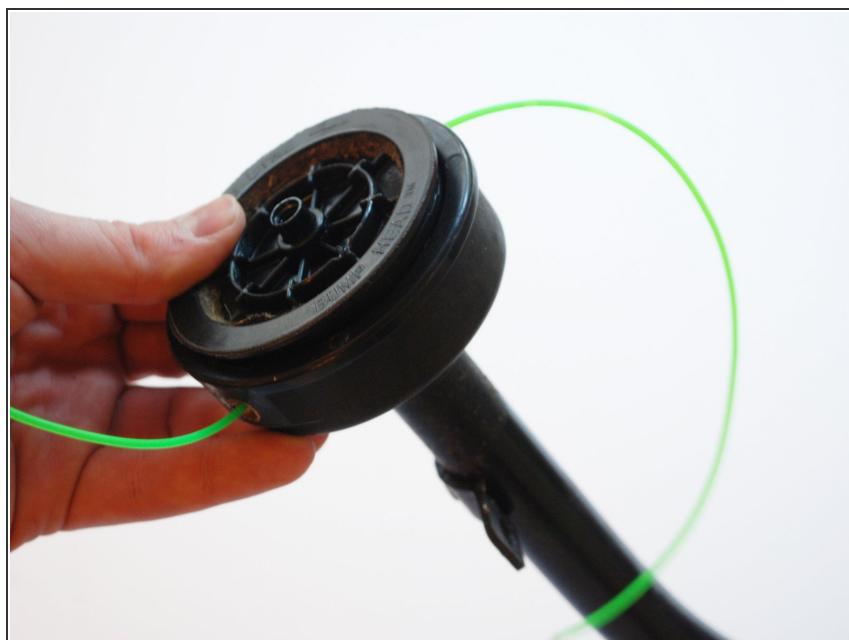
Step 8

- Replace the plastic piece with the cutting lines back onto the rotor, being sure that the coils remain in place, and the lines remain in place through the eyelets.

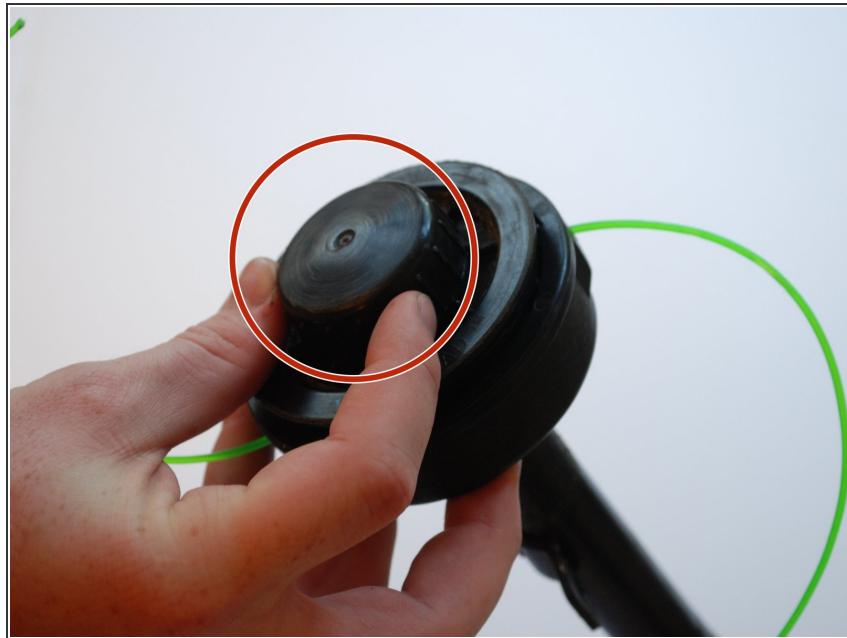
Step 9

- Replace the cap that was removed at the beginning of the assembly.

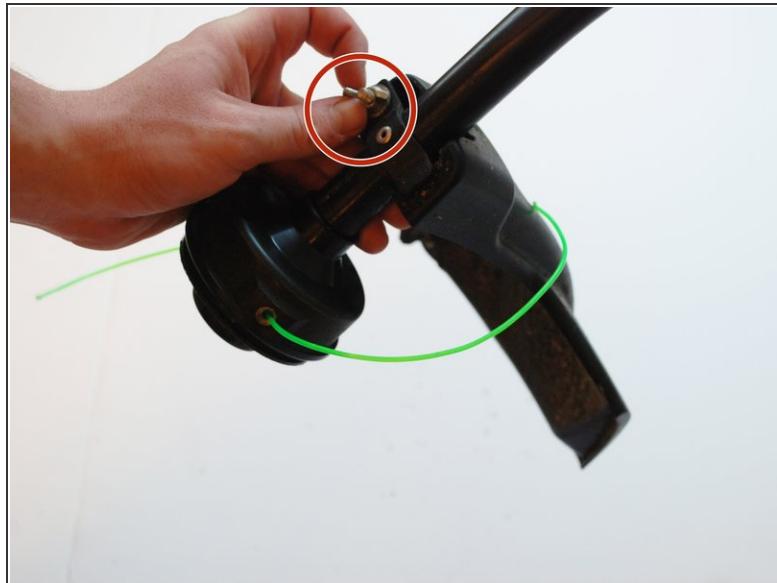
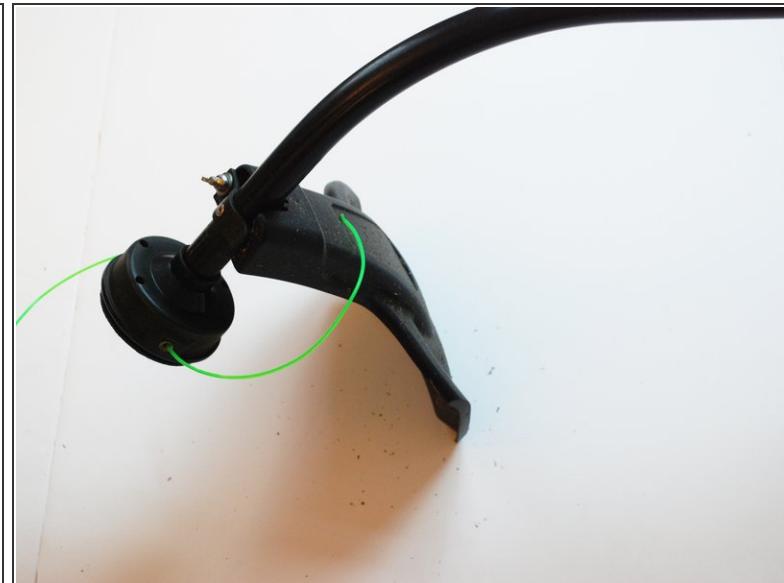
Step 10

- Replace the cutting line guard.
