Wine Cooler Fan replacement

Often a wine cooler is replaced because of a noise problem. Often a \$10 fix

Written By: Michael Williams

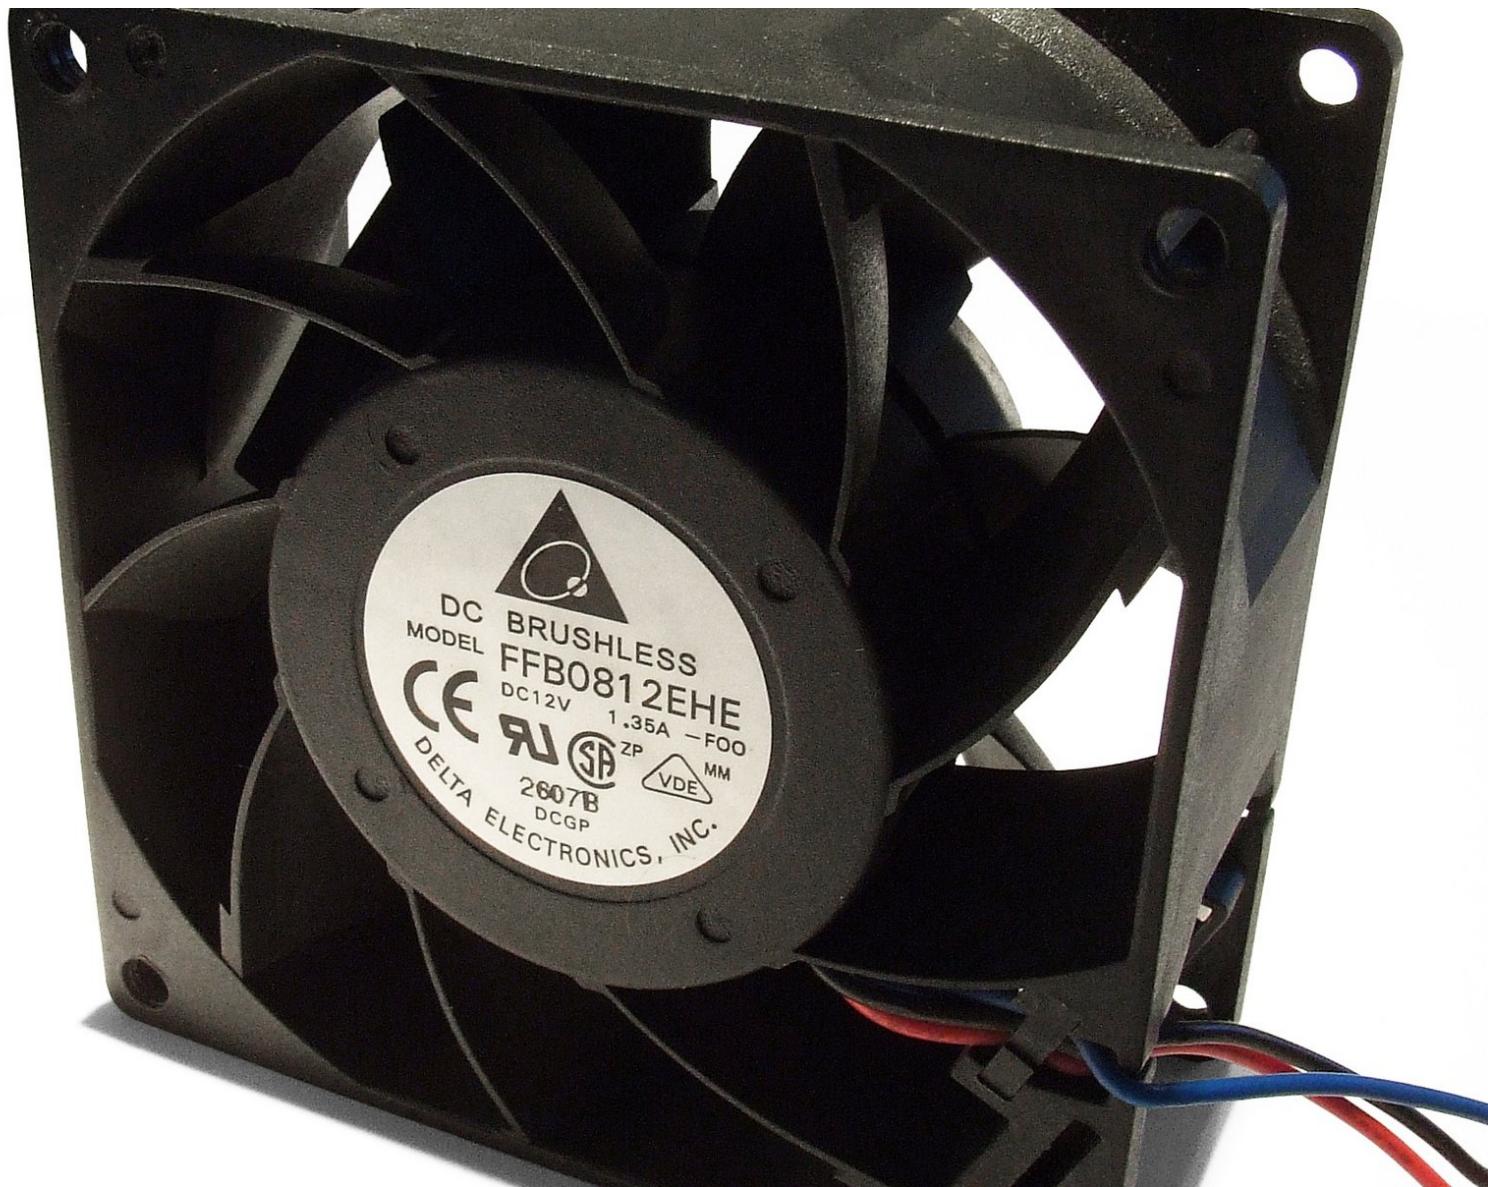
Often a wine cooler is replaced because of a noise problem. Often a \$10 fix
