Wolf Gourmet WGTR102S Slide Assist Plunger Replacement

Details how to replace the slide assist plunger for the Wolf Gourmet WGTR102S Toaster.

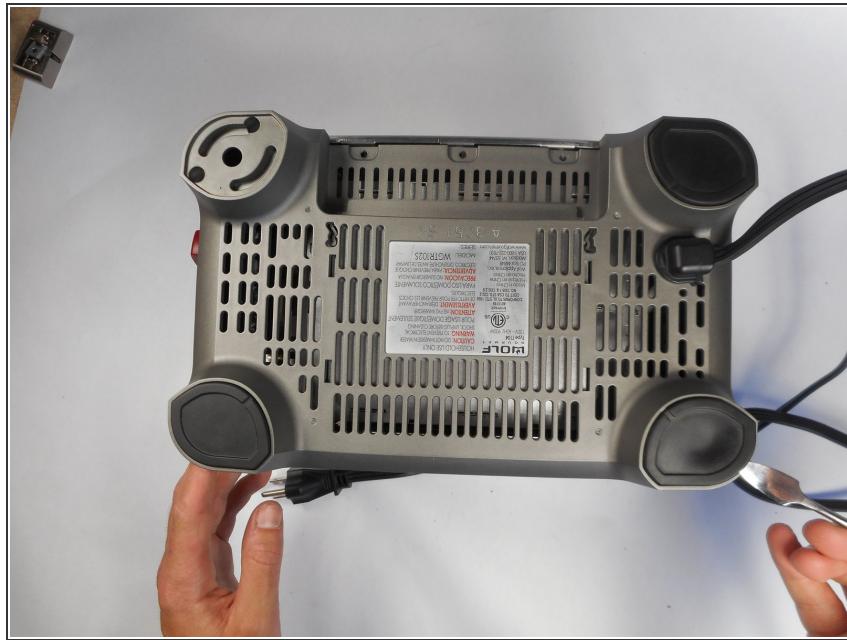
Step 1 — Outer Shell

- Using a wedge, pry off the rubber pieces on the bottom of each foot of the toaster.

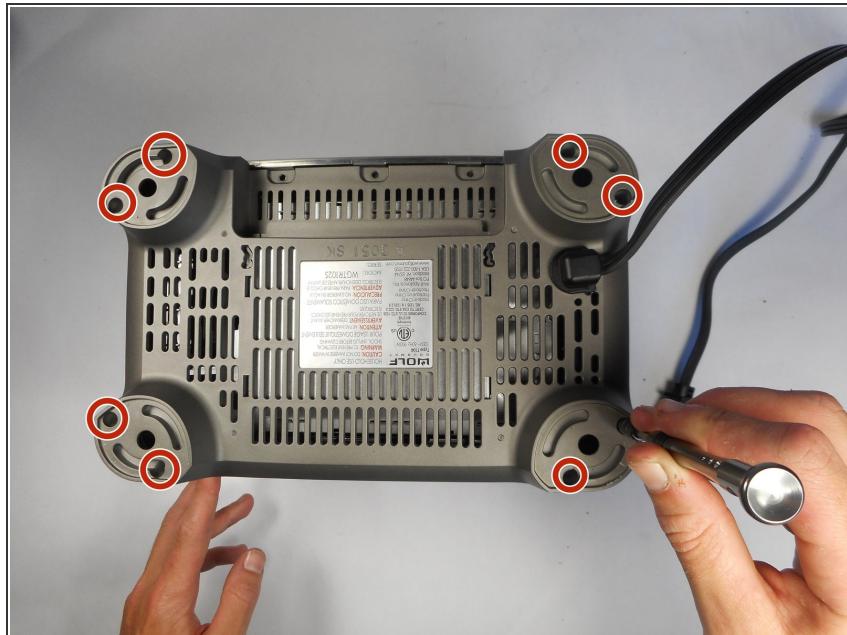
Step 2

- Remove the eight 8mm screws on each toaster foot using a Tri-point Y1 screwdriver.

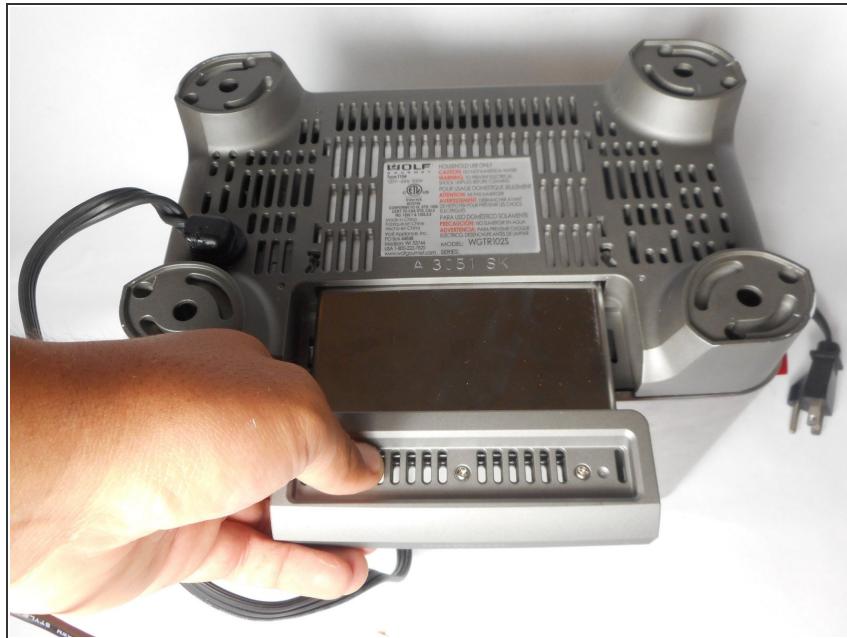
Step 3

- Remove the crumb collector located on the bottom of the toaster.

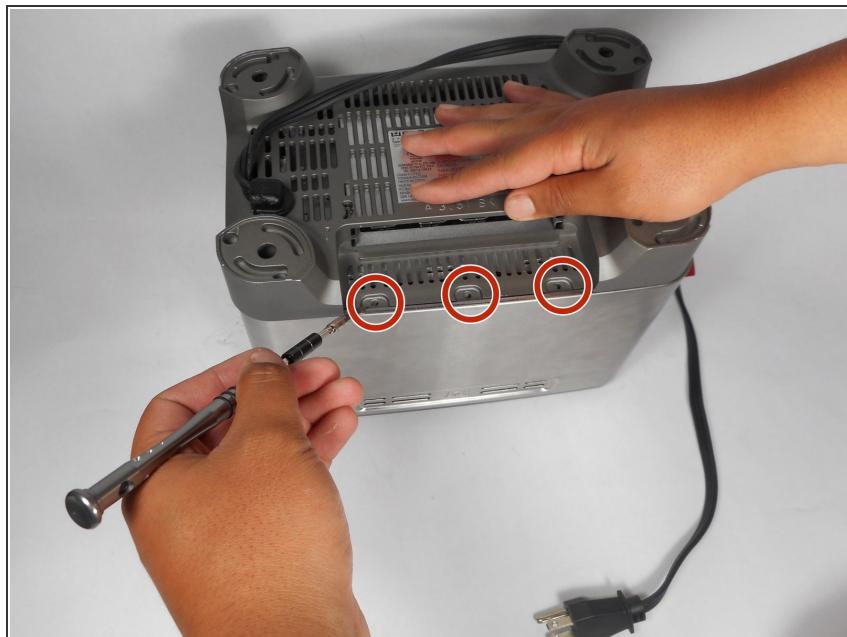
Step 4

- Remove the three 8mm screws using the Tri-point Y1 screwdriver.

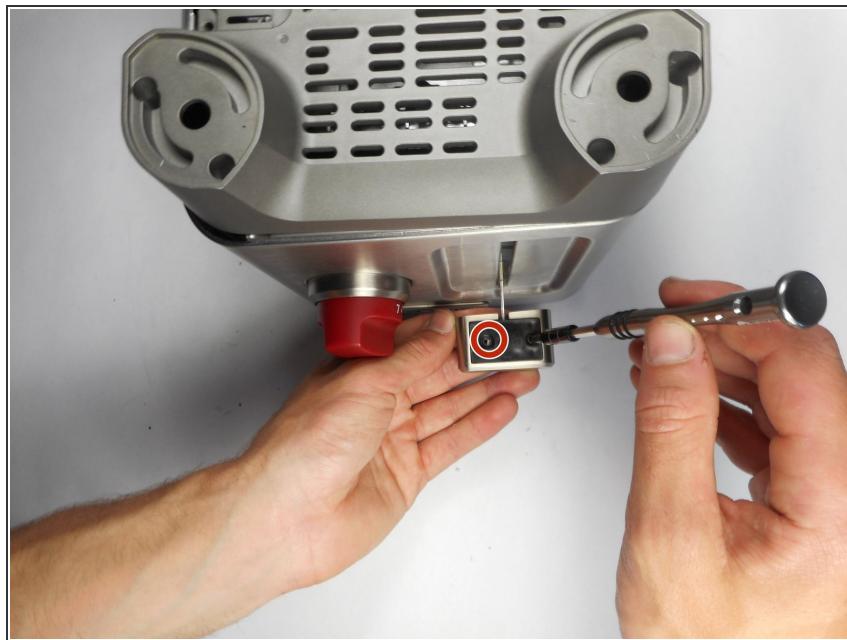
Step 5

- Remove the two 8mm screws on the bottom of the slide lever using a Tri-point Y1 screwdriver.
- Once the screws are removed, detach the black plastic cover on the bottom of the slide lever.

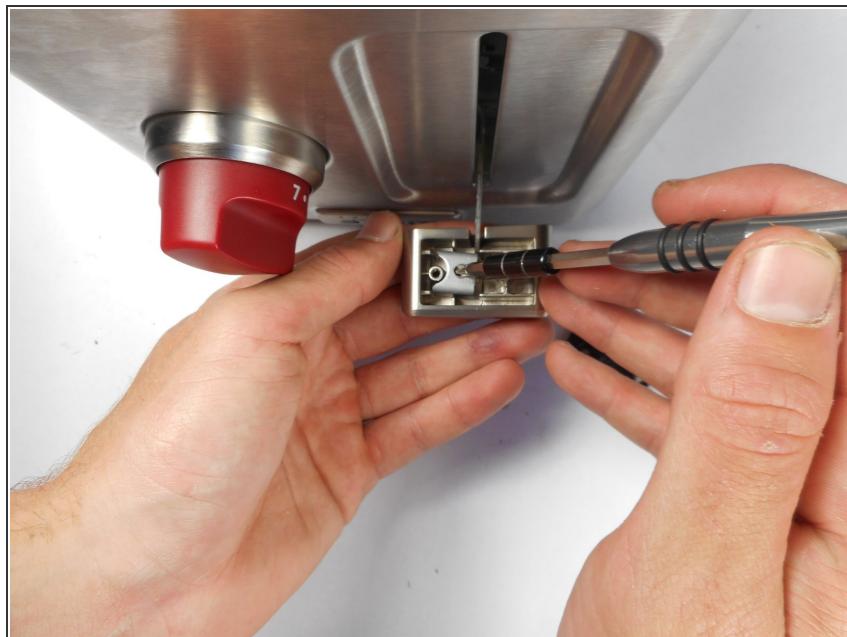
Step 6

- Remove the final 8mm screw in the slide lever.
- The lever can now pull away from the entire unit.

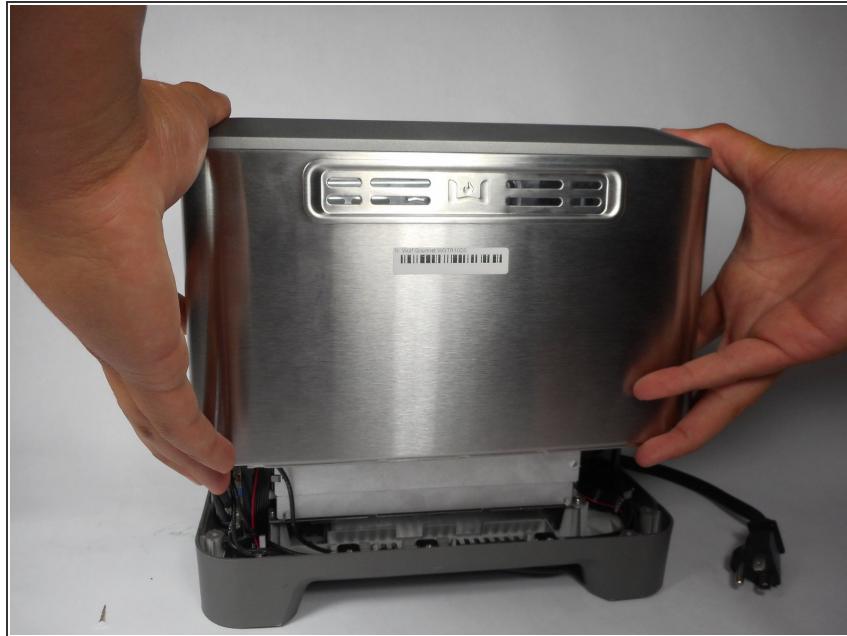
Step 7

- Remove toaster's outer shell by lifting straight up.

⚠ Slowly remove the outer shell. Disconnect ground wire before fully separating the shell and inner components.

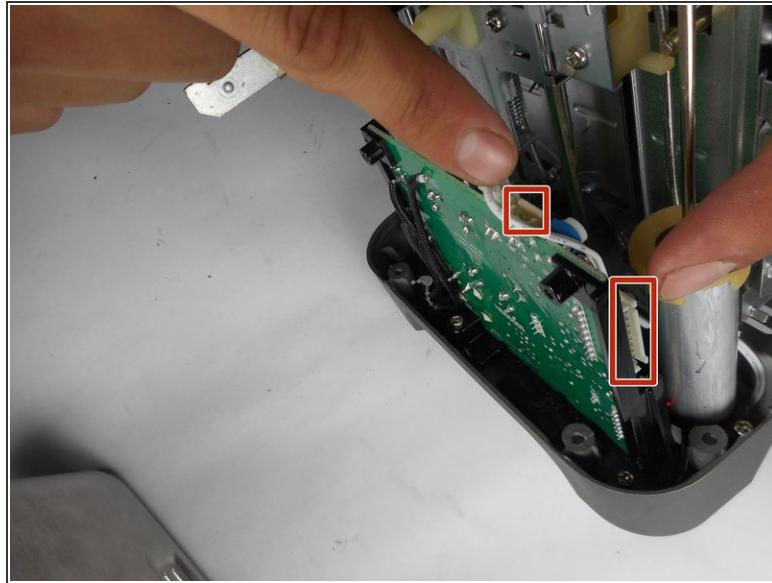
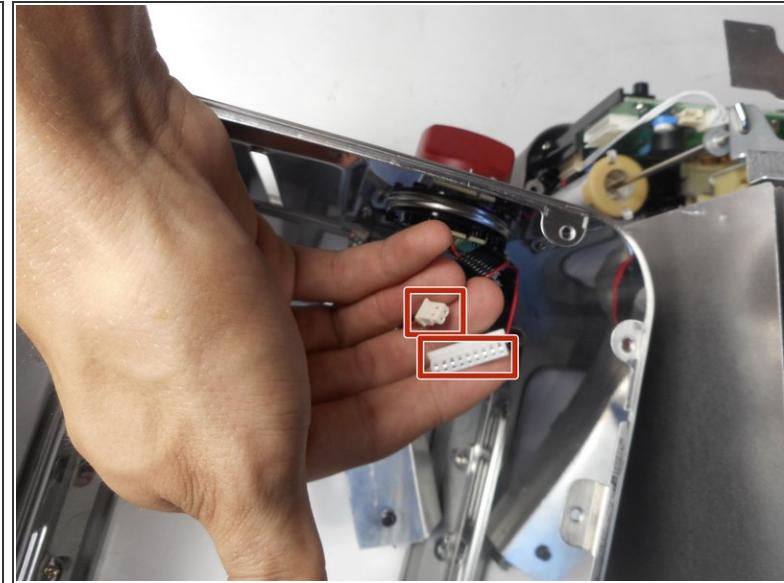
Step 8

- Disconnect the wire cluster that connects the lights and circuit board by pulling apart the two plastic connectors.
- Remove the outer shell from the device.

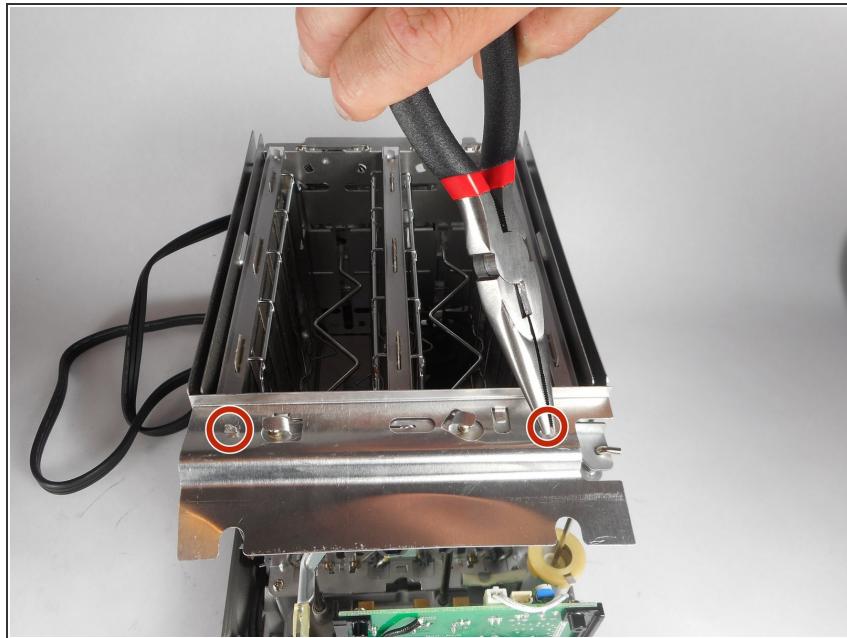
Step 9 — Slide Assist Plunger

- Remove the top panel by bending the tabs on each side straight up.

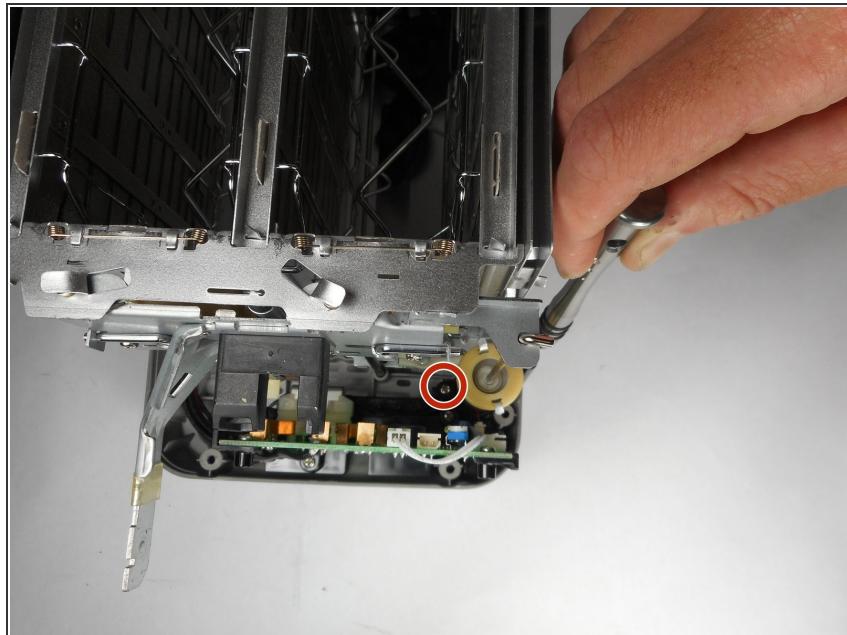
Step 10

- Remove the two 8mm screws on the bottom of the plunger using a Tri-point Y1 screwdriver.

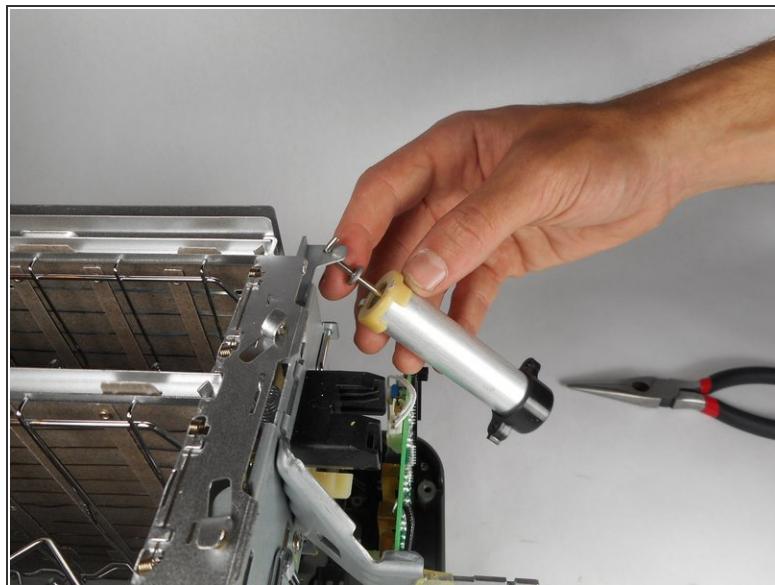
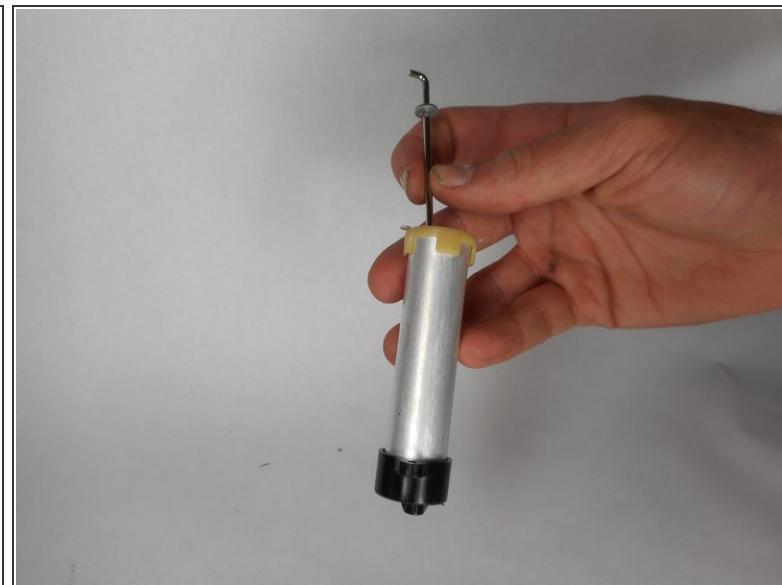
Step 11

- Remove the plunger from the device.

To reassemble your device, follow these instructions in reverse order.
