Xbox 360 HDD Replacement

This is how to take apart the Microsoft Xbox 360 HDD to possibly upgrade your drive capacity.

Written By: R Trent

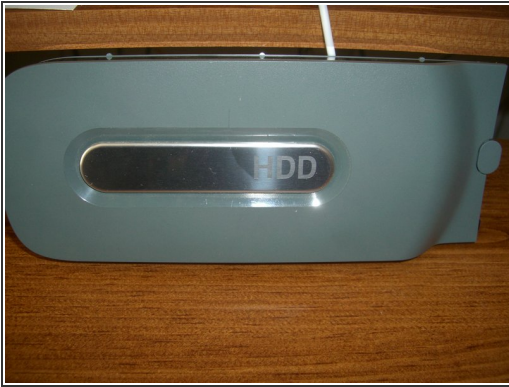
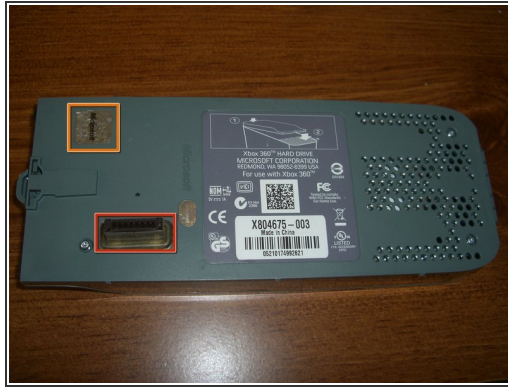
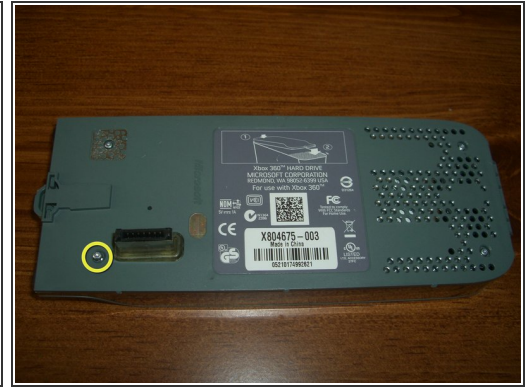
Step 1 — HDD

- Here it is. The standard 20GB HDD for the Xbox 360.
 - Notice the proprietary adapter. Inside is just a pretty standard 2.5" SATA drive...
 - I took these pictures as I was putting it back together, hence the Microsoft warranty sticker looking a little funny.
 - You may also notice the screw in the bottom left is partly out. This is because as I was replacing the screw before it, I broke my bit. I was using a 1/16" flathead bit (I don't have a T6 Torx) and used just a little too much torque and it snapped. I found another 1/16" bit to finish, but didn't get a pic.
- ☑ If you have Torx bits/drivers, use them. They will work much better than the flatheads.

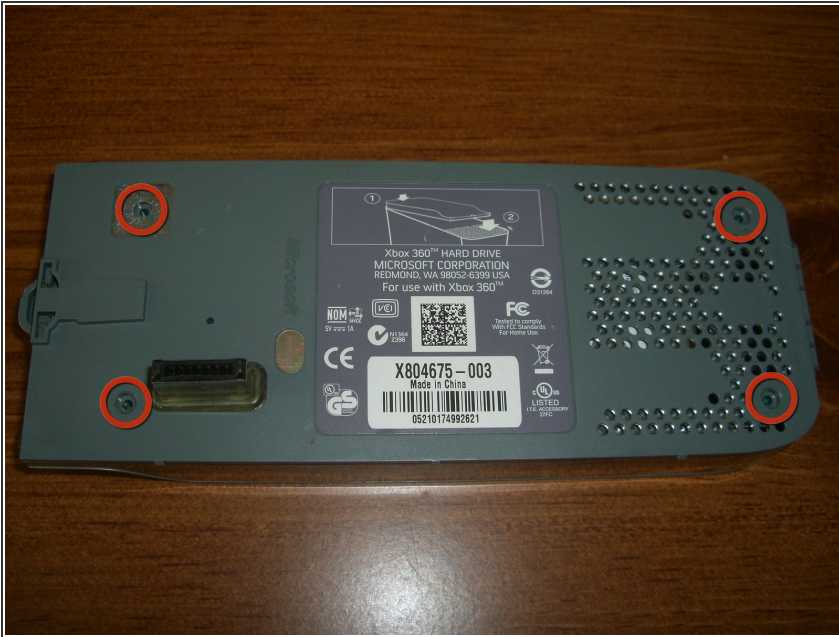
Step 2

- ❗ Remove the Microsoft warranty sticker. I used my fingernail. Note: doing so voids the warranty for the drive, if it is still valid.
- It only voids the warranty for the drive, not the console, being as their warranties are separate.
- Proceed to remove the four T6 Torx screws.

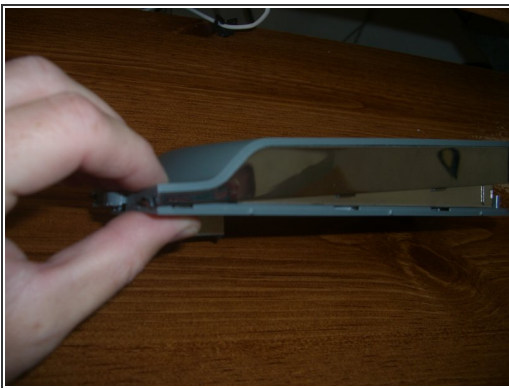
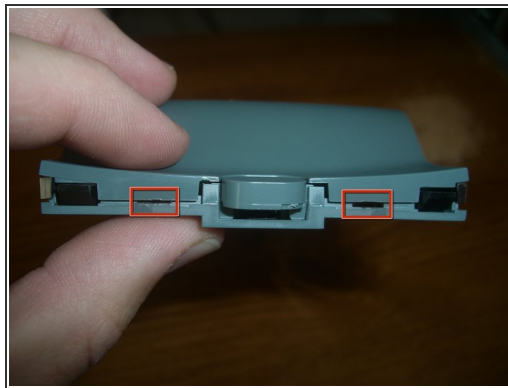
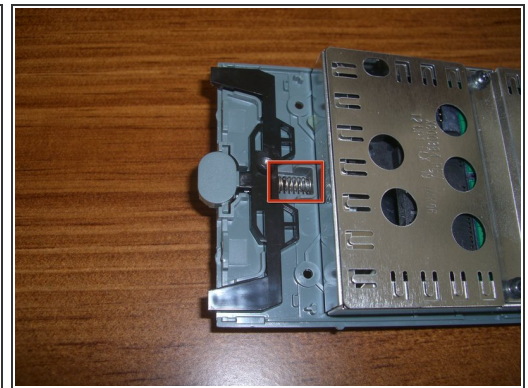
Step 3

- Holding the drive top up, gently pull the top half up from the bottom half. The back will rotate up as the front is connected by two plastic clips.
- These clips are most easily undone by rotating the top enclosure to about 30° then lifting it up firmly.
- ❗ Be careful to not let it jerk violently during separation. Once the top is removed, there isn't much of anything holding the latch mechanism in place. It would be a bummer to lose the spring, though getting the latch assembly back in place if it comes out is not too difficult, just don't lose the spring.

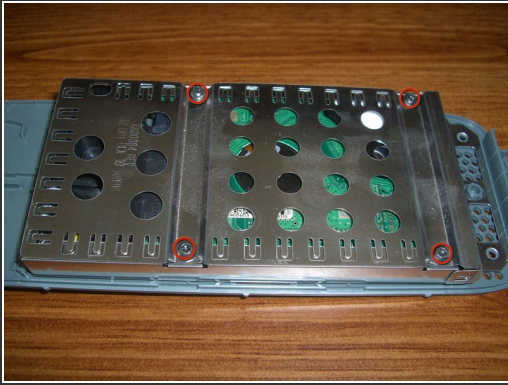
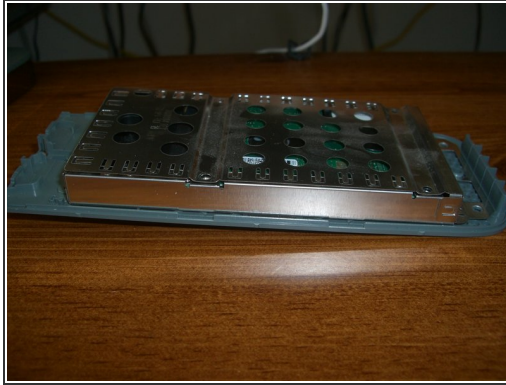
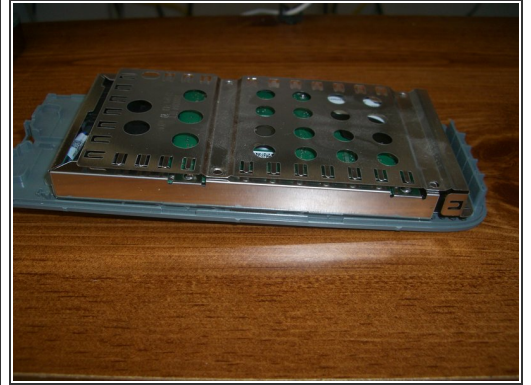
Step 4

- Remove the four T10 Torx screws.
- Slide the cover towards the back of the enclosure and remove. There is a small dot of lock-tite on each screw, fyi.
- The third image is unnecessary, but if you quickly mouse over the second and third images it kinda makes it look animated.

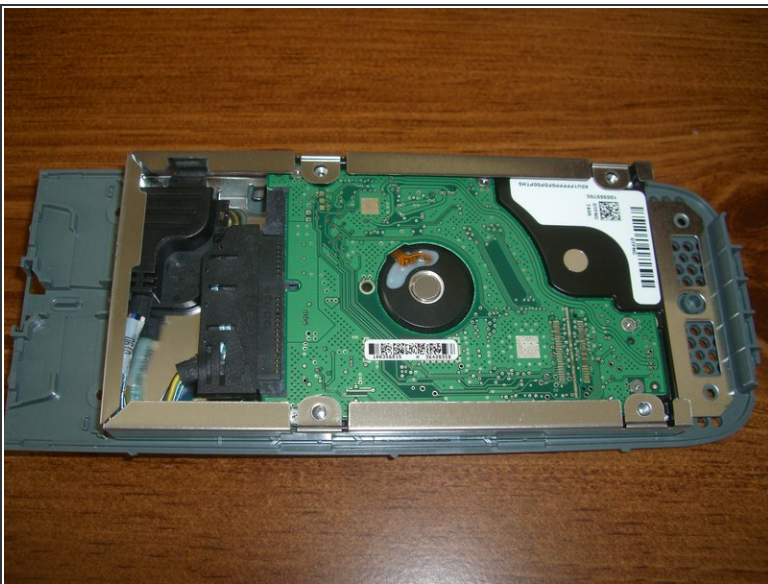
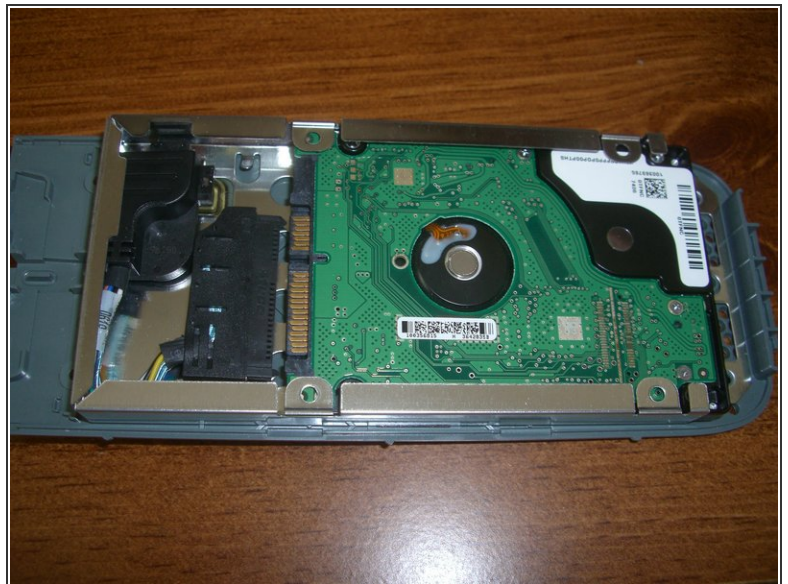
Step 5

- Here are the innards in all their glory.
- The four screws that held the cover on also held the drive in place, so just pull off the SATA connector and the drive is almost free.

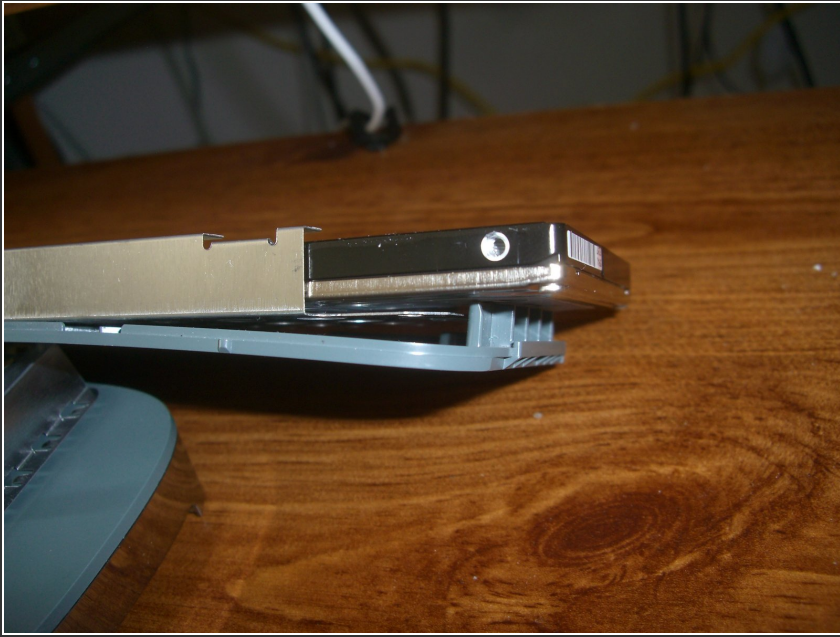
Step 6

- To actually get the drive out, you must bend the back of the plastic part of the bottom enclosure down a little bit. Doing so shouldn't break anything, just don't go overboard and bend it excessively.

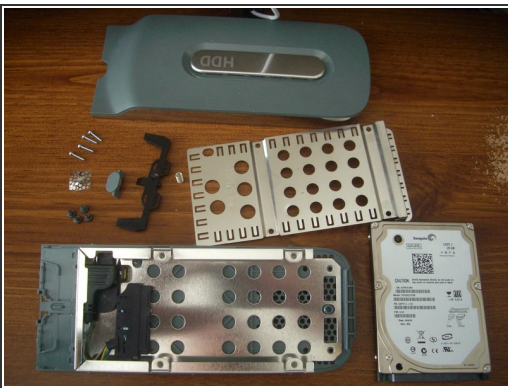
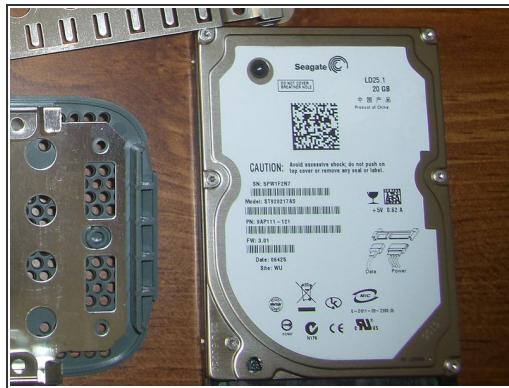
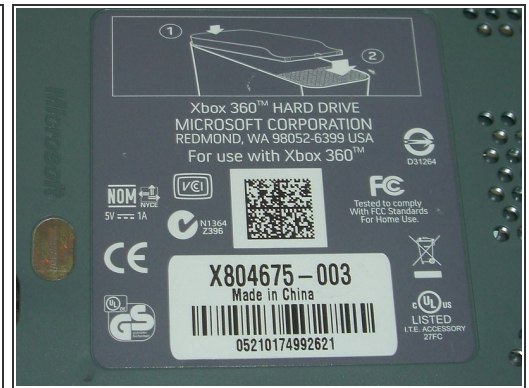
Step 7

- All the parts disassembled. The adapter cable will probably come out as it doesn't seem to be attached directly, but removing it would have required bending the metal enclosure and I didn't want to mess with that.
- I thought it interesting to note that the drive runs at 5V 0.62A when the enclosure states 5V 1A. I wonder where the other 380mA are going.
- Also interesting to note: this is a Seagate drive, while the 250GB drive upgrade I mention in the description requires a WD drive. If I understood correctly, this is because the software to format the drive to be recognized by your 360 is written for the WD firmware.
