Xbox 360 Top Vent Replacement

Top vent replacement.

Use this guide to remove the gray plastic top vent from your Xbox 360.

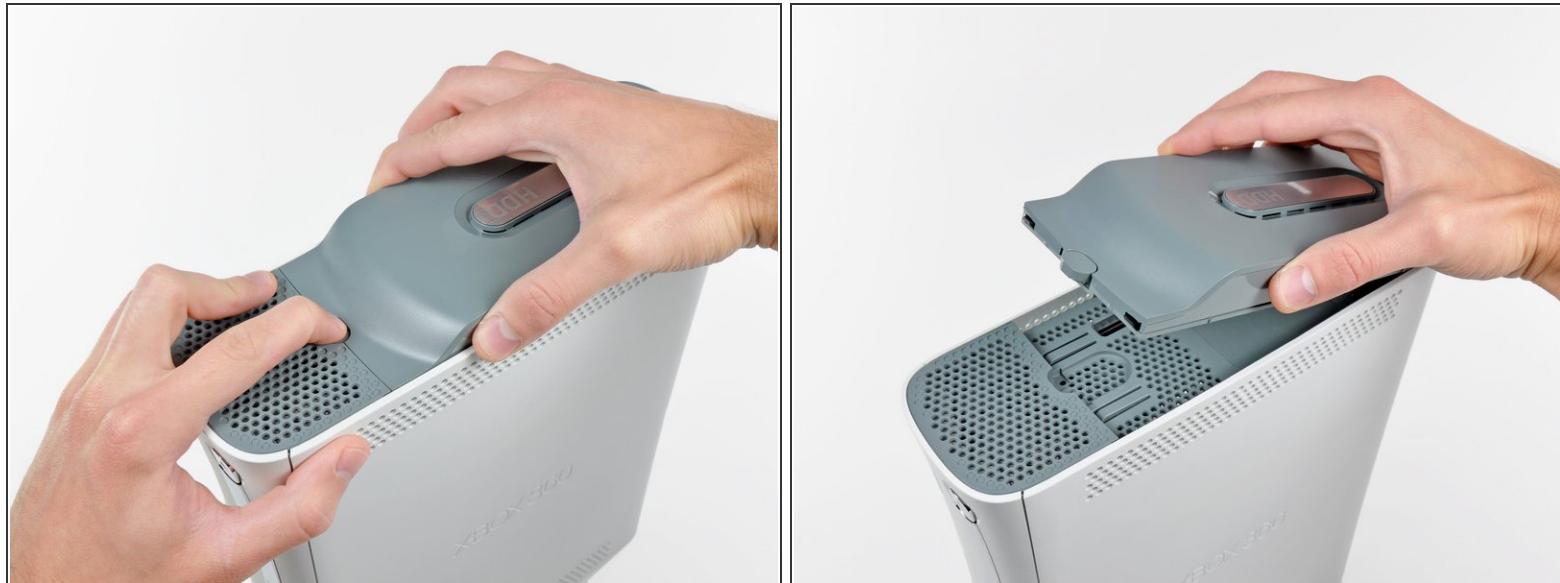
Step 1 — Hard Drive

- Grasp the hard drive assembly and press the release button while lifting its front edge.
- Remove the hard drive assembly from the top vent.

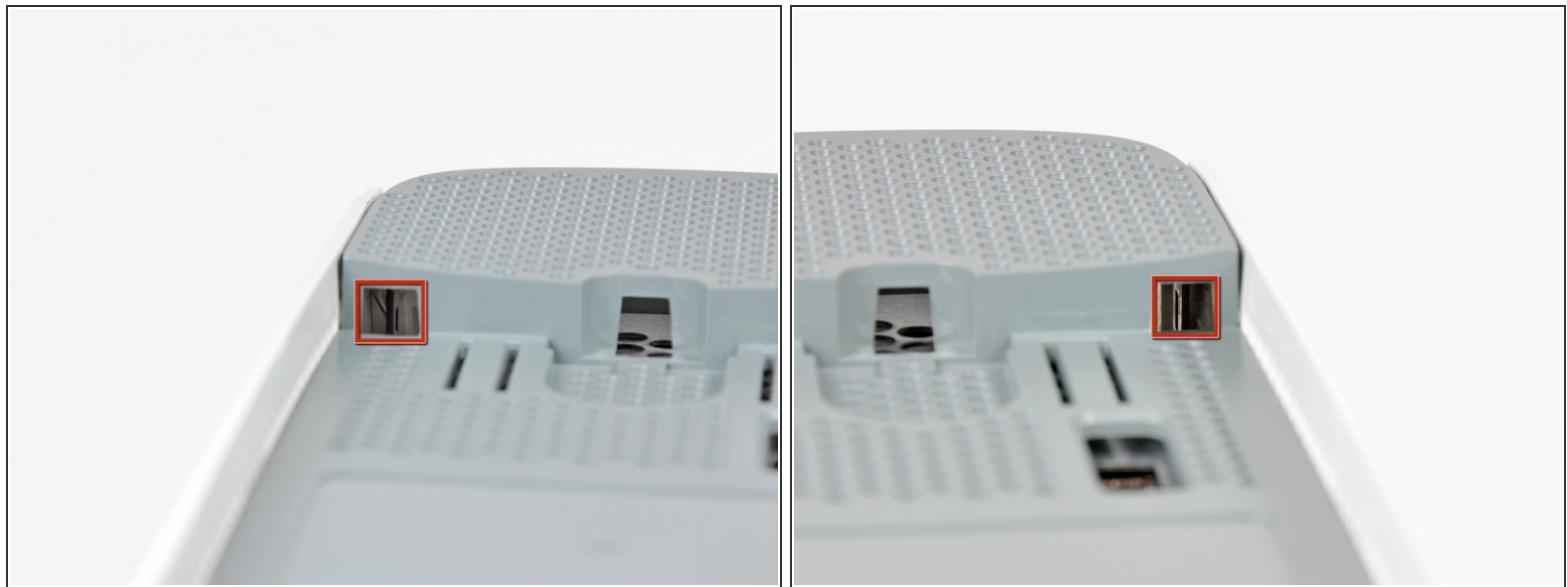
Step 2 — Top Vent

Stand the console vertically with the top edge facing up.

- The top vent is secured to the console via clips. The first two clips are located underneath the top vent closest to the faceplate, as shown in the pictures.

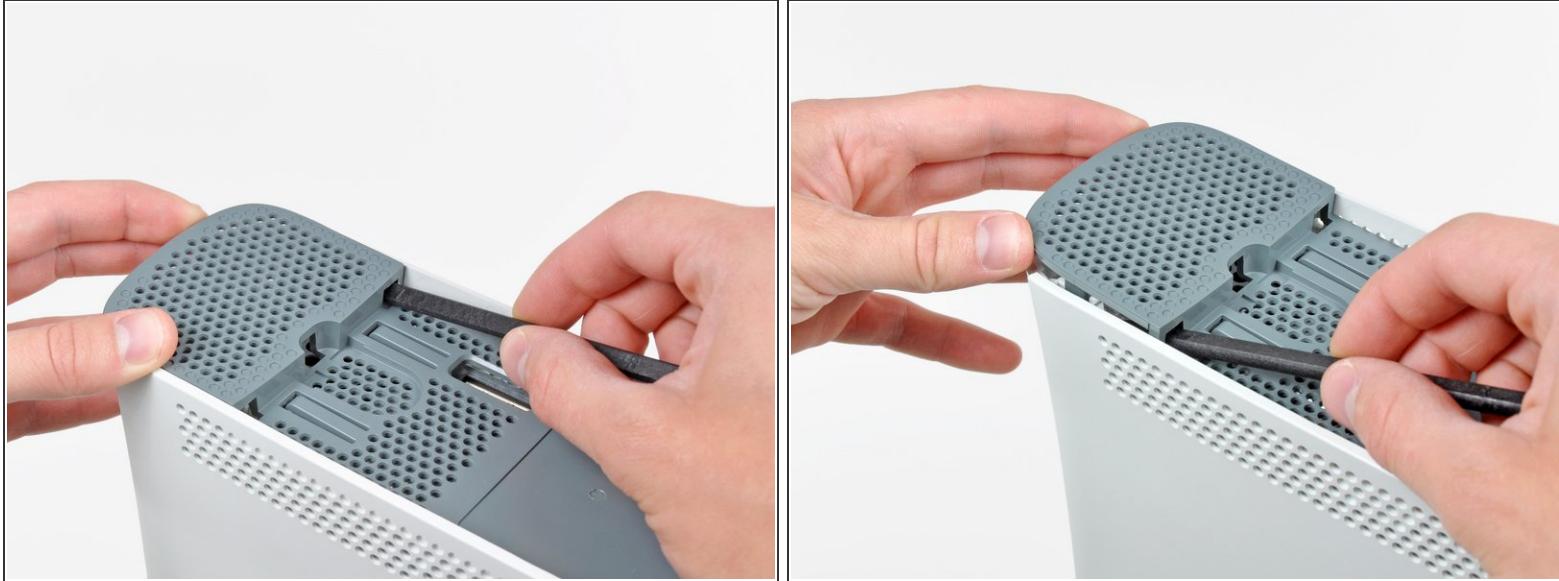
Step 3

- Insert the flat end of a spudger into the small gaps previously mentioned to release the clips.
- You may also use the long finger of an Xbox 360 opening tool to accomplish this task.

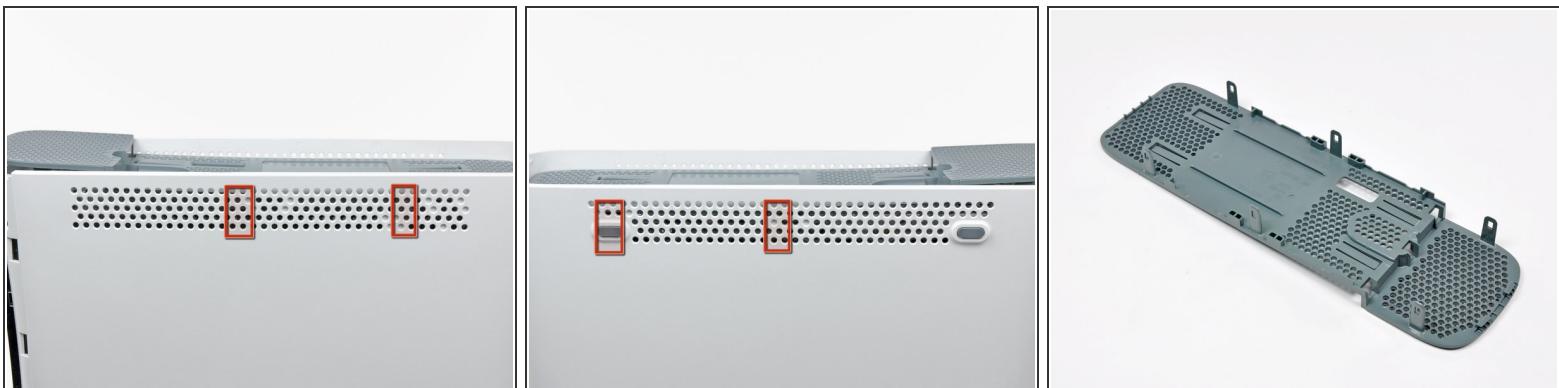
Step 4

● In the next few steps, you will use the tip of a spudger or the finger of an Xbox 360 opening tool to release the clips along the left and right sides of the top vent. Their locations are highlighted in red.

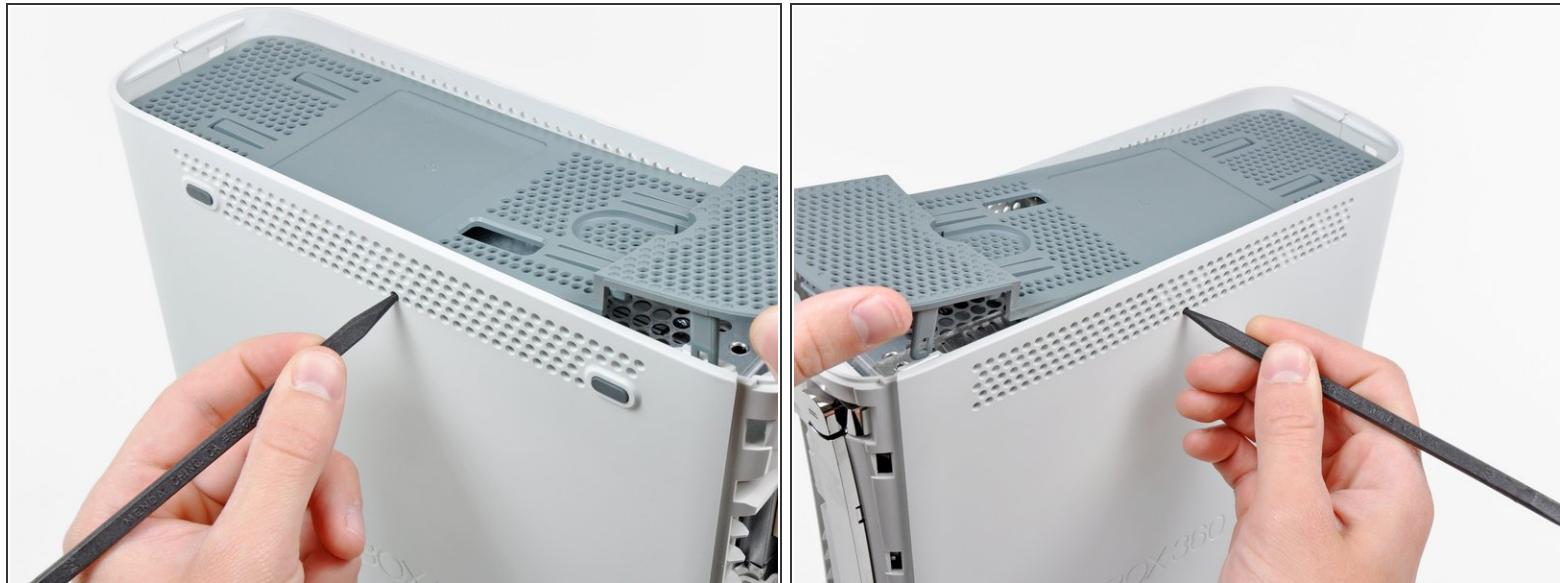
Step 5

- To release the clips, work from the middle of the top vent.
- While slightly lifting the front edge of the top vent, use the tip of a spudger to push the clips closest to the center of the top vent towards the inside of the console.

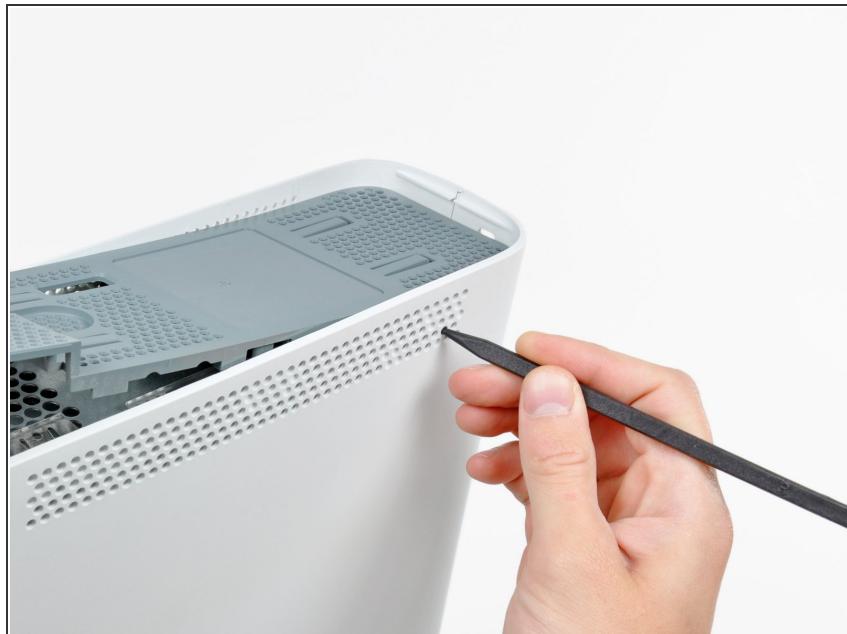
Step 6

- Use the tip of your spudger to release the clip on the top vent nearest the back of the Xbox's upper case.

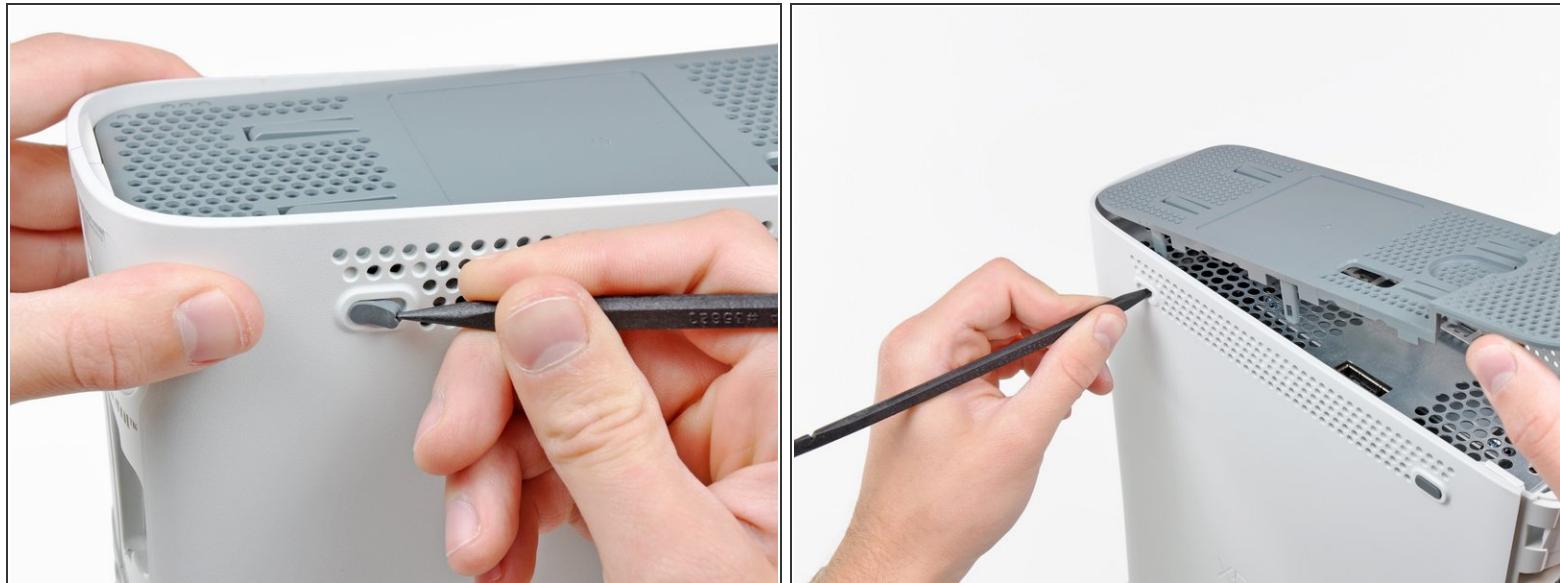
Step 7

(i) The last clip is hidden underneath the rubber foot nearest the back of the console.

- Use the tip of your spudger to release the clip on the top vent nearest the back of the Xbox.
- Remove the top vent from the 360.
