# iDea USA CT 1020 Front & Rear Camera Assembly Replacement

A step-by-step replacement guide for front and rear camera assembly.

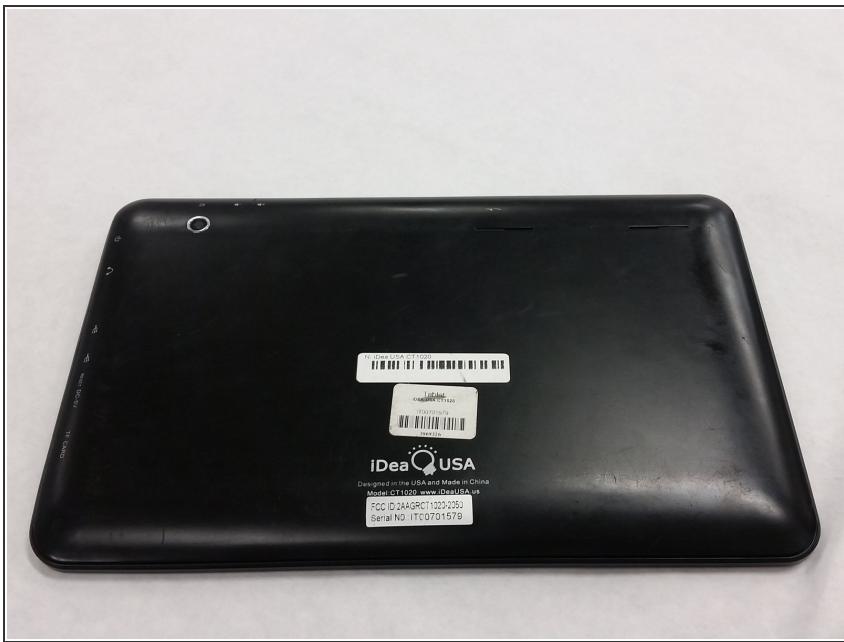
## Step 2

⚠ First, power down the tablet to avoid the chance of electrical shock or damaging the machine during repair work

- Place the tablet on a clean surface with the screen down

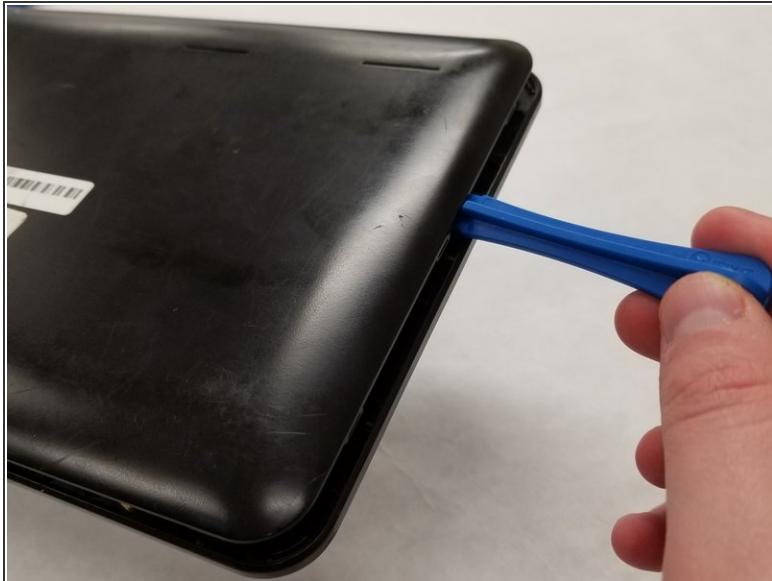
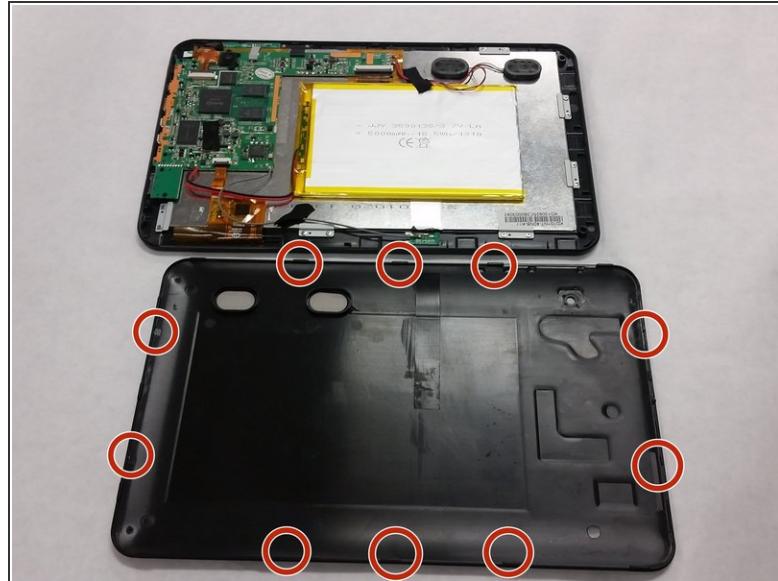
- Remove the back plastic casing of the tablet by releasing the plastic clips with a plastic opening tool or a spudger.
- *i* Be cautious and take your time here; the plastic clips are quite fragile.

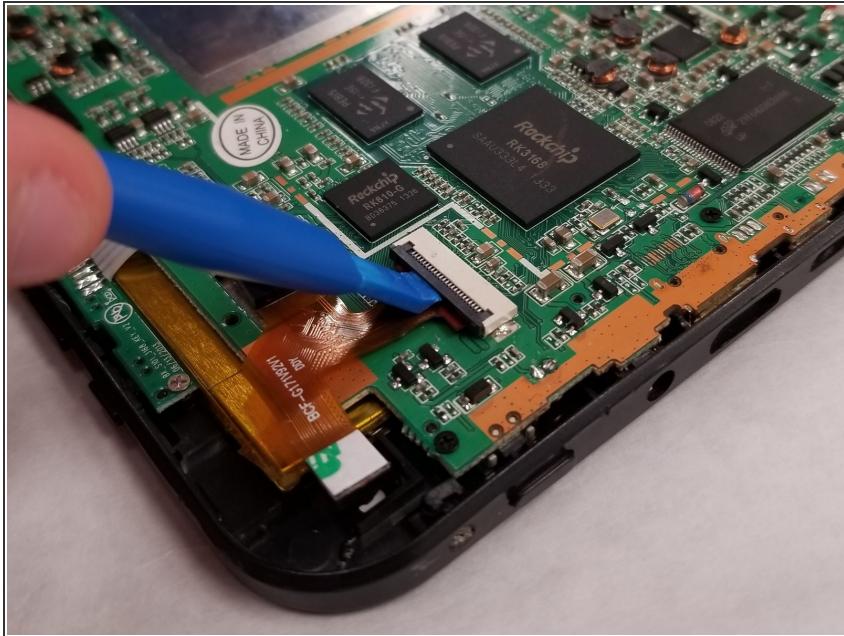
## Step 3

- Use a plastic opening tool or spudger to lift and release the camera assembly ZIF tab.
- Gently pull the ribbon cable free.

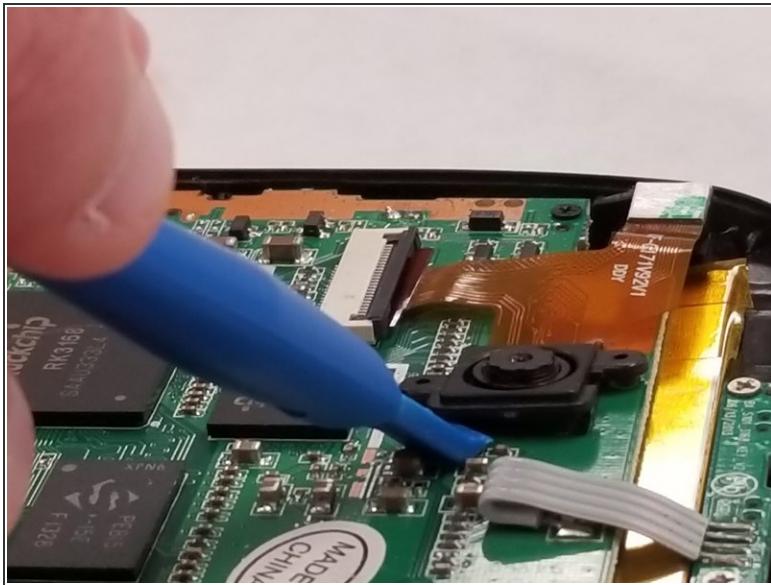
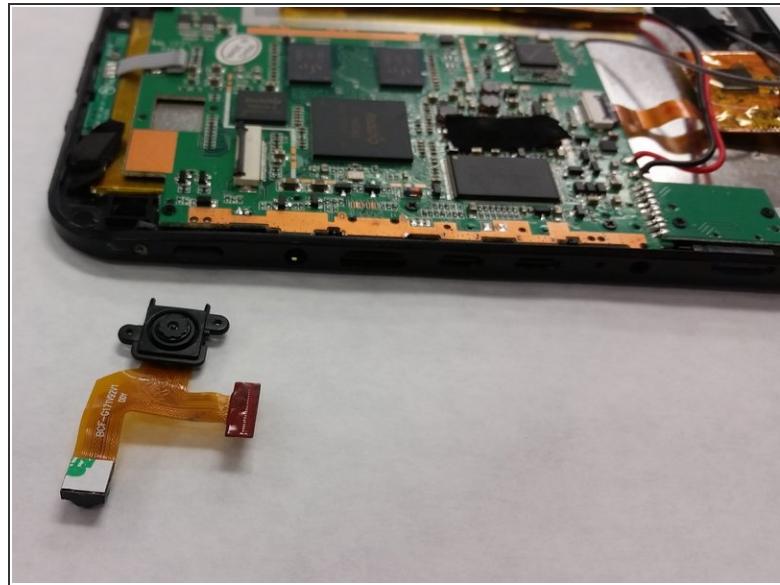
## Step 4

- The camera is held in place by adhesive material on the back of the camera
- To complete removal, peel the camera off the mother board
