iPad Mini Wi-Fi Teardown

iPad Mini Wi-Fi teardown, torn down on Halloween 2012.

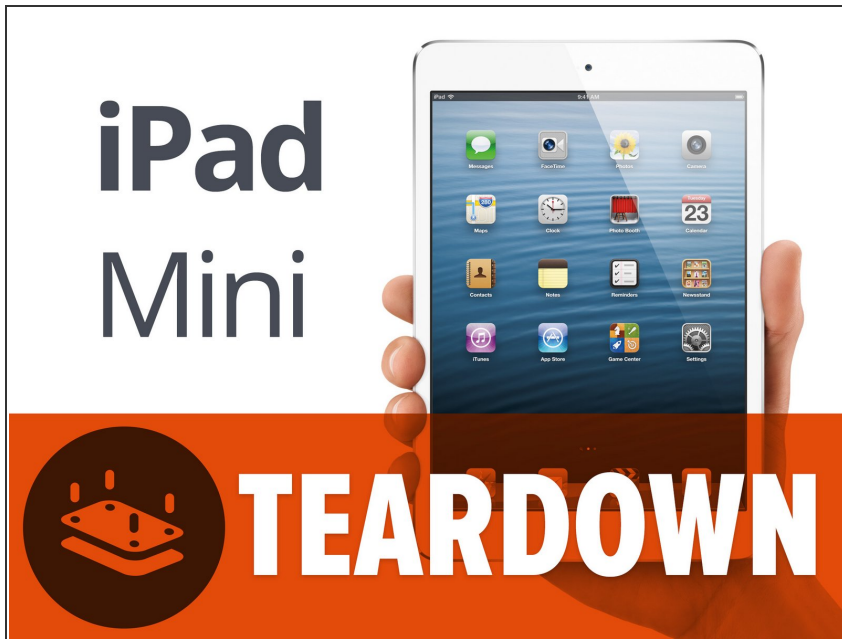
Step 1 — iPad Mini Wi-Fi Teardown

- What do you get when you cram an iPad into a smaller and lighter frame?
 - 7.9" 1024 x 768 pixel (163 ppi) multi-touch display
 - Dual-core A5 processor
 - 5 megapixel rear-facing and 1.2 megapixel front-facing cameras
 - Bluetooth 4.0
 - Lightning connector
 - 16, 32, or 64 GB capacity

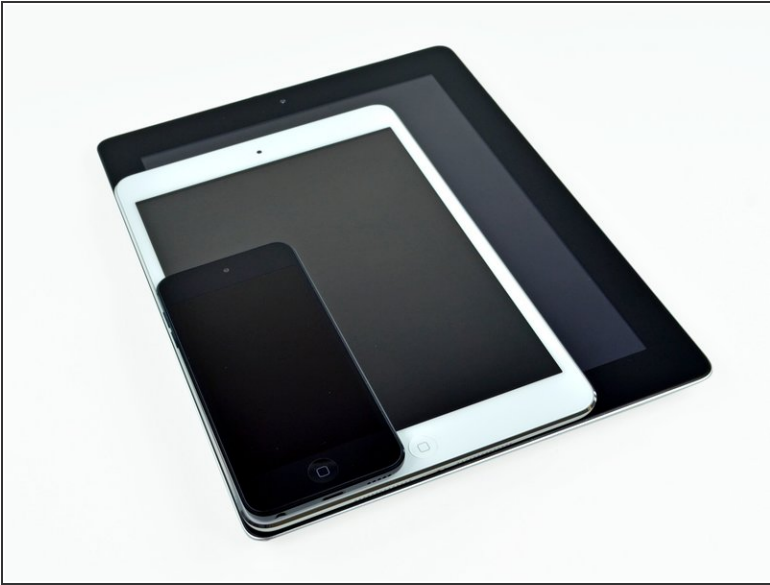
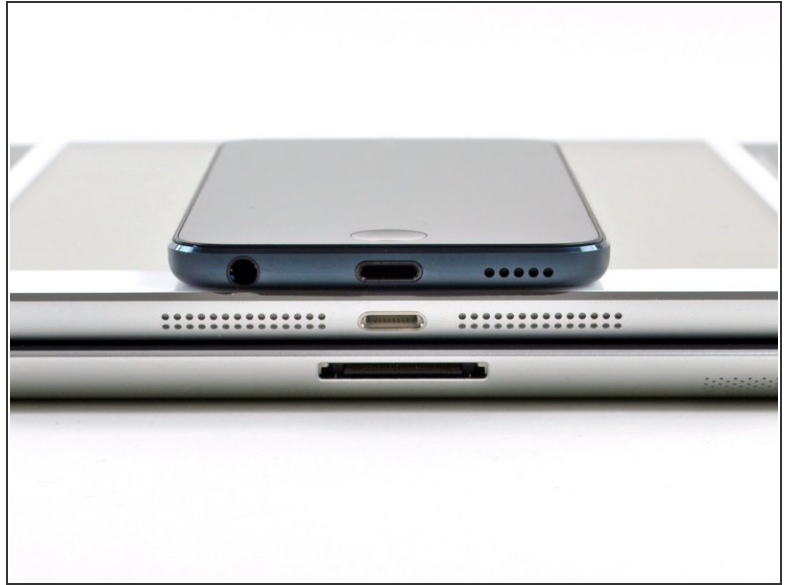
Step 2

- Comparison time! With the introduction of the Mini, Apple now offers iDevices fit for any budget. Let's take a look at how they stack up.
- From bottom to top:
 - [iPad \(3rd Generation\)](#)
 - [iPad Mini](#)
 - [Slightly smaller iPad Mini—aka iPod Touch](#)
- The iPad Mini has not one, but **two** speaker grilles to pump out mini beats. Don't let the [iPhone 5's dual grilles](#) fool you; the Mini is the first handheld iDevice to house stereo speakers.

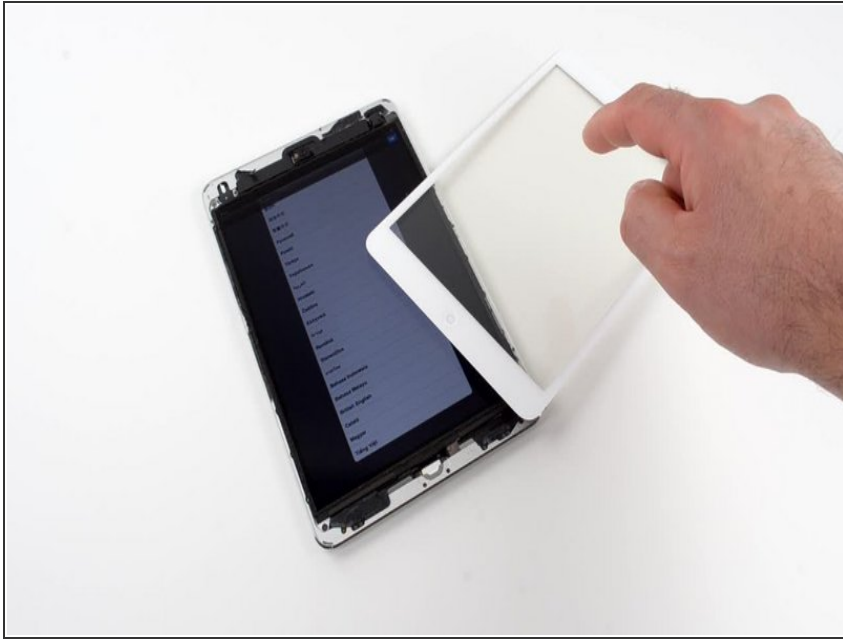
Step 5

- The touchscreen still functions with the glass separated from the LCD.
- We were pleasantly surprised that this round of glass removal was easier than [previous ones](#), requiring less patience and a near-zero fear-factor.
- With the glass removed, we are ready to get at the guts of this pint-sized iPad (or gallon-sized iPod, depending on how you look at it.)

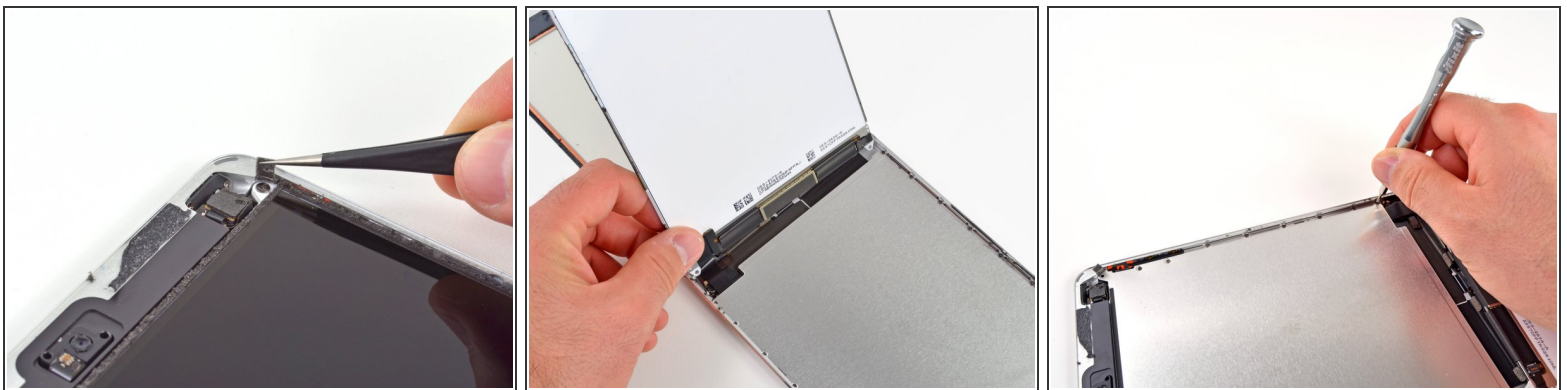
Step 6

- So far it looks like Apple has more tricks than treats for us with a hidden screw securing the display.
- After dispatching two hidden screws and two exposed screws with our [54 Bit Driver Kit](#), we are able to lift the LCD.
- Pulling up the display reveals a large metal plate, held in with no fewer than **16** screws.
 - We found similar plates in the [iPod Touch 5th Generation](#), and the [iPhone 5](#), so this seems to be a new iDevice design convention.

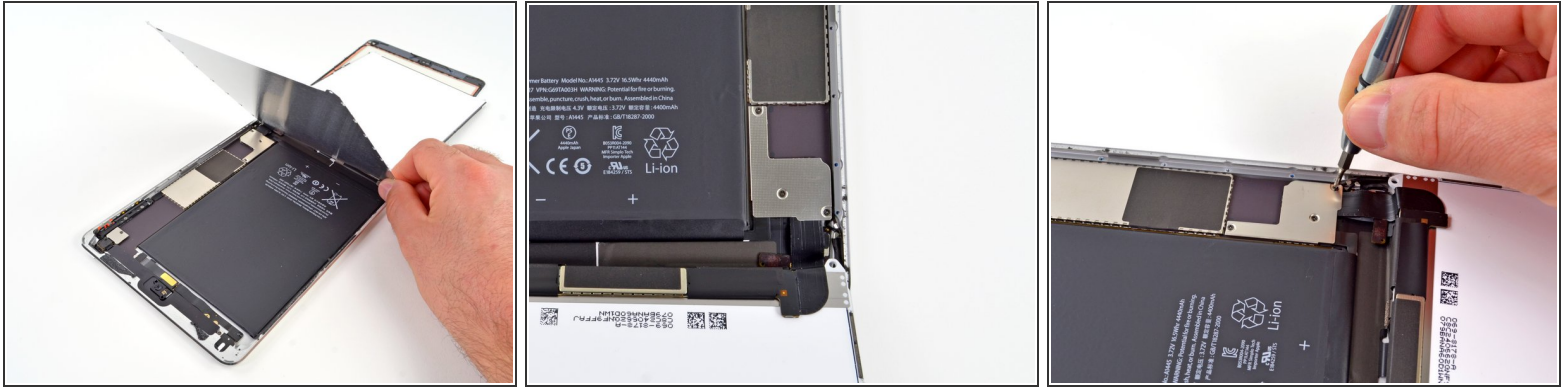
Step 7

- Time to remove some metal. With the inner frame and the connector covers, there is enough metal here to forge at least two—maybe three—paperclips.
- All this prying and disconnecting is reminding us a lot of our recent [iPod Touch teardown](#). But remember, the Mini and the Touch are, in fact, [different devices](#).

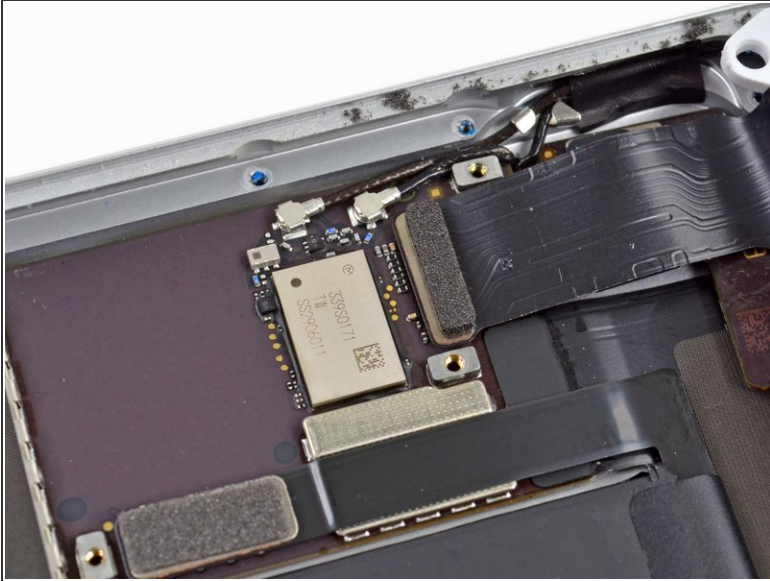
Step 8

- Our first exposed IC is one we've seen before, in the [iPhone 5](#).
 - In fact, you might say we've got a pretty close relationship with the [Murata 339S0171 Wi-Fi module](#).
- More tricks, fewer treats! With [plastic opening tool](#) in hand, we disconnect the display connector, but there's still something holding the LCD in...

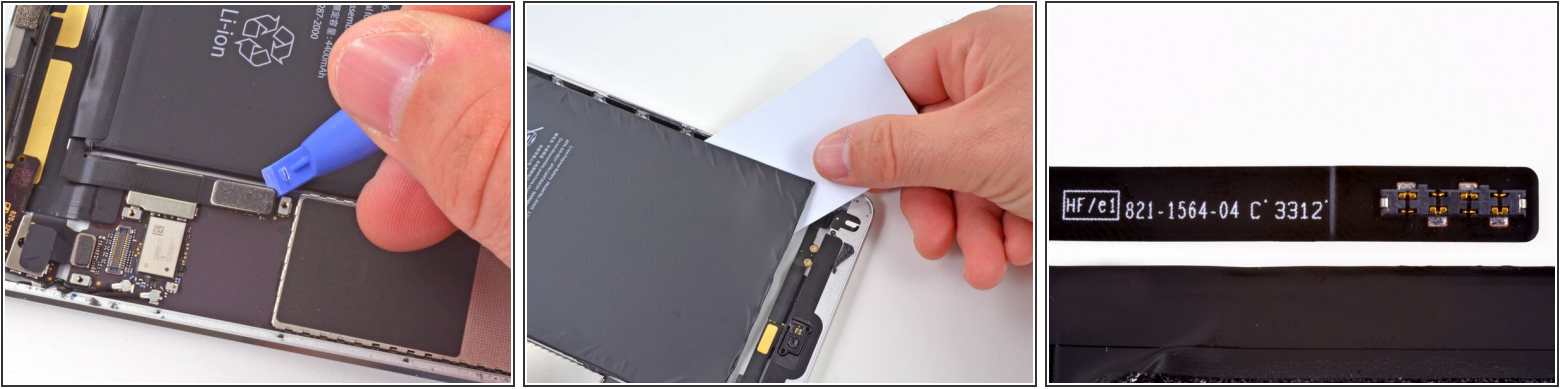
Step 11

- Fortunately, the iPad Mini inherited the connector-fastened battery from its [larger sibling](#), not the soldered-in battery found in the [iPod Touch](#).
- A [plastic card](#) makes a nice tool to pry the battery up from the rear panel, but it's still a very difficult task to break through all of the adhesive securing it to the rear case without puncturing the cells.
- A close-up of the battery connector exposes the numbers 821-1564-04 C 3312.

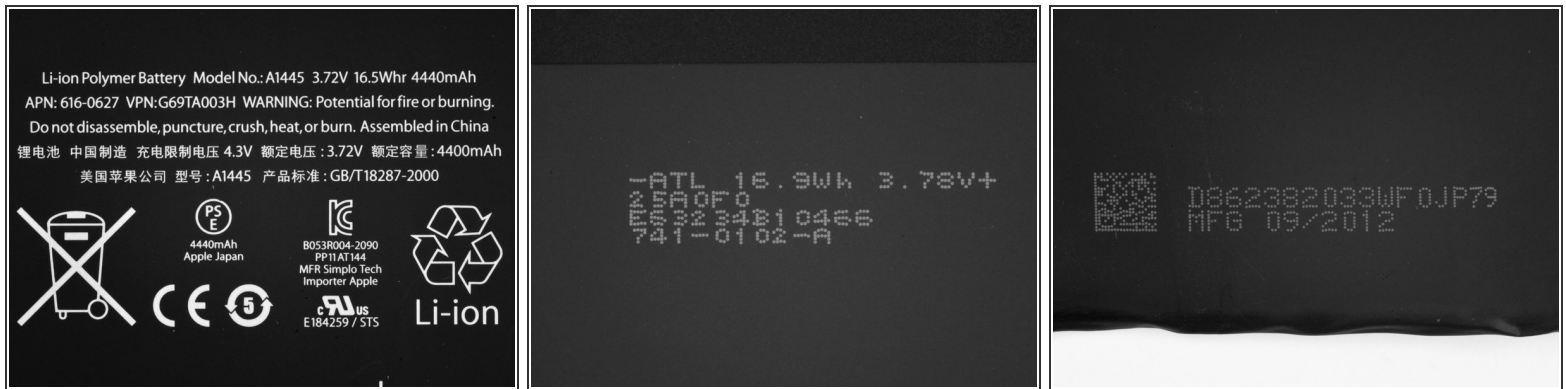
Step 12

- We get a good look at the battery, and find ourselves scratching our heads a bit.
 - This is a 3.72 V, 16.5 Whr, 4440 mAh battery.
 - Or maybe it's a 3.78 V, 16.9 Whr, 4400 mAh battery?
 - Or maybe it's a 3.72 V, 4400 mAh battery?
 - Or maybe, according to Apple's tech specs, it's only [16.3 Whr](#).
- Whatever the capacity, it's decidedly mini when compared to the massive [43 Whr](#) battery in the iPad 3. Even the venerable iPad 2 sports a [25 Whr package](#), 50% more than the iPad Mini.

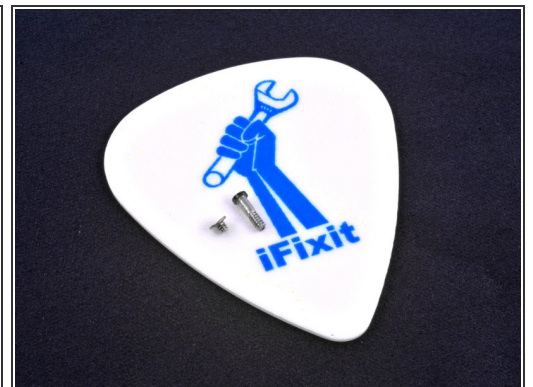
Step 14

- An antenna sits on top of each speaker, presumably Wi-Fi and Bluetooth.
- ❗ Apple wasn't joking about "mini"; these are some of the smallest screws we have ever seen!
- For comparison, the screw on the right is from the [bottom of an iPhone 5](#), where the screw on the left is from the Mini.

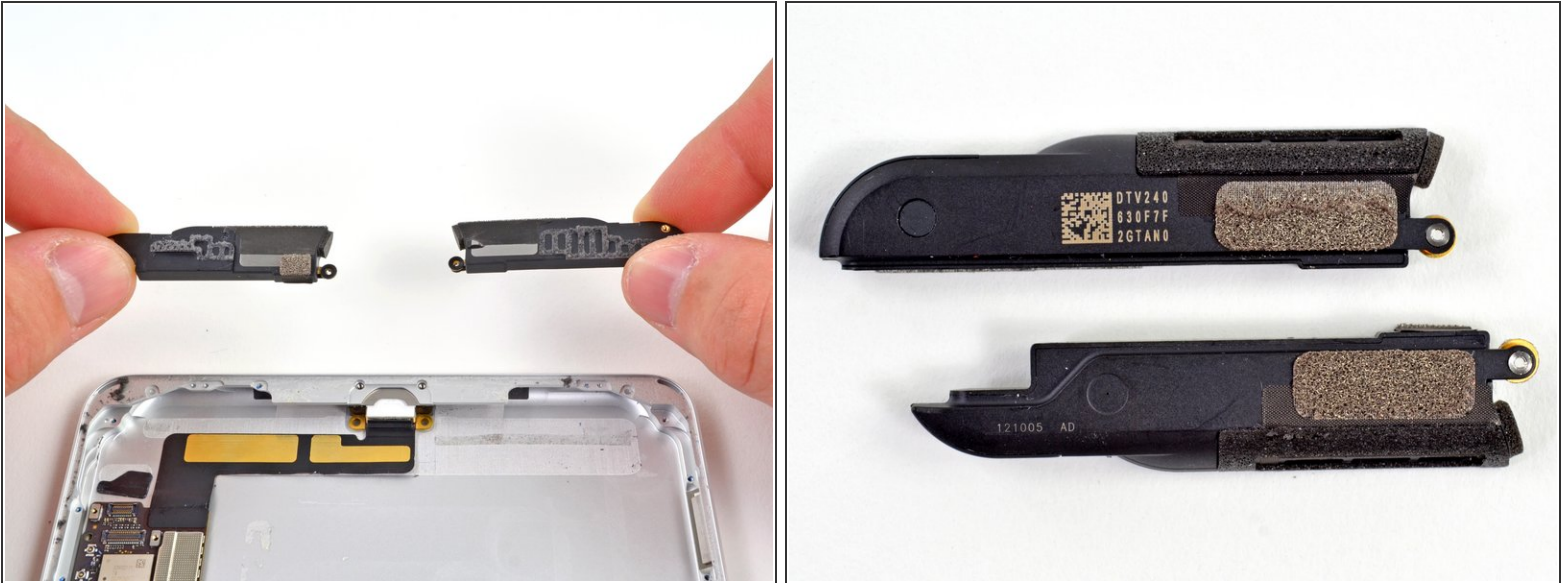
Step 15

- The folks at [Amazon doubted](#), but we can confirm the Mini does indeed sport stereo speakers. In this one regard, the Mini outdoes the still-mono Retina iPad.
- The reduction of connector size (30-pin to Lightning) has left just enough space to squeeze a second speaker into the device, allowing for sound quality that is anything but mini.

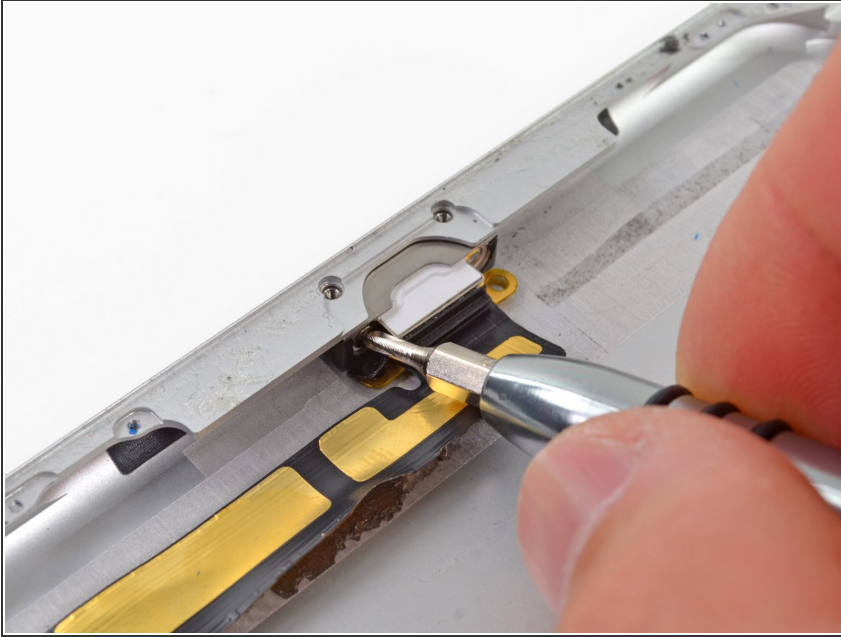
Step 16

- Two hidden screws secure the Lightning connector to the rear case.
- They've been around less than two months, but Lightning ports are spreading like wildfire across nearly the entire iOS lineup. However, the iPad 2, iPhone 4/4S, and iPod Shuffle are still Lightning-less...for now.
- As badly as we want to completely remove the Lightning port ribbon cable, we will have to wait, as it appears to be soldered to the logic board.

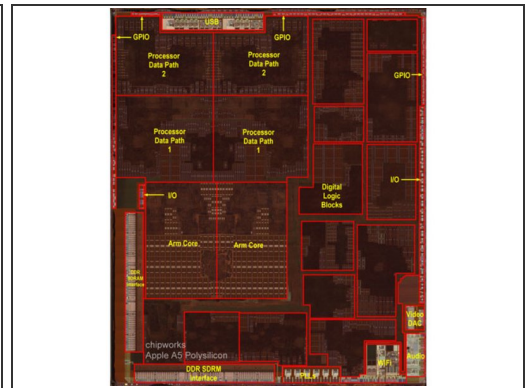
Step 20

- The A5 processor has 512 MB RAM, just like the processor in the latest iPod Touch.
- How do we know? The package markings E4064P3PM-8D-5 indicate the A5 has two 2 Gb, LP DDR2 RAM dies inside, according to [Chipworks](#).
- These die photos from [Chipworks](#) shows the inner workings of the A5. Care to see the die in all its gory glory? Check out the [high-res](#) version.

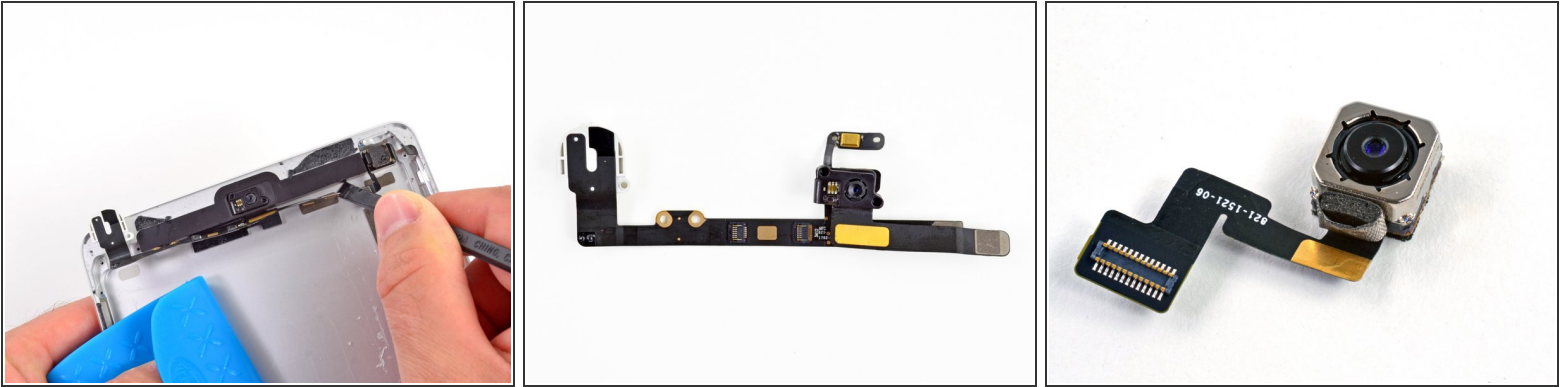
Step 22

- Strong adhesive continues to slow our advance, so another hit with the heat gun is prescribed to pry the headphone jack and front facing camera assembly out of the rear case.
- The iPad Mini does well in the camera department. While most hardware specs closely match the aging iPad 2, its cameras match those found in the the Retina iPad. Its front-facing FaceTime HD camera delivers 1.2 MP photos, and the rear-facing iSight camera delivers 5 MP resolution and HD video.

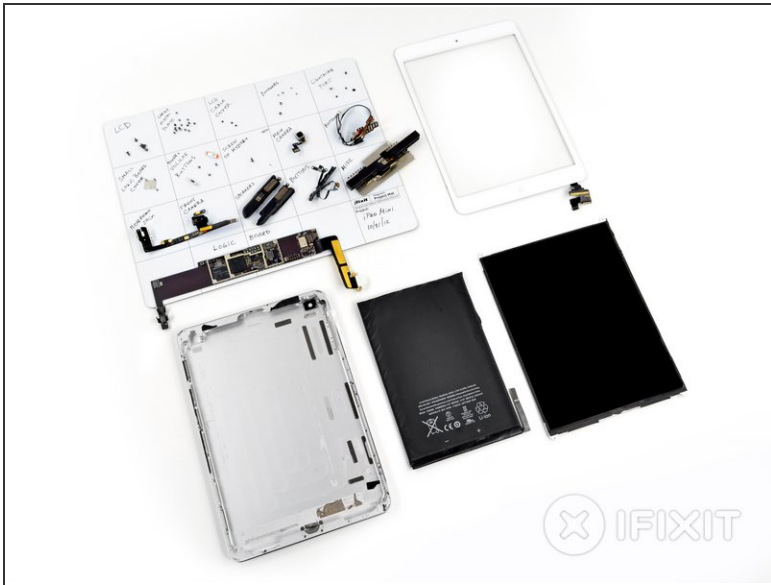
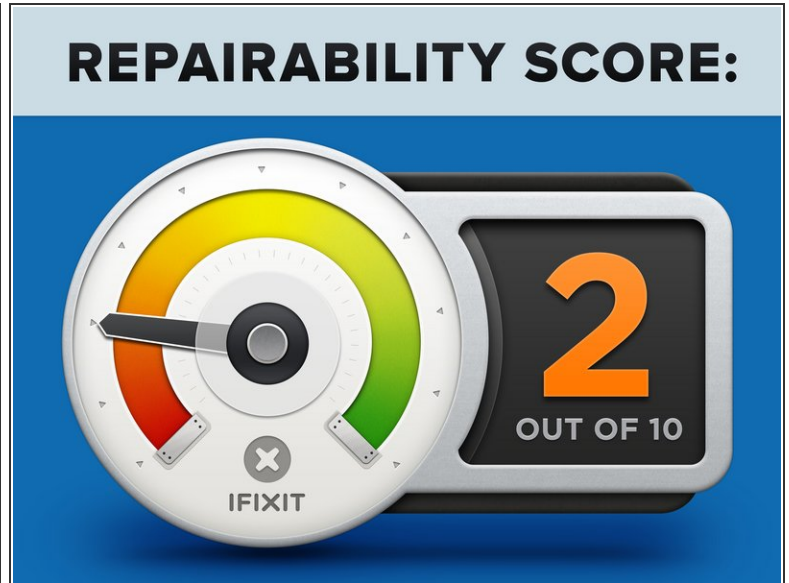
Step 23

- iPad Mini Repairability: **2 out of 10** (10 is easiest to repair).
 - The LCD and glass are not fused together and can be replaced independently.
 - The battery is not soldered to the logic board or other components.
 - Teeny-tiny screws can be easily misplaced if you're not careful. Don't sneeze too hard while taking them off.
 - Copious amounts of adhesive hold many components in place -- front glass, logic board, battery, front camera, back camera, ribbon cables -- making repair extremely difficult.
 - The Lightning connector is soldered to the logic board, so don't bend its pins.
 - Hidden screws mean you'll need to be very diligent when trying to remove internal components.
