iPhone 11 Pro Max Teardown

Exploratory teardown of the newest iPhone, with new ultra-wideband hardware and rumored reverse wireless charging. Performed Sept. 20, 2019.

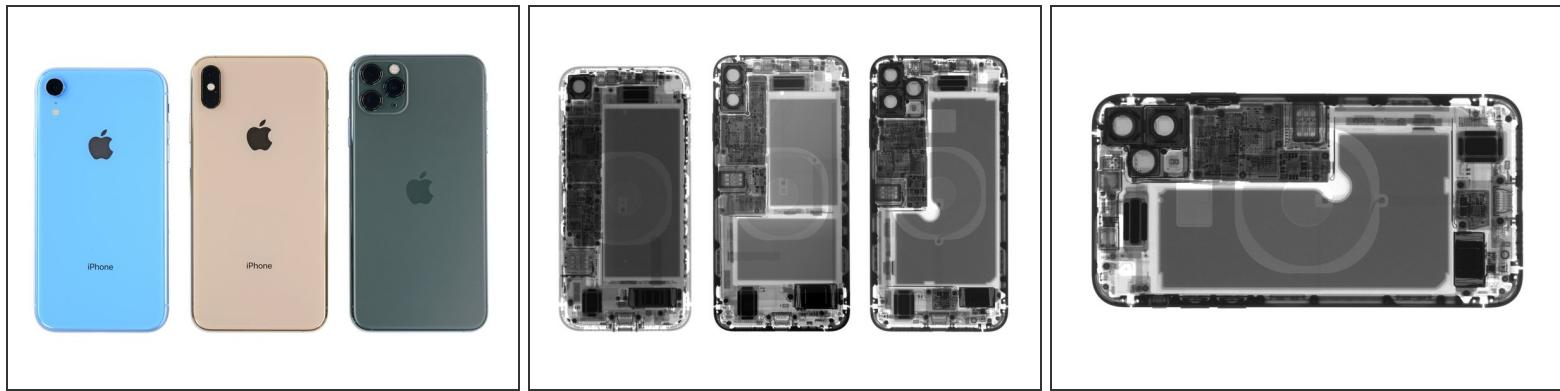
Step 2

- Before getting too far, we ask our friends at [Creative Electron](#) for a little help. Wielding the power of X-rays, they give us a sneak peek of what lies ahead.
- Lined up for your viewing pleasure (from left to right) are the iPhones XR, XS Max, and 11 Pro Max.
- Our see-through preview leaves us with some initial impressions:
 - The battery in the 11 Pro Max looks to be the same single-cell design that we saw [last year in the iPhone XS](#) but this marks the first inclusion in a Max phone.
 - Apple appears to have shaved down the logic board [yet again](#), almost certainly to make room for that huge three-camera array.
 - Last but not least, it looks like there might be a mysterious new board sitting below the battery.
 - Could this be related to the rumored [bilateral wireless charging](#)?

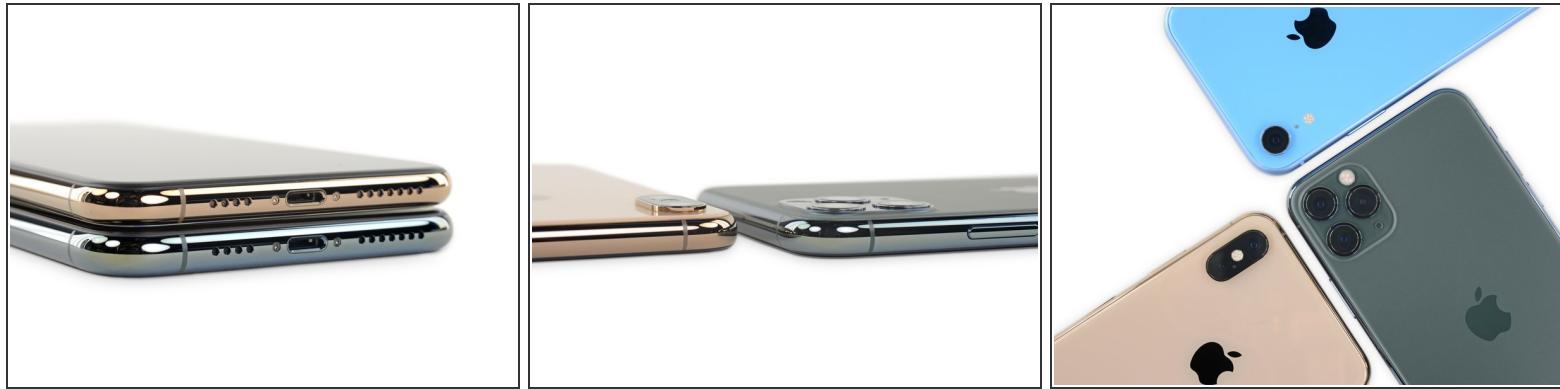
Step 3

- This year's iPhone adds a little extra material around the middle, and a *lot* around the cameras.
 - Camera "bump" doesn't quite seem adequate anymore ... "[mesa](#)" maybe?
 - At least this iPhone's camera plateau has ramped edges that blend it with the back of the phone a little better.
- And most importantly, our phone came in Apple's latest color: [Boba](#) Midnight green.
- Two last things to note here before we dig in to this green machine: a newly-centered Apple logo, and a new model number [tucked away in the SIM tray](#), A2161.

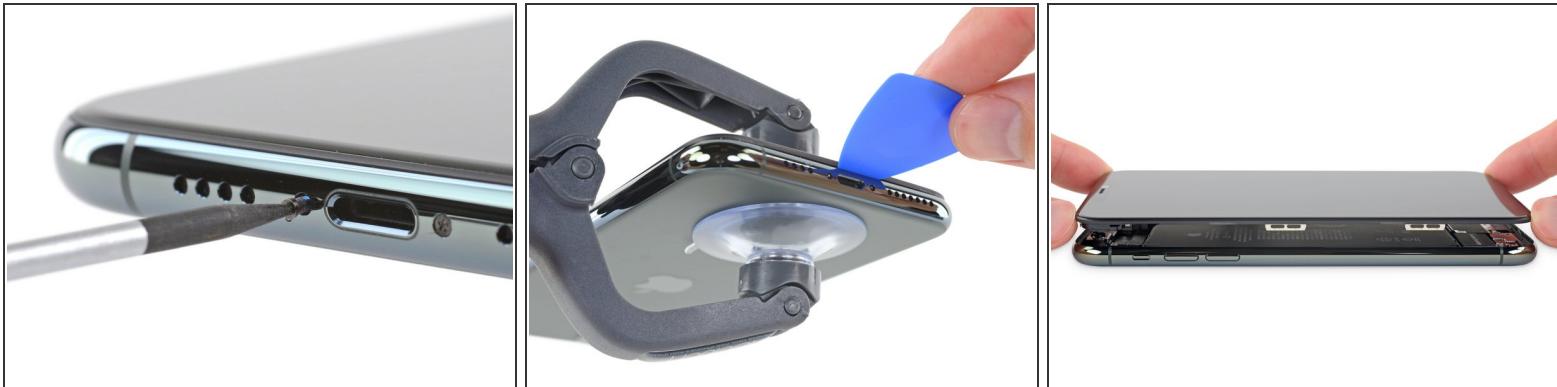
Step 4

- Fancy new iPhone, same old opening procedure—with a twist!
 - This year we pull our fixed-bladed P2 driver from the new [iPhone-specific Marlin set](#) to free a pair of pentalobes.
 - Then the [iSlack](#) and an [opening pick](#) move in to handle the rest, and we can start to lift the display.
- *(i)* Despite being Apple's "most water-resistant iPhone ever", the adhesive around the display feels similar to last year's phones. So too the pentalobe-based gasketing of yore.

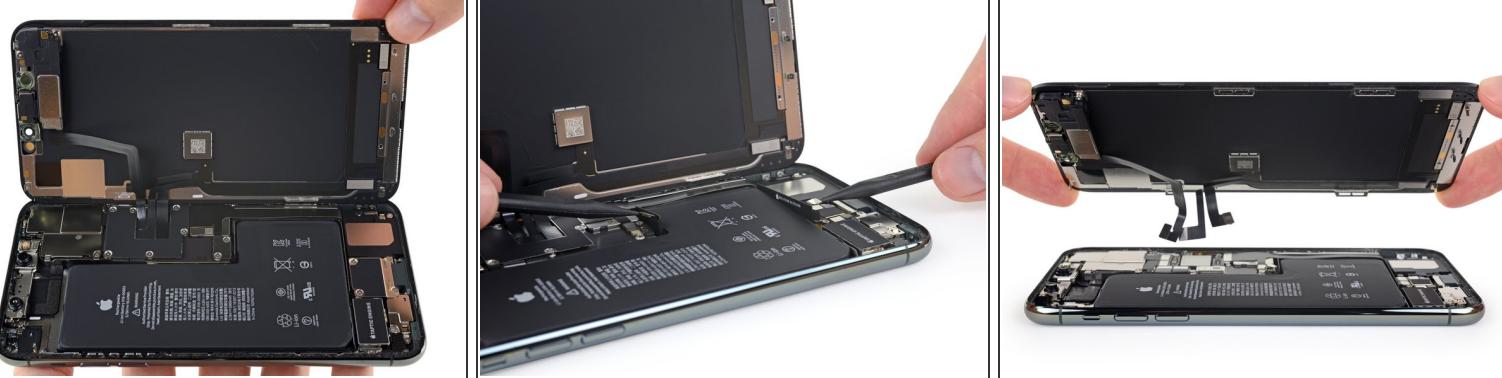
Step 5

- Time to get our first glimpse inside this Professional Maximum iPhone complete with monstrous L-shaped battery—with **two** battery connectors? Now *that's new*.
 - ⓘ There could be a number of reasons for this extra cable to exist, but bilateral charging is certainly one of them.
- Some testing yielded the following results:
 - The phone *will* function without the charging-port-end connected (reconnecting it threw a temporary temperature warning for us).
 - While that lower cable is disconnected, the phone will charge via the Lightning port, but *not* the wireless charging coil.
 - When we disconnected the "main" cable that goes directly to the logic board, the phone shut down as normal and would not boot, even with the other cable connected.

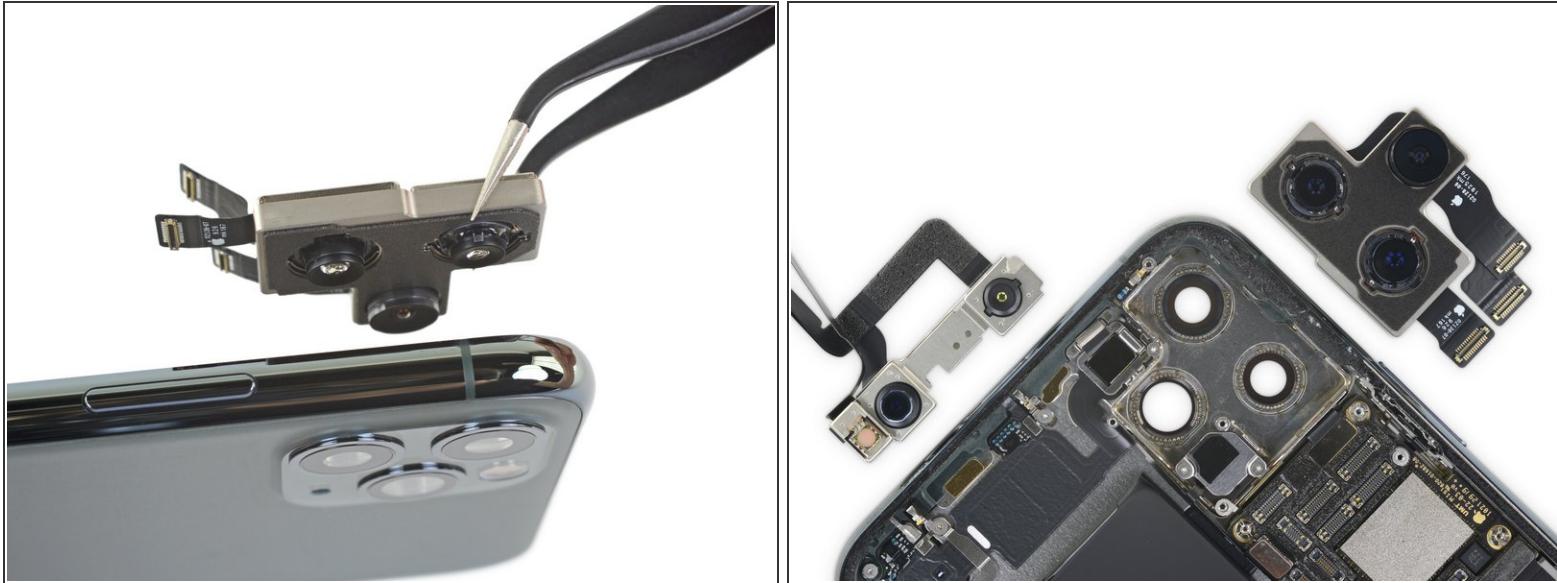
Step 6

- Smartphone makers have increasingly focused on [software magic](#) to improve image quality, so it may come as a surprise that Apple worked so hard on camera hardware this year.
- The biggest upgrade is the new ultra-wide angle sensor/lens, but standard wide-angle and telephoto lenses also get a boost to their ISO range and shutter speed. Even the front-facing camera gets a small resolution boost.
 - For all the gritty details on the cameras, check out [Halide's write-up](#).
- The FaceID sensor array also sees some beneficial changes here: the front-facing camera is now 12 MP—up from 7—and its cables are no longer trapped under the battery, so removal is quicker and easier than ever!

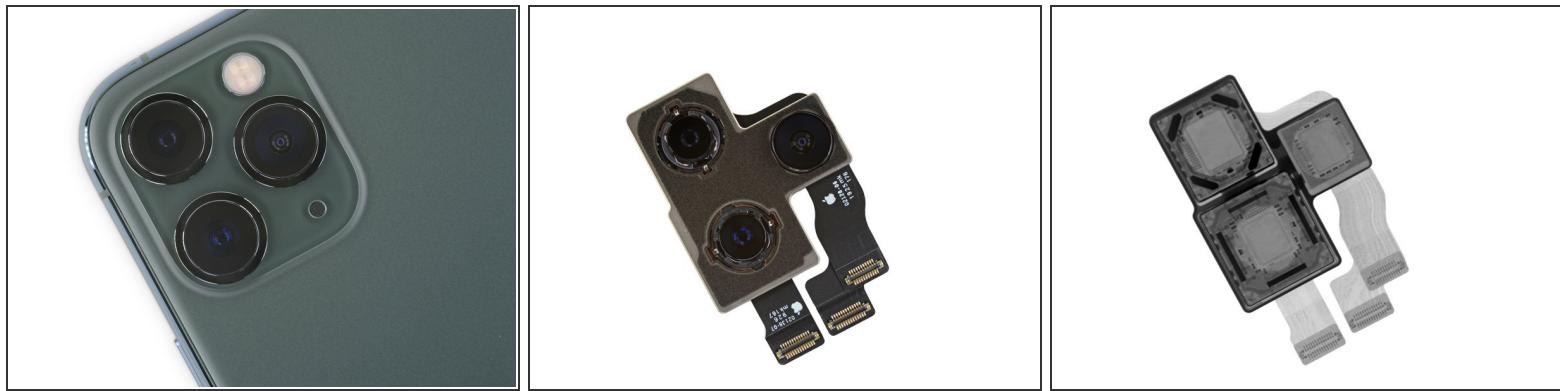
Step 7

- The "eyes" have it! [Three of 'em!](#) Plus a flash and a microphone hole.
- Diving a little deeper, we find the cameras are nestled together, each with their own independent cable.
- The X-rays reveal few surprises—the dark bars are evidence of OIS, and the tiny spots seem to match last years components, so no dedicated RAM chips here ... probably.
- You didn't think we'd leave it at that though, did you? Of course we're taking a deeper look—stay tuned!

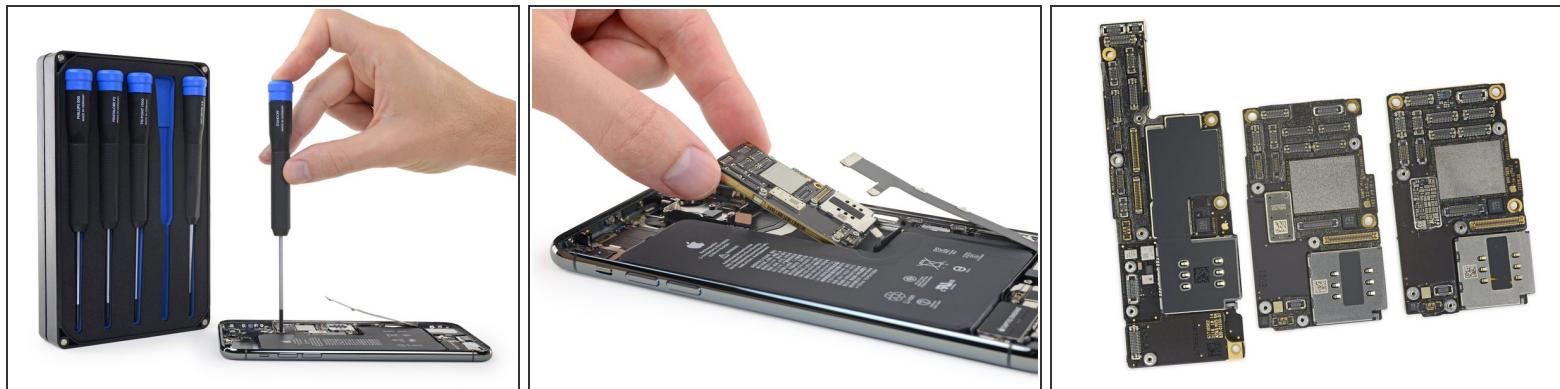
Step 8

- The [iPhone Marlin driver set](#) still has our back, helping us free the final standoffs securing the oddly squarish logic board.
- Shrinking from a distinctly Idaho silhouette in the iPhone XS to something more Colorado in the iPhone 11 Pro Max, this new board is dense!
- Are you seeing double? Don't worry, so are we! The iPhone 11 Pro Max board is identical in construction to the one in the iPhone 11 Pro!
- Could they really be the same board? We'll keep you posted ...

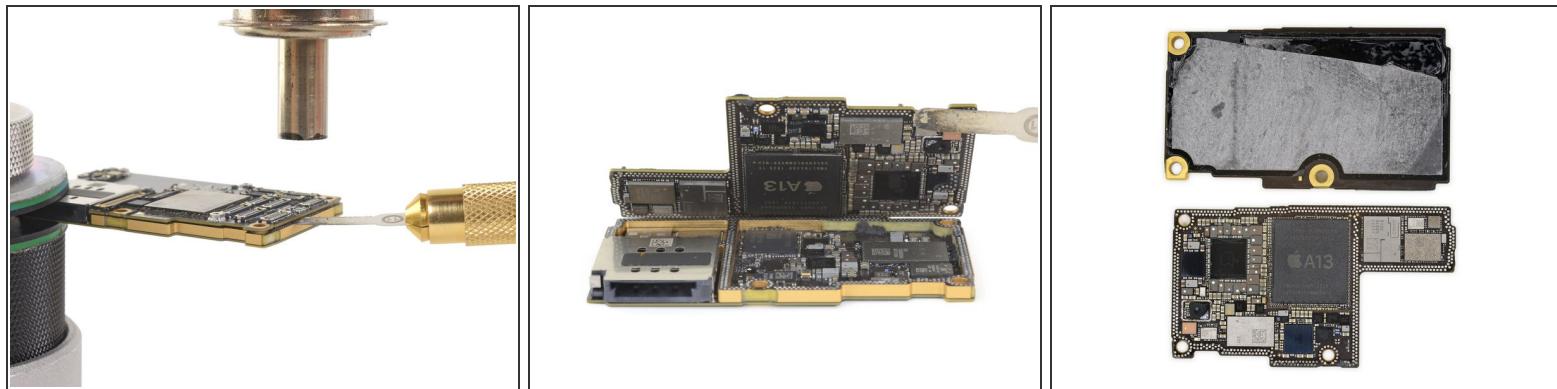
Step 9

- New shape, same dual-layer design and separation procedure.
- With a whole lot of concentrated heat and just a little prying, the top board peels off of the interconnect board.
- We get a glimpse of the lauded A13 processor, plus a ton of other silicon bits jammed onto these tiny boards.

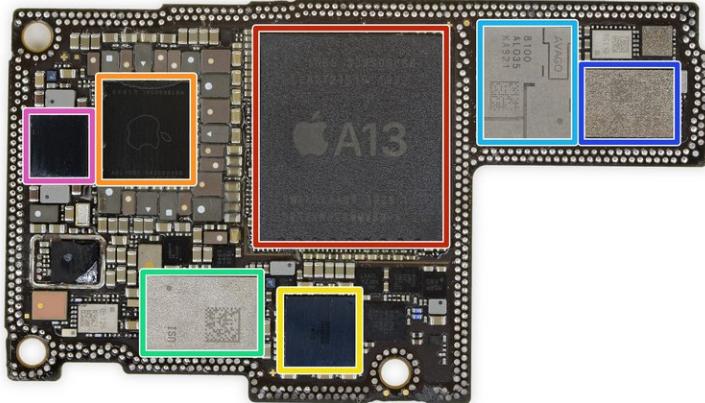
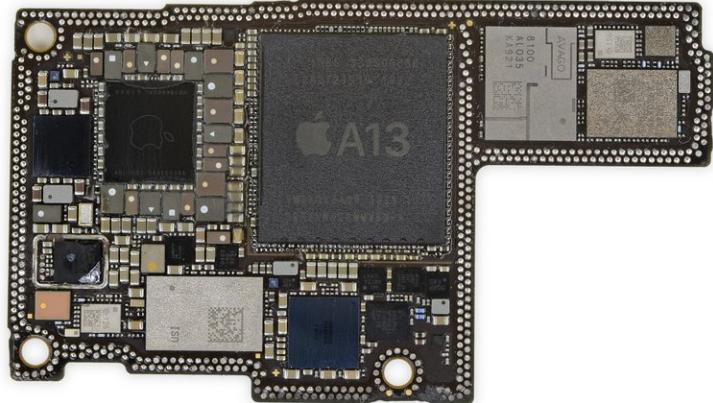
Step 10

- We put on our best chip detector specs and go to work. Here's what we can identify so far:
 - Apple APL1W85 A13 Bionic SoC layered over SK Hynix H9HKNNNCRMMVDR-NEH LPDDR4X (*seemingly* [4 GB](#), but SK Hynix needs to update their decoder)
 - Apple APL1092 343S00355 PMIC
 - Cirrus Logic 338S00509 audio codec
 - Unmarked USI module—**teardown update**: it turns out that this *is* where Apple's new U1 ultra-wideband chip is hiding. Read all about it about it in our [blog post](#).
 - Avago 8100 Mid/High band PAMiD
 - Skyworks 78221-17 low-band PAMiD
 - STMicroelectronics STB601A0N power management IC

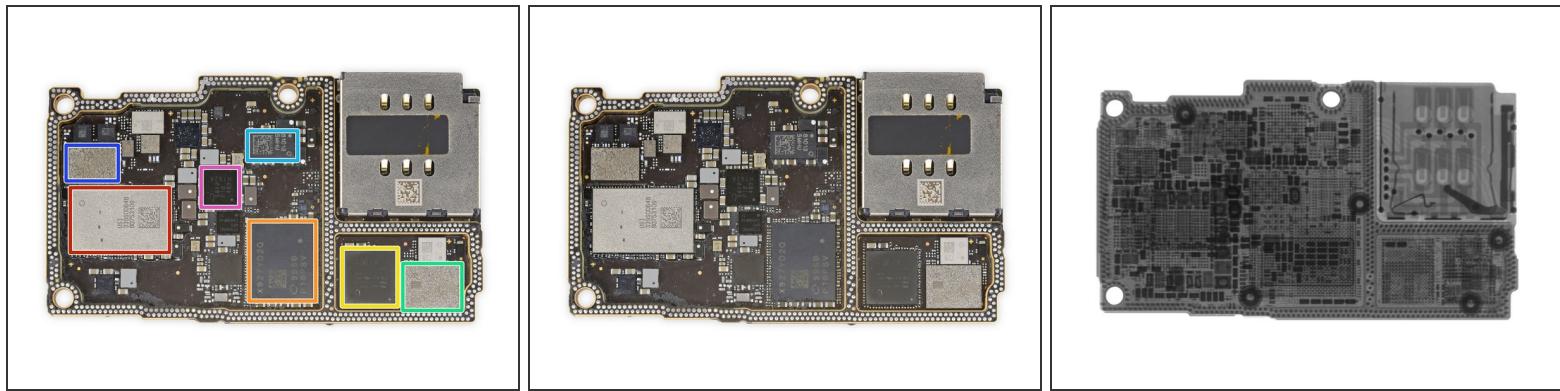
Step 11

- More chips than you can shake a stick at, but we're shaking as fast as we can. Here's the RF board:
 - Apple/USI 339S00648 WiFi/Bluetooth SoC
 - Intel X927YD2Q (likely XMM7660) modem
 - Intel 5765 P10 A15 08B13 H1925 transceiver
 - Skyworks 78223-17 PAM
 - 81013 - Qorvo Envelope Tracking
 - Skyworks 13797-19 DRx
 - Intel 6840 P10 409 H1924 baseband PMIC

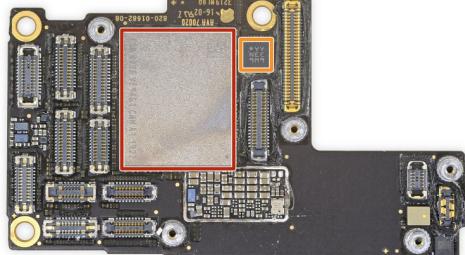
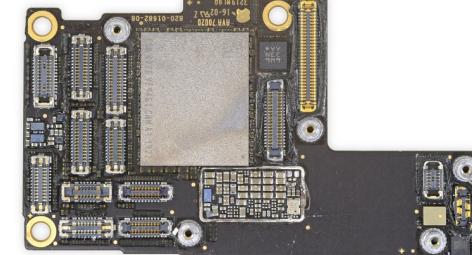
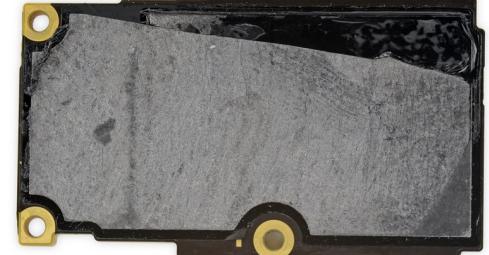
Step 12

- Last but not least, top side we find:
 - Toshiba TSB 4226VE9461CHNA1 1927 64 GB flash storage
 - YY NEC 9M9 (likely accel/gyro)
- In addition to all these chips, we tease apart several layers of graphite thermal transfer material backing the RF board.
- Apple says its improved thermal design gives these iPhone Pros the "best sustained performance ever in an iPhone." That's accomplished by pulling heat from the logic board straight through several layers of graphite where it dissipates into the rear case.
- *(i)* This may not seem as fancy as the liquid cooling systems we've seen in [some Android phones](#), but it certainly must be enough to keep the [super-efficient A13](#) cool, while not interfering with any signals traveling to or from the RF board that it clings to.

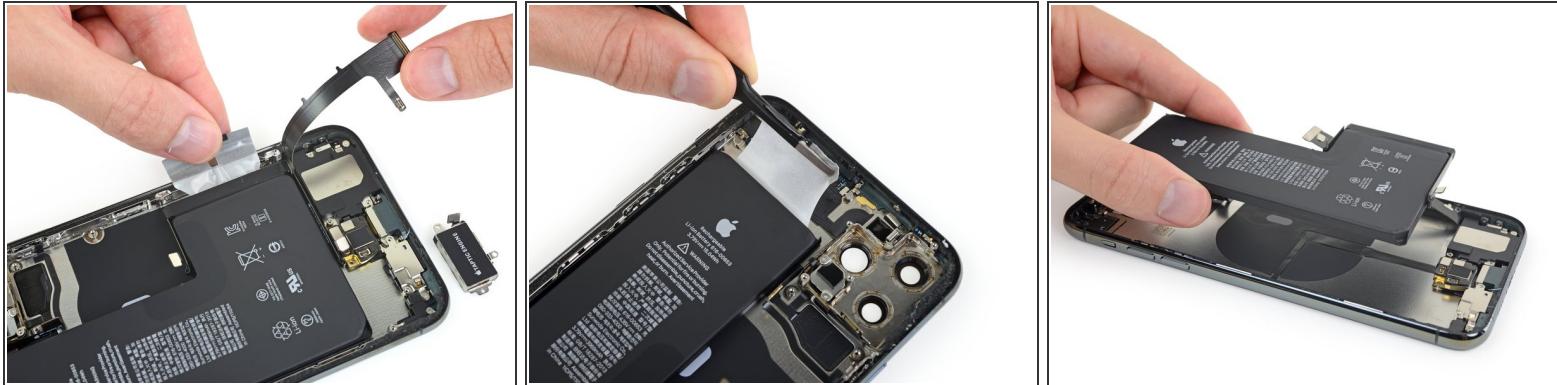
Step 13

- Turning to the battery, we're pleasantly surprised to find some relatively repair-friendly features.
- The only thing standing in our way is the Taptic Engine—with that out, a few extra-wide (and more durable!) stretch-release adhesive strips are all that secure the battery.
- *(i)* This relatively simple process reminds us more of the [iPhone 6](#) than any more recent phones.
- Adhesive strips stretched away, the battery lifts free from its iPhone.

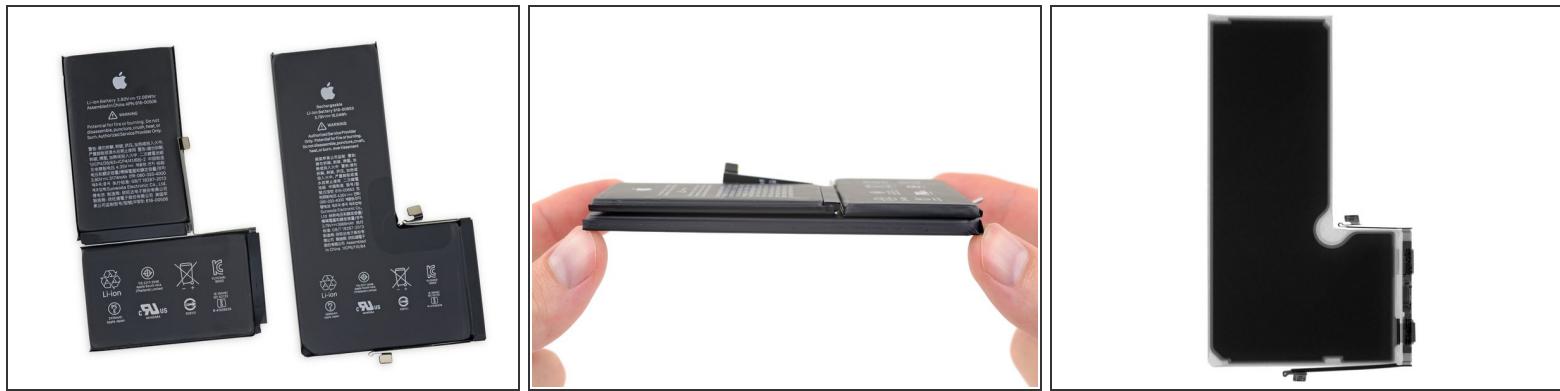
Step 14

- Looks like this year at Apple, big is in. The iPhone 11 Pro Max's powerhouse pumps out 3969 mAh at 3.79 V, for a total of 15.04 Wh. That's a whopping 2.96 Wh more than the [XS Max battery](#), and 1.52 Wh less than the [Galaxy Note 10+ 5G battery](#).

- Where does this massive power come from? It's 4.6 mm thick, has a volume of 23.8 cm³, and weighs in at 59.6 g. Compared to the XS Max, that's 0.7 mm thicker, 4.2 cm³ larger by volume, and 13 g heavier.

- *(i)* We were suspicious when Apple alluded that the new A13 chip and PMU alone were responsible for the extra five hours (five hours!) of battery life. Turns out *you can* just make a phone a little thicker for massive battery life gains. Who would have guessed?

- We saw this same single-cell, L-shaped design [last year in the iPhone XS](#), where we learned about the complexities of internal corners and thermal expansion in battery design.

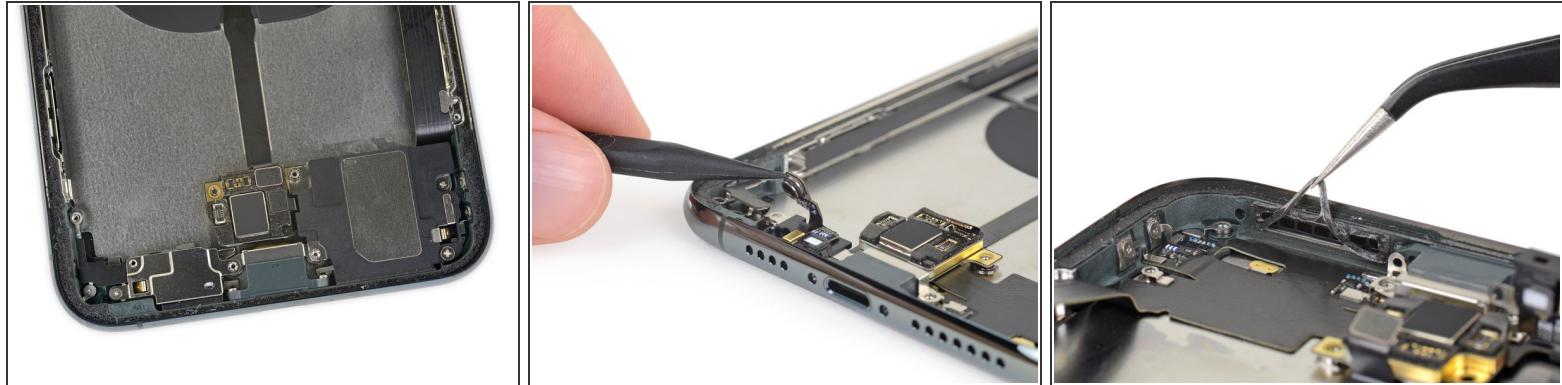
Step 15

- That mystery board that we spotted in the X-ray below the battery serves (in part anyway) as an interconnect for the battery, wireless charging coil, and Taptic Engine.

- So we have a secondary battery connector for the first time ever in an iPhone, plugging in directly adjacent to the wireless charging coil. We're not sure what Apple was up to here.

- **i** Apple did post a [new support document](#) today, stating that iPhone 11 Pro contains new hardware for monitoring and managing battery performance. So maybe that's all this is, and it just *looks* suspiciously like bilateral charging hardware.

- We pop out what appears to be a new barometric sensor design complete with ingress proofing o-ring.
- All the components at this end of the phone are stuck to the frame with what seems to be a slightly goopier, stickier adhesive than the foamy stuff we remember from last year. Best guess, it's more waterproof that way.

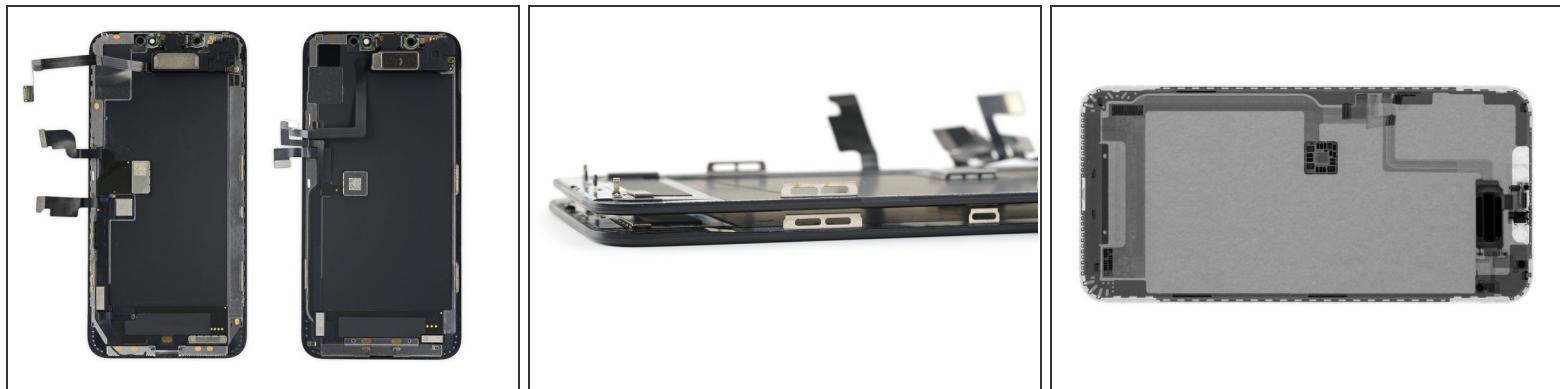
Step 17

- There was absolutely nothing wrong with the XS Max display—apart from it being really, really expensive—so we're unsurprised to see this year's "XDR" display looks superficially very similar.
☞ However, this "XDR" display does not have a \$999 stand, so it's basically unusable.
- One minor but helpful update is that the three flex cables all congregate in the same place—so there are fewer booby traps when slicing open the phone for repair.
- We *did* expect the loss of the [3D Touch layer](#) to factor in a little more—this display measures about a quarter of a millimeter thinner than its predecessor, and that's all. That plus the *slight* increase in the iPhone's overall thickness is apparently responsible for a good chunk of the increased battery capacity.
- One last [chip](#) hides under a shield: Samsung S2D0S23 display power management IC

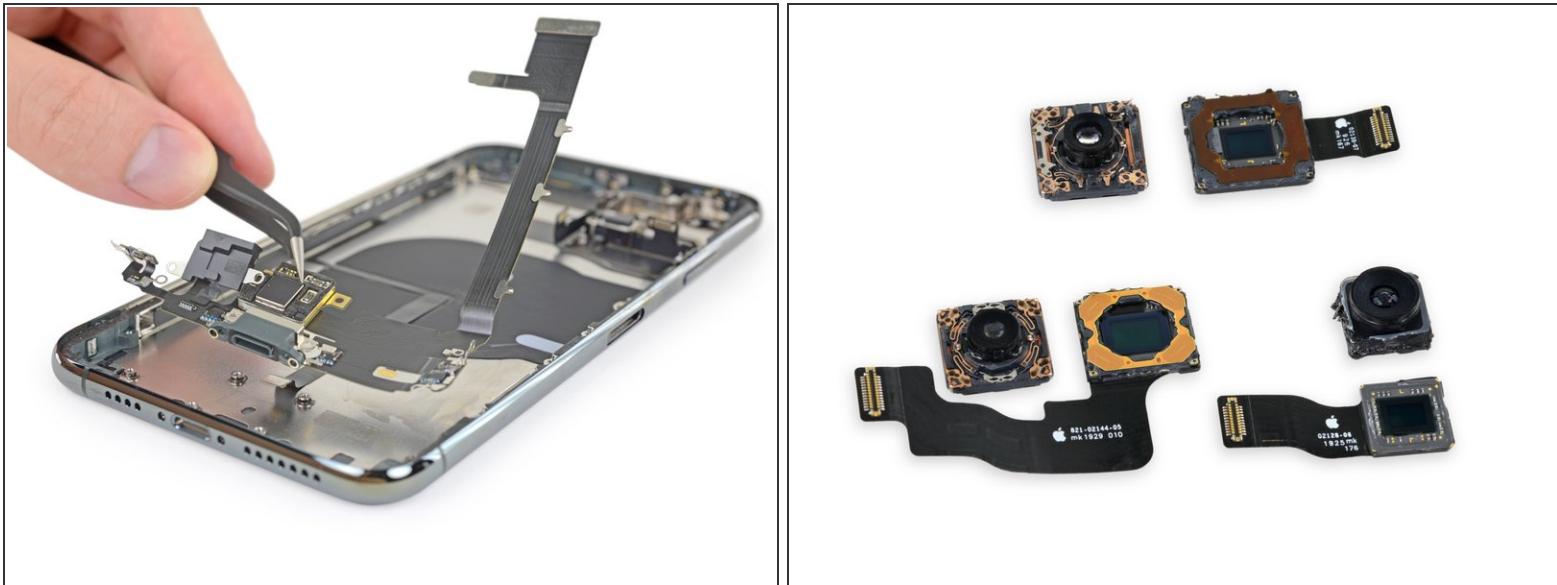
Step 18

- The Lightning connector assembly comes out with the new interconnect board attached. It doesn't exactly come out without a fight, though—a maniacal medley of screws and glues holds it in place, so you're in for a ride if either of these parts fails on you.
- We take one final stab at looking for a second elusive RAM chip by peeking into each camera module. Other than some shiny unshielded sensors, we see nothing—hey wait, is that it??
-

Nope. This [AD5844CDA0 chip](#) is probably an image stabilizer (and leprechaun commune).

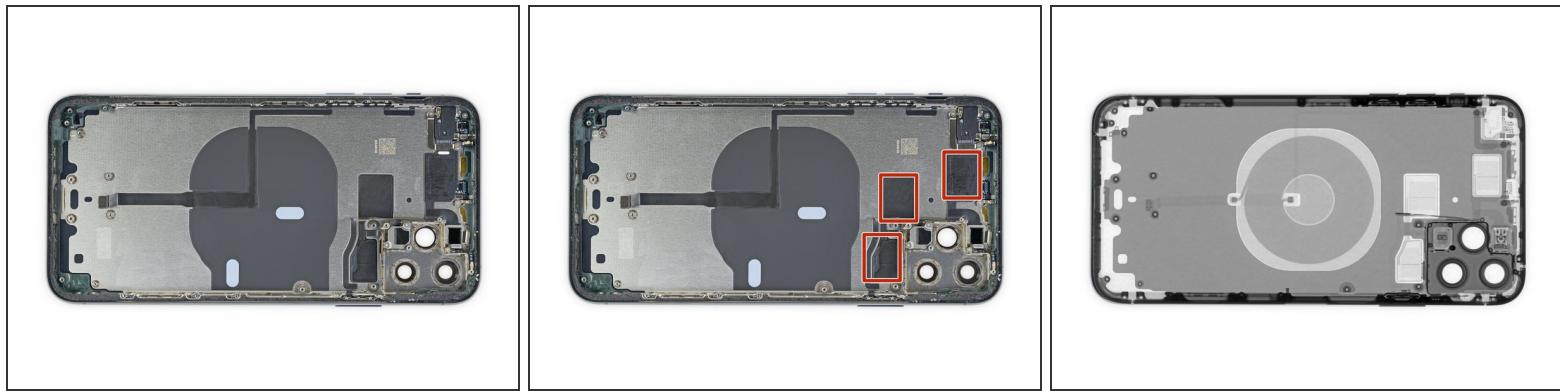
Step 19

- We spot what looks like three additional thermal pads lining the back case. However...
- X-rays reveal that each pad sits atop a clean cut through the steel case lining. The only reason we know of for doing that is RF pass-through.
- Furthermore, each pad is connected via a flex cable to a complex antenna bus.
- We're not 100% sure what we're looking at, but it seems likely this is our first peek at some ultra wideband antenna hardware.

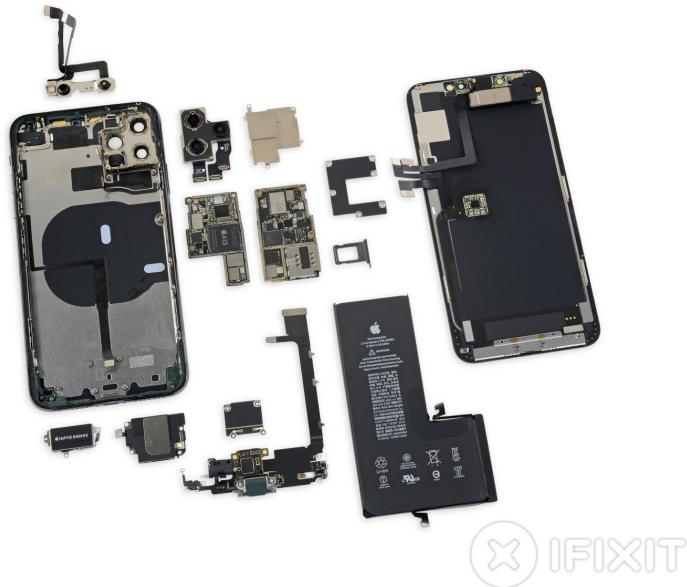
Step 20

- This teardown officially goes to eleven, and here's what we found!
- A much bigger battery made possible by bumping the body 0.4 mm and winning 0.25 mm from 3D Touch.
- Two battery cables that *may* have helped Apple's allegedly-scraped bilateral charging out—but could just as easily help manage battery life.
- A very non-definitive "4 GB confirmed" rating, given our inability to find dedicated camera RAM.
- Plus, some RF antennas (we're pretty sure), all the better for the U1 to seek with.
- Don't touch that dial—we'll have more teardowns for you soon!
