iPhone 5S Teardown by X-ray

Using a high resolution x-ray system, we did a complete teardown of an iPhone 5s.

iPhone 5s Teardown by x-ray

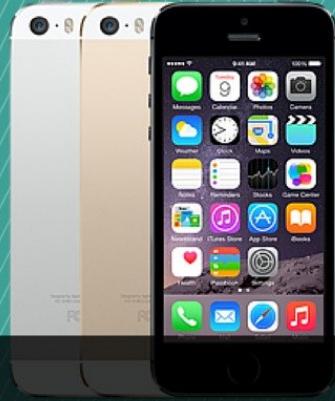
Step 1 — iPhone 5S Teardown by X-ray

- We are going to take a look inside an iPhone 5s using a high resolution x-ray inspection system - the TruView 200. This system packs an impressive 130kV microfocus source and a large 3"x4" x-ray sensor capable of delivering 1um resolution.
- For more information about the system we used please visit [TruView Number Series](#).

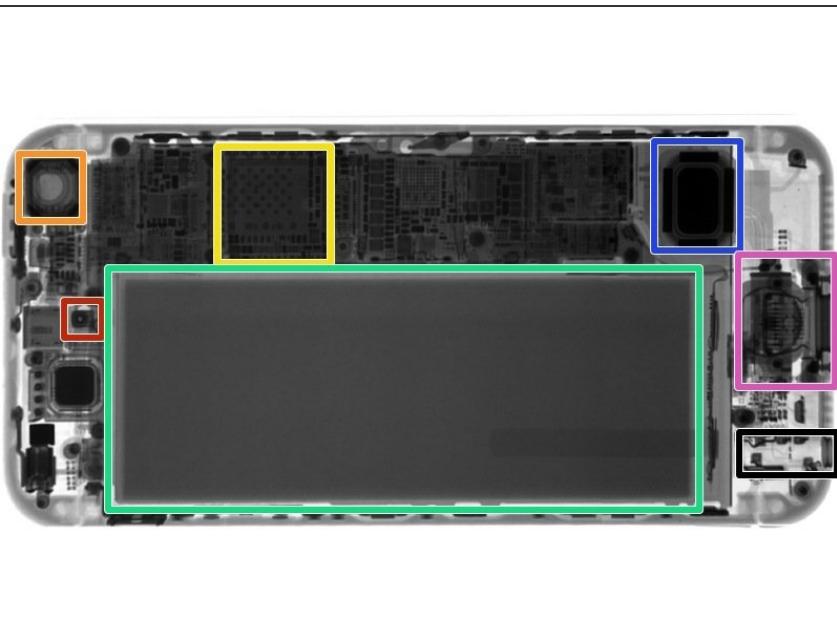
Step 2

- Now it's time to start the x-ray inspection!
- 1.2MP FaceTime camera.
- 8 MP iSight camera (with larger 1.5μ pixels).
- Yellow: Apple A7 processor with 64-bit architecture
- This iPhone 5S has a 3.8V - 5.92Wh - 1560 mAh battery. Not much improvement from the iPhone 5 3.8 V - 1440 mAh - 5.45 Wh. Talk time: Up to 8 hours on 3G. Standby time: Up to 225 hours.
- Speaker
- Lightning connector and Touch ID interface
- 3.5mm audio jack

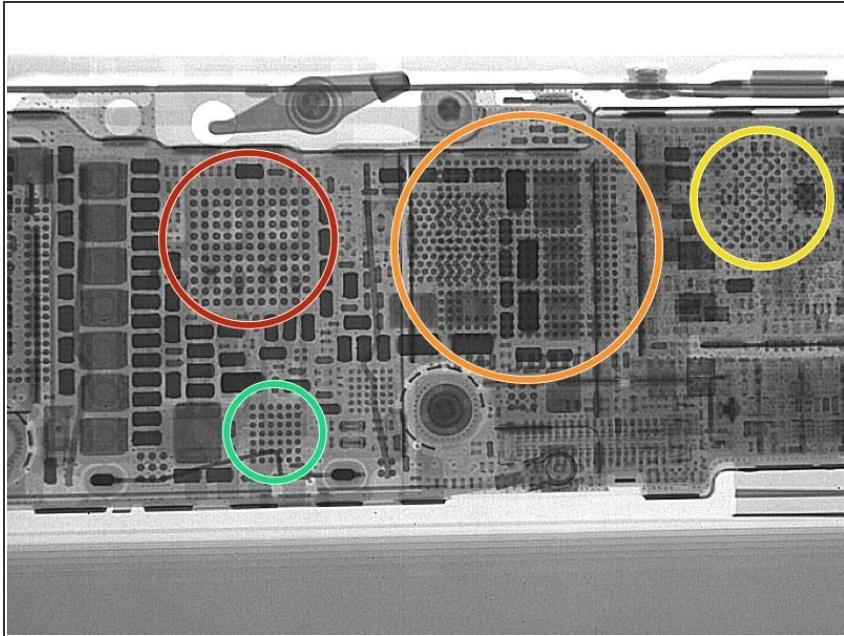
Step 3

- Here's some of the powertrain in the iPhone 5S:
 - Apple 338S120L.
 - Qualcomm PM8018 RF power management IC and Qualcomm MDM9615M LTE Modem
 - Qualcomm WTR1605L LTE/HSPA+/CDMA2K/TDSCDMA/E DGE/GPS transceiver.
 - Avago A790720

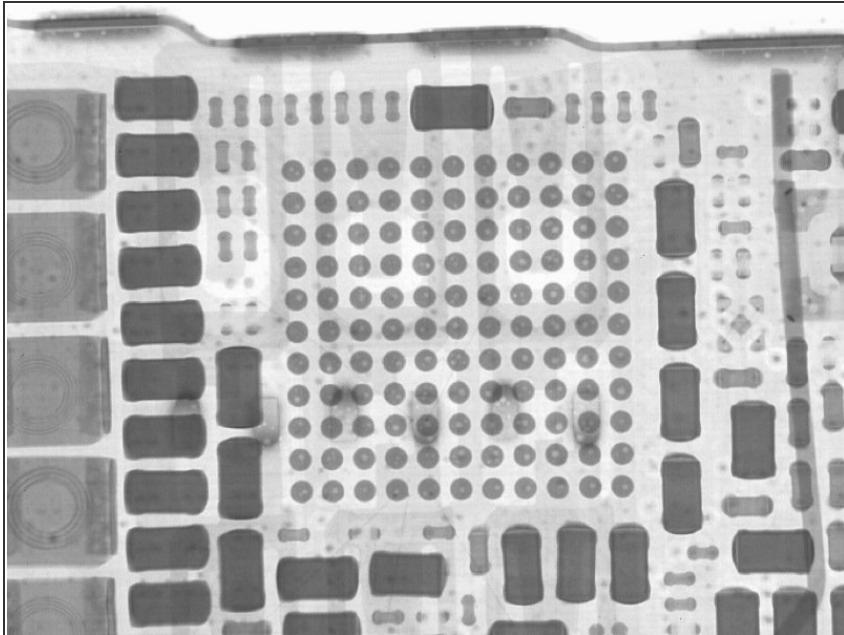
Step 4

- We know voids in ball grid arrays (BGA) can be problematic to the reliability of any electronic product. In our x-ray inspection of the iPhone 5S, we noticed that the Apple 338S120L chipset had a large number of voids. So the natural next step was to use the BGA inspector included in the TruView 200 to measure the voids.

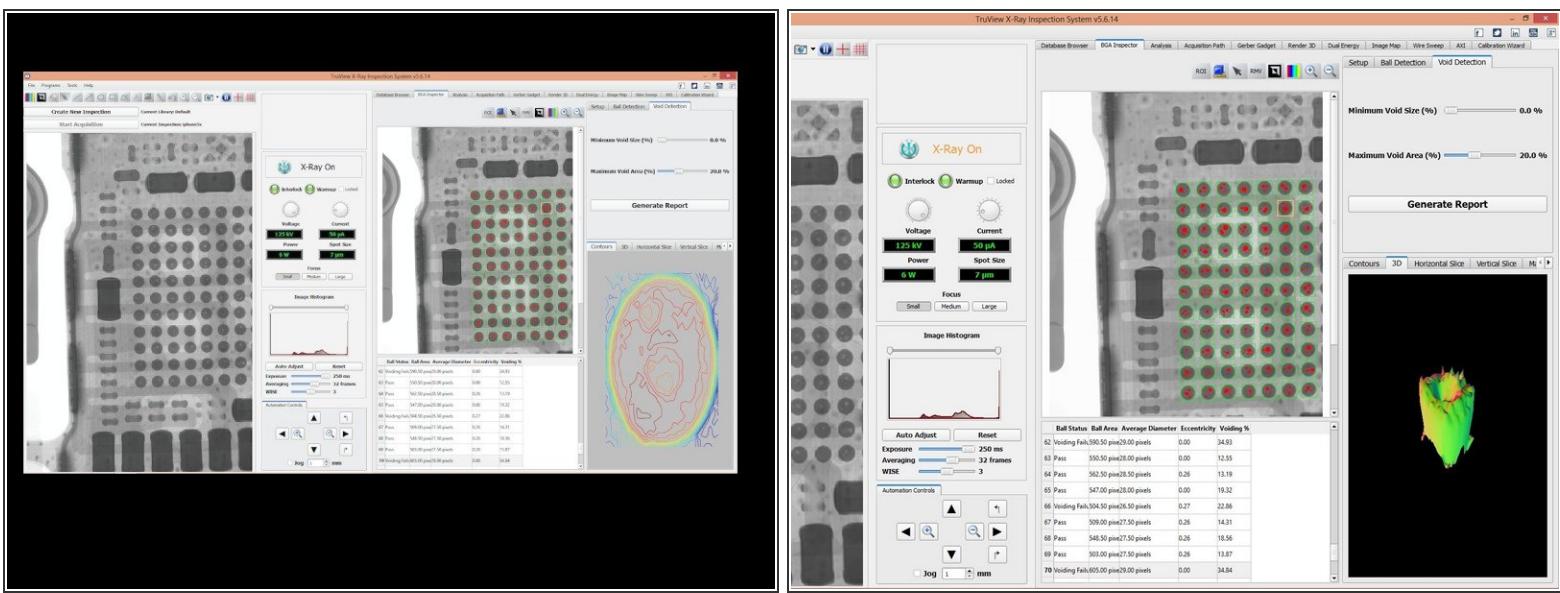
Step 5

- A quick analysis of the BGA voiding in the Apple 338S120L shows voids as large as 35%. That does not mean this is a problem, but certainly something a quality manager would need to check and validate. Besides, none of the other surface mount components in the iPhone 5S have this level of voiding.
- The BGA inspector allows us to visualize the void in a 3D representation of x-y and density as the height of the volume.

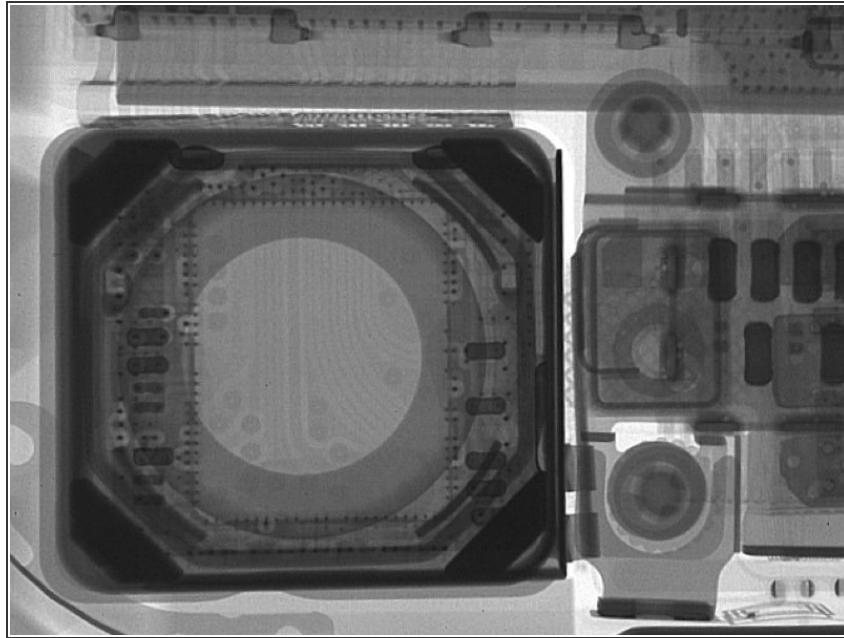
Step 6

- Closer look... the iPhone 5s iSight Camera has 8 megapixels of fun, autofocus and auto HDR for photos, among other features.
- Size wise its not much different than the Camera on the iPhone 5.

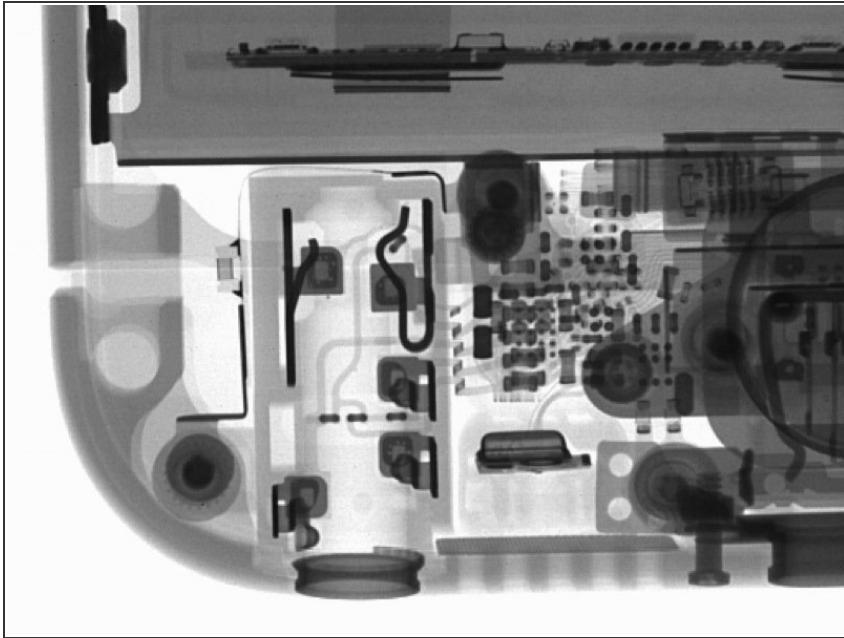
Step 7

- This corner shot of the iPhone 5S shows the standard 3.5mm audio jack. You can also see the corner of the Touch ID interface and supporting mechanics.

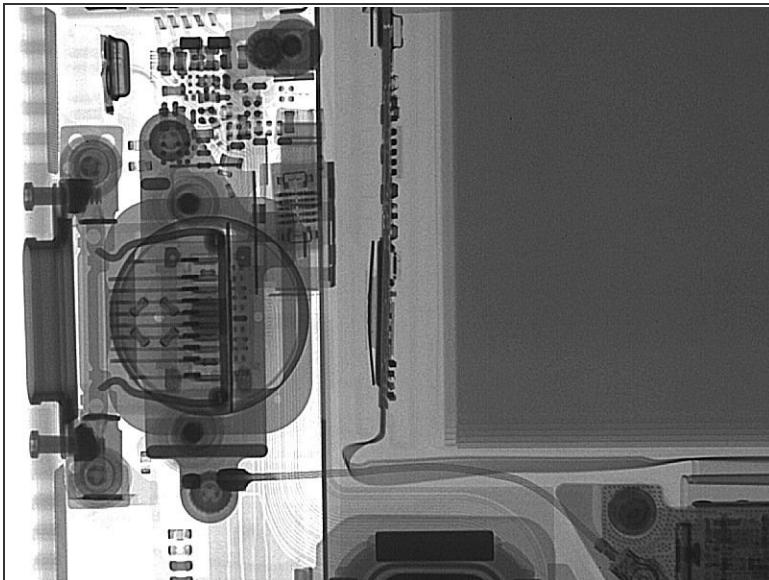
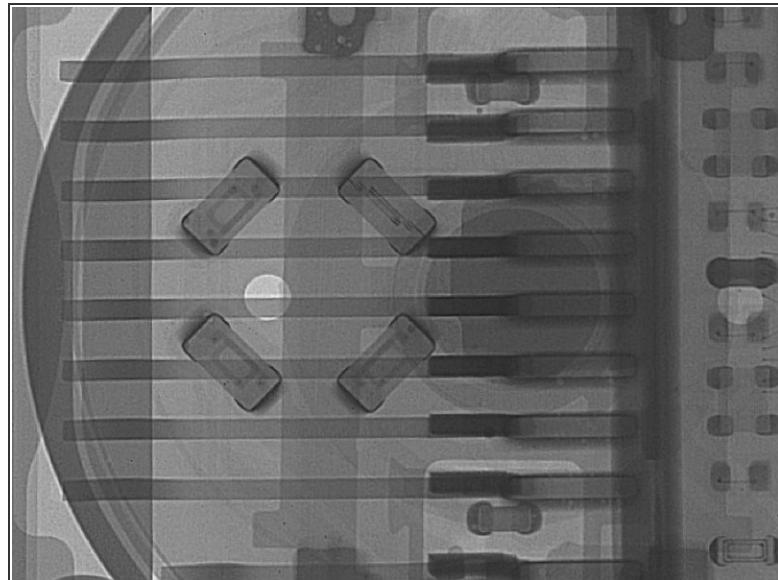
Step 8

- Here's a detail image of the Touch ID sensor. Note that it sits on top of the Lightning connector, that's why you see them overlaid in this x-ray image.

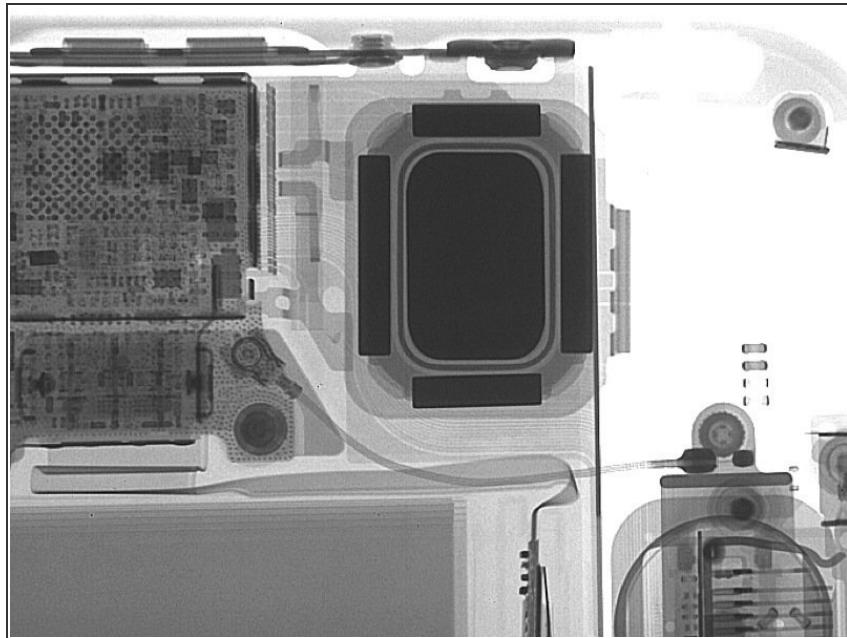
Step 9

- This corner of the iPhone 5S has not changed since the iPhone 5/4S. The large high performance speaker is located in the same place, and the antennae connections are very similar to previous models.
