iPhone 6s Plus Teardown

Torn down on September 25, 2015 in Melbourne, Australia.

Written By: Andrew Optimus Goldheart

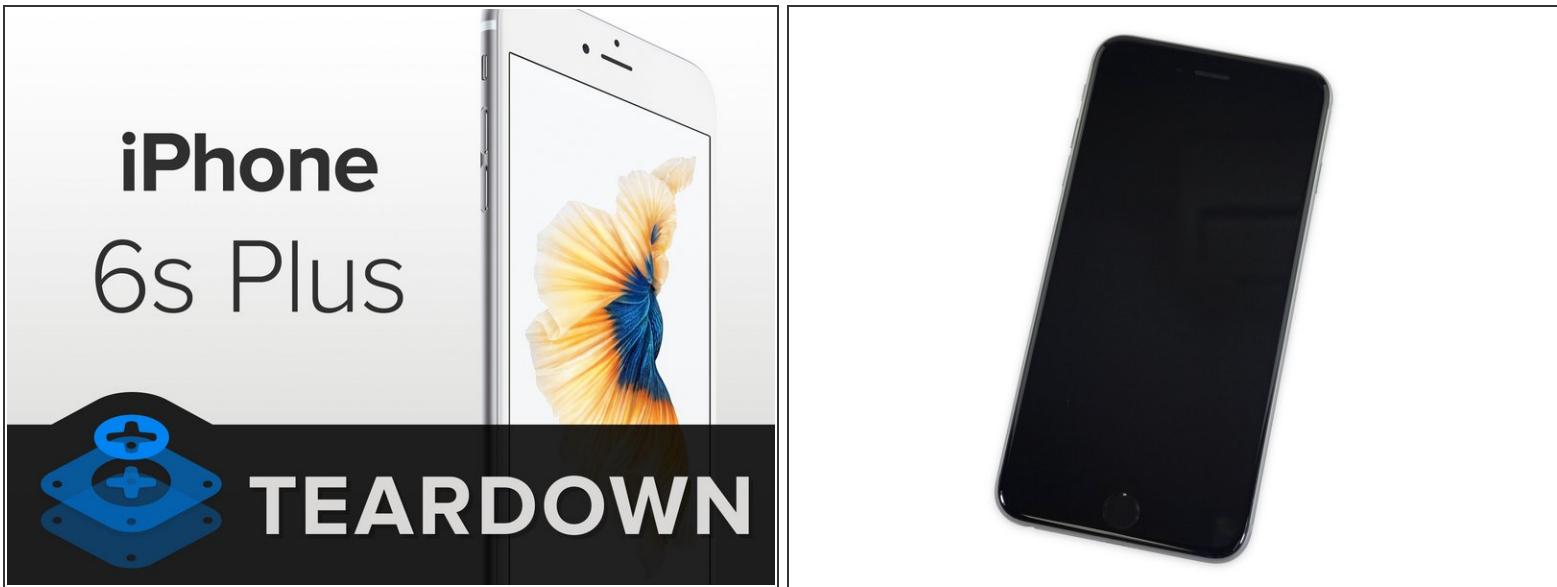
Step 1 — iPhone 6s Plus Teardown

- Before we put this bad boy under the knife spudger, we have to ask: "Hey Siri, what's under the hood?":
 - Apple A9 processor with embedded M9 motion coprocessor
 - 16, 64, or 128 GB of storage
 - 5.5-inch 1920 × 1080 pixels (401 ppi) Retina HD display with 3D Touch
 - 12 MP iSight camera supporting 4K video recording with 1.22μ pixels, and a 5 MP FaceTime HD camera
 - 7000 Series aluminum enclosure and Ion-X Glass
 - 802.11a/b/g/n/ac Wi-Fi with MIMO + Bluetooth 4.2 + NFC + 23-band LTE
 - Taptic Engine

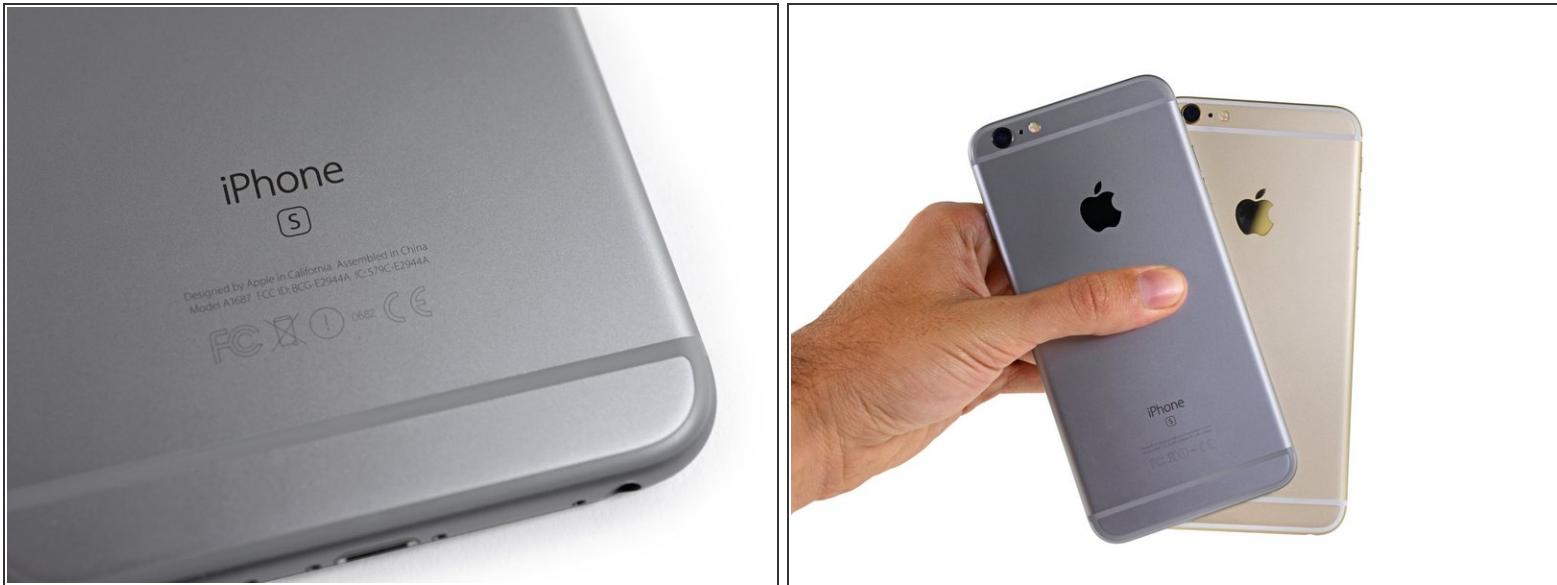
Step 2

- The 6s Plus stops by for a closeup and gives us a better view of that custom [7000 series aluminum alloy](#) and flaunts a new model number: A1687
- [Early analysis](#) of this new alloy breaks it down to around 91.17% aluminum, 0.08% iron, 7.64% zinc, and 0.106% tungsten.
 - The higher zinc content should provide a significant increase in tensile strength (and manufacturing cost) from the [6063 aluminum alloy](#) in the iPhone 6.
- That little "S" looks out of place on the new iPhone's large outer casing—but how else will you show your friends that you buy a new phone [every year](#)?
 - Really though, Apple's new push to encourage early upgrades is a low blow to the environment. As recyclable as Apple claims their devices are, a shorter product lifetime means increased [carbon dioxide emissions](#) and more e-waste.

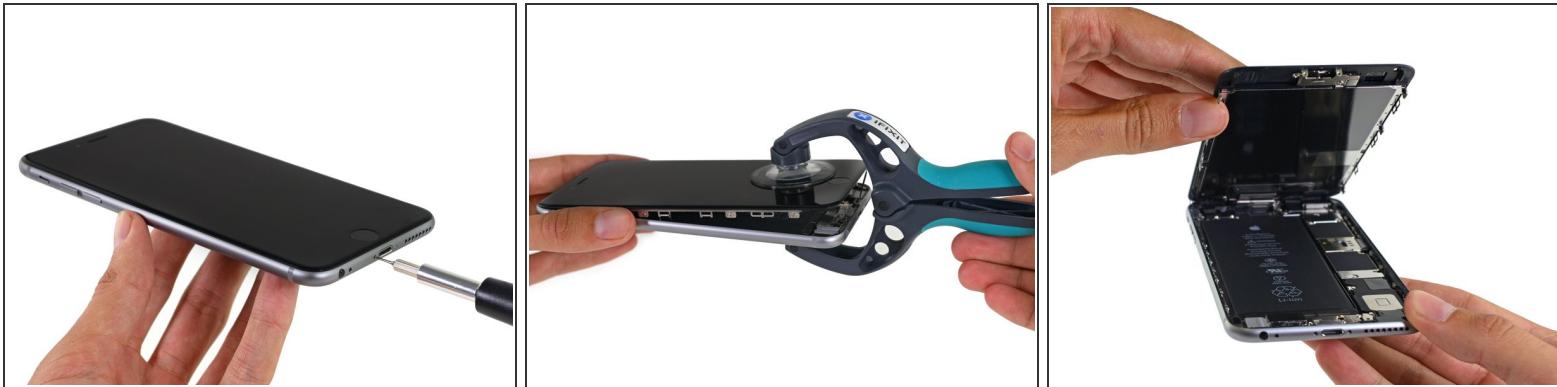
Step 4

- Having just torn down the 6s, we know exactly where to start with the Plus.
- Our teardown engineer busts open the phone in two seconds flat—one second for each screw, all caution thrown to the wind. (Just kidding, he's actually very careful and takes his time. This is the only 6s Plus we've got.)
- Just like its [smaller sibling](#), the 6s Plus features an adhesive strip along the perimeter of the display assembly. Lucky for us, it doesn't stand a chance against the [iSclack](#).
- With the Pentalobe screws out and display adhesive defeated, we're in!

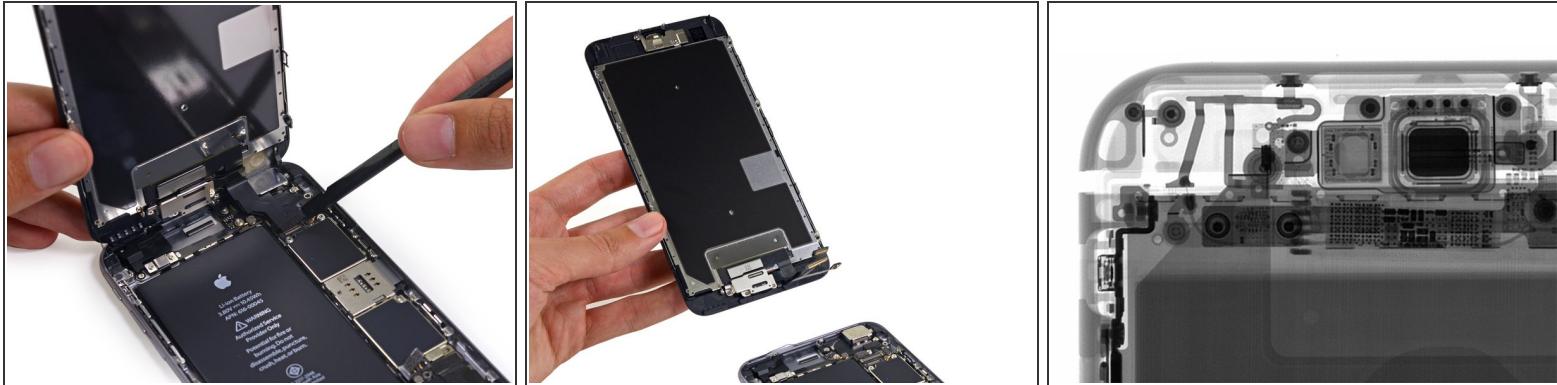
Step 6

- With three [flicks](#) of our spudger, we quickly disconnect and remove the display assembly.
- Before we move on, we toss it on the scale. We note that the display assembly on the 6s Plus weighs in at 80 g—while on last year's 6 Plus, it weighed a measly 60 g.
- This astonishing 33% increase in weight is all because of Apple's new 3D Touch technology. That's some heavy stuff.
- A quick blast of X-rays reveals the presence of some new silicon piggybacking onto the display —[just like we found on the 6s](#).

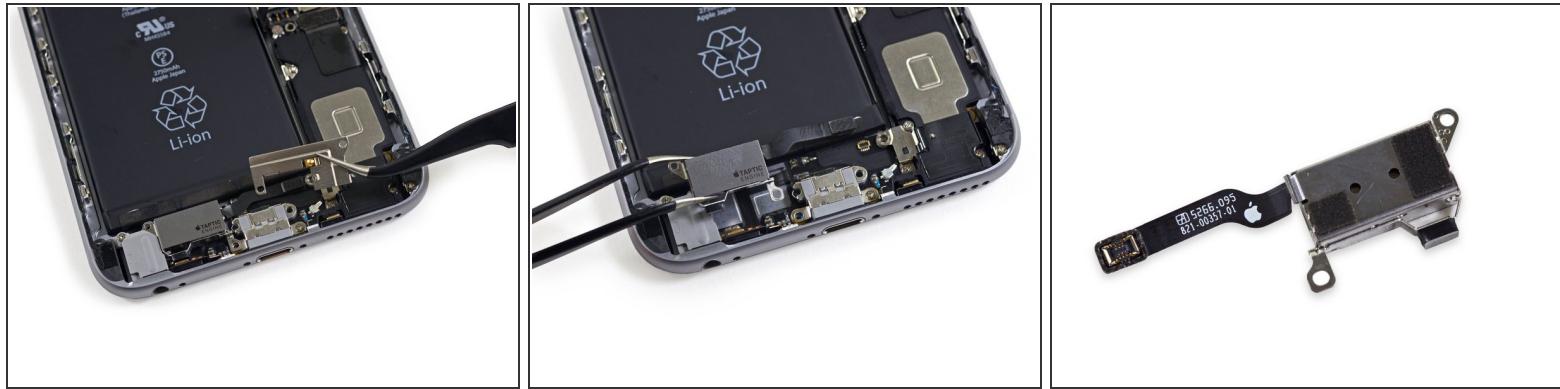
Step 7

- A new bracket secures the (bitty!) Taptic Engine and its new cable.
- The Taptic Engine in the 6s Plus measures 15 x 8 x 4.9 mm compared to the 35 x 6 x 3.2 mm one found in the 6s.
- *(i)* Our guess as to the reason for the substantially smaller footprint: Apple didn't want to shave off too much from the already-scaled-down battery.
- No question about it—[it's a tight fit with everything assembled.](#)
- The Taptic Engine also has a lil' rubber bumper for bracing against the microphone.

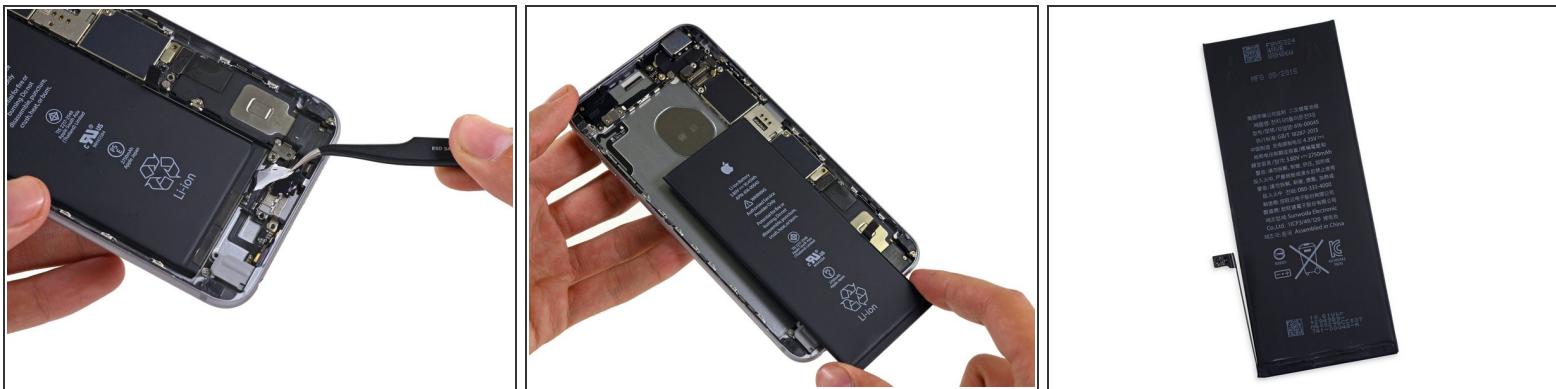
Step 9

- Moving on to the battery, we're greeted with a few familiar friends—adhesive pull tabs.
- Never stop being awesome, adhesive pull tabs. *Never.*
- Much like the 6 Plus before it, removing the battery is as easy as pulling 3 tabs. Well, as long as you pull them *exactly* right.
- The battery capacity sits at 2750 mAh (10.45 Wh); a modest 165 mAh downgrade compared to last year's 6 Plus.
- *(i)* Despite the downgrade, Apple claims battery life will be comparable to that of the 6 Plus—that is, 14 hours of 3G talk time, approximately 10 hours of internet use, or up to 10 days on standby.

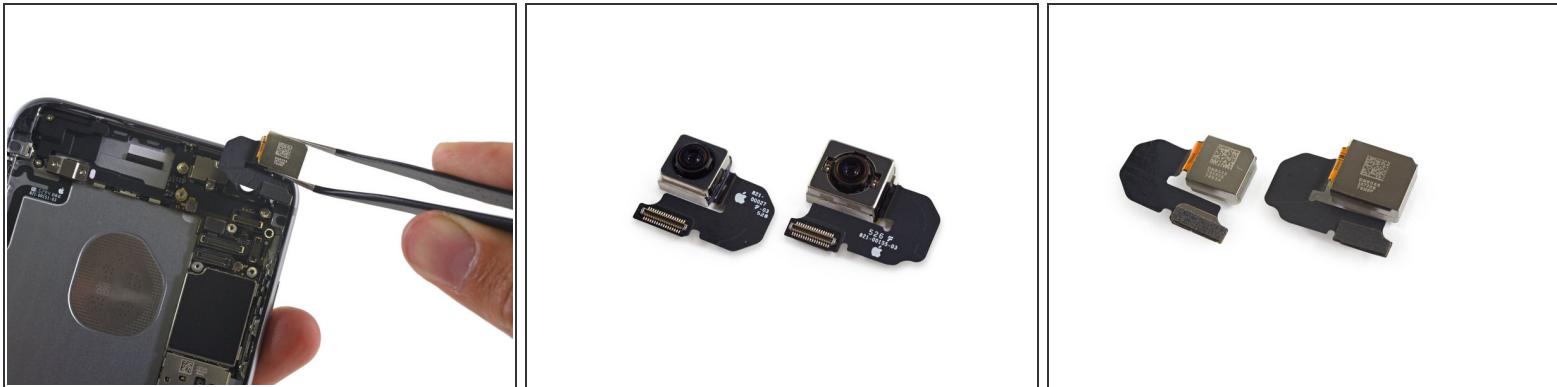
Step 10

- For the second time today, we pluck the 12 MP iSight camera from its cavity for a closer look.
- At first glance, the iSight camera in the 6s Plus is fairly similar to the one found in the 6s. When the two cameras are laid out side-by-side though, the additional heft of the [optical image stabilization](#) hardware in the iPhone 6s Plus camera becomes readily apparent.
