# iPod Touch 5th Generation Lightning Connector Assembly Replacement

Written By: Andrew Optimus Goldheart

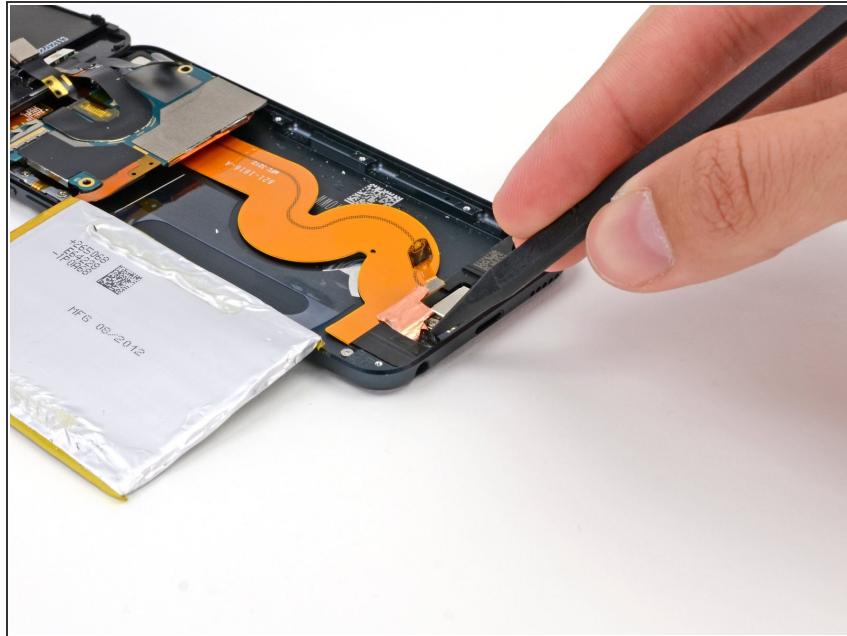
## Step 1 — Lightning Connector Assembly

- Use the tip of a spudger to peel back a small piece of tape covering a screw on the left side of the headphone jack.

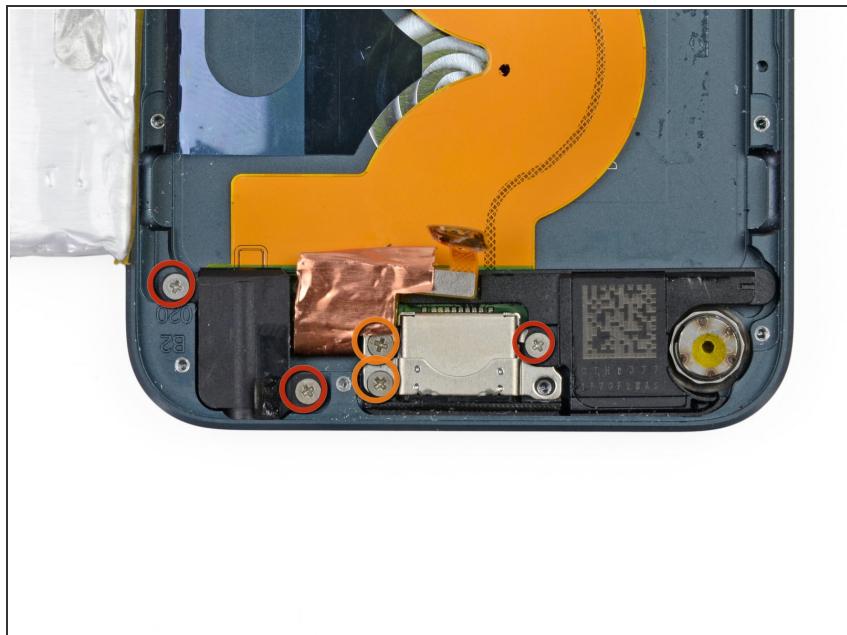
## Step 2

- Remove the following screws securing the headphone jack, Lightning connector, and speaker.
  - Three 2.6 mm #000 Phillips screws
  - Two 2.0 mm #000 Phillips screws

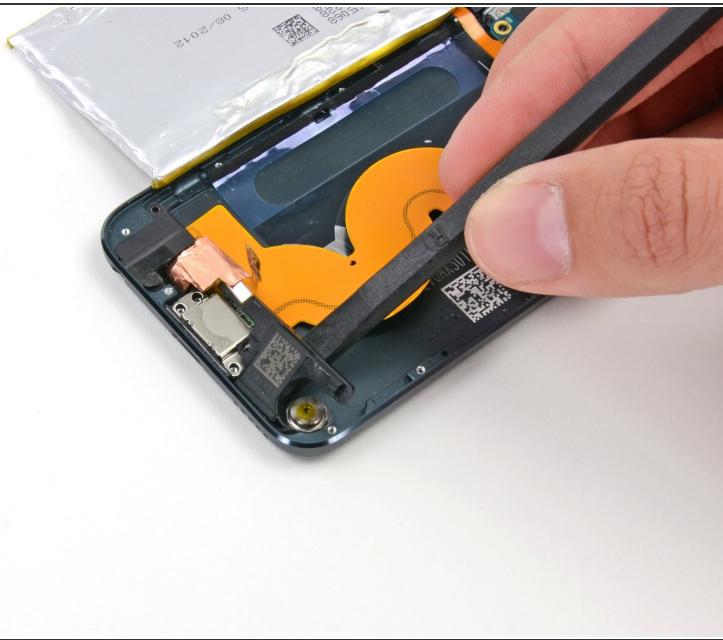
## Step 3

- Use the flat end of a spudger to pry the speaker up from the rear case.

**⚠** Do not try to remove the speaker, as it is soldered to the Lightning connector assembly.

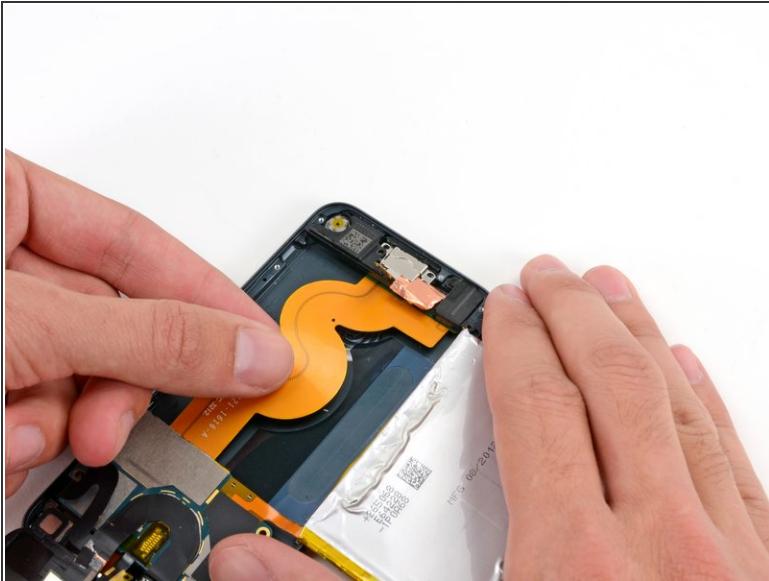
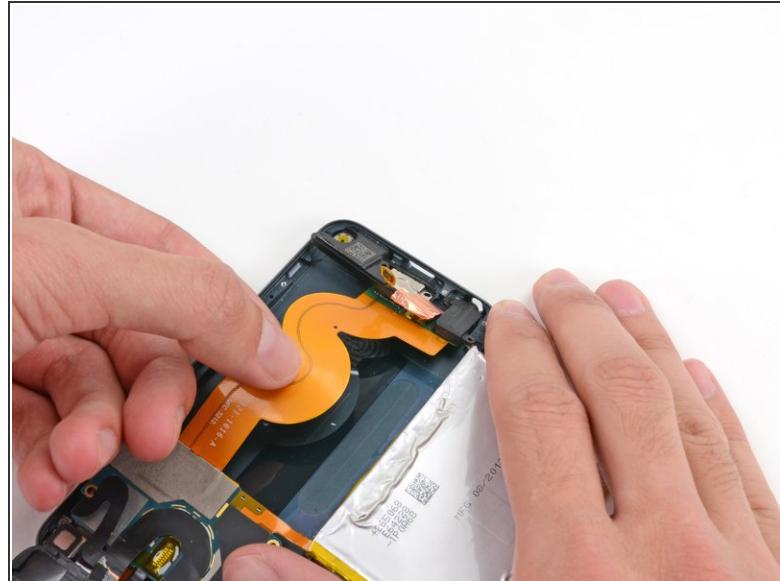
## Step 4

- Grasping the large ribbon cable, gently pull the Lightning connector assembly out of the bottom of the case.
