# iRobot Roomba 560 Fan Replacement

Replace the fan inside of the Roomba 560's vacuum bin.

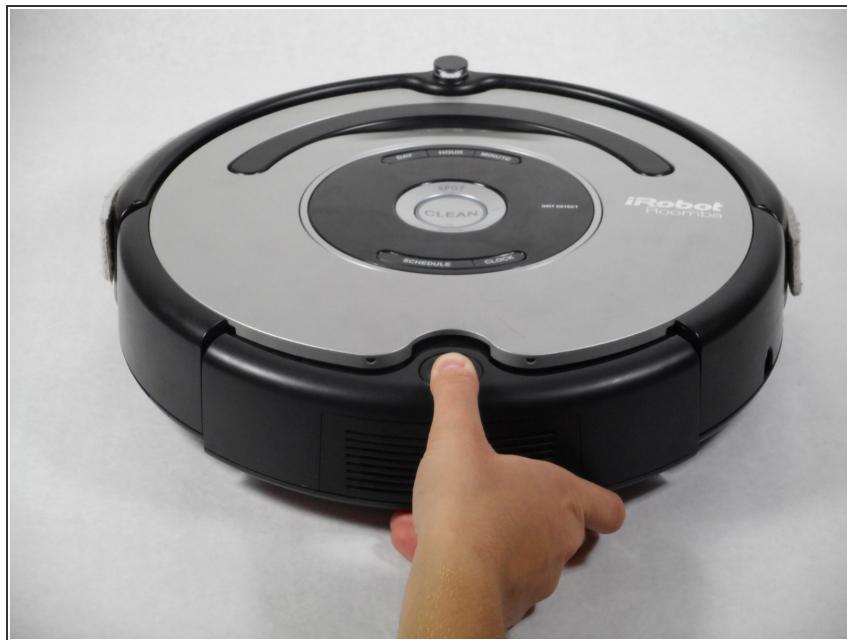
## Step 1 — Fan

- Press the black circular button on the back end of the Roomba and pull the bin out towards you to remove the vacuum bin.

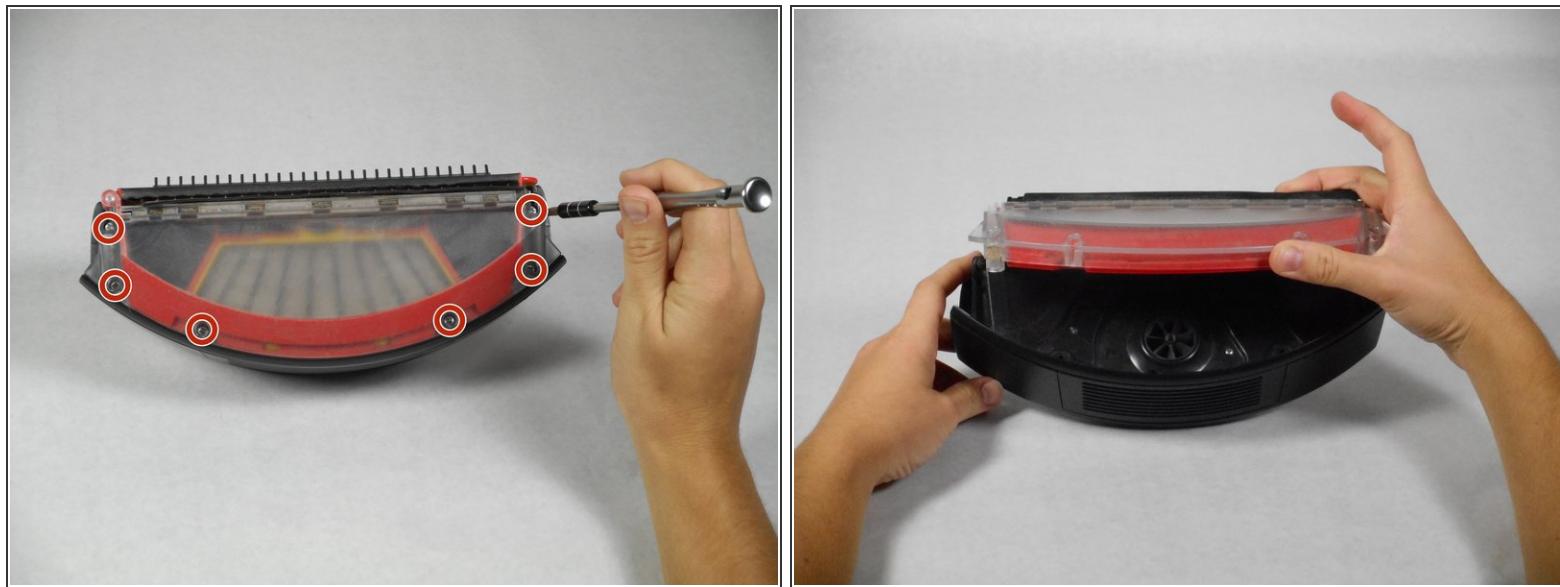
## Step 2

- Lay the vacuum bin down and remove the six 15 mm screws around the outside of the vacuum bin using the Phillips JIS #1 driver.
- Remove the top of the vacuum bin by pulling it straight up.  
**⚠** The bin is composed of two parts (the clear top casing and the red bottom filter). To avoid a mess, be careful to not let these two pieces detach, unless over a trash bin.

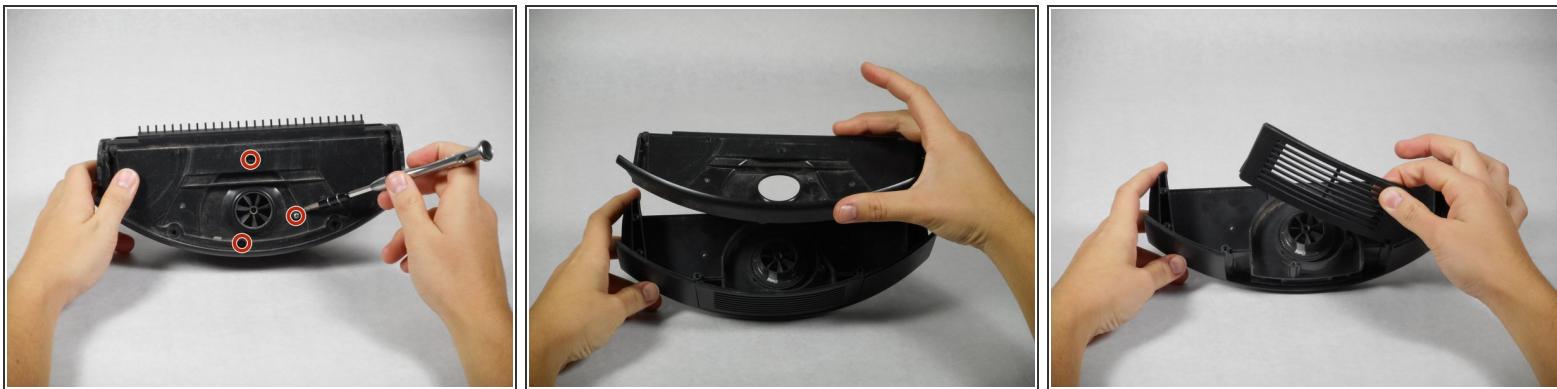
## Step 3

- Remove the three 10 mm screws that surround the fan using the Phillips JIS #1 driver.
- Remove the casing that surrounds the fan by pulling it straight up.
- *(i)* The casing is composed of 2 parts (the large top casing, and a small air filter). If these parts detach, they are very easy to put back together. Do not lose the air filter.

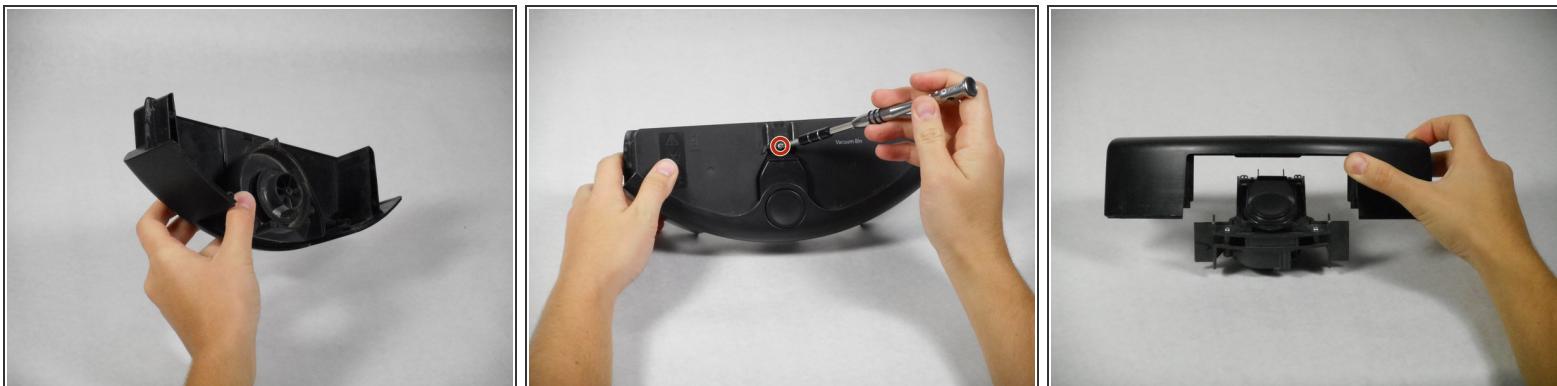
## Step 4

- Turn over the remainder of the fan casing and remove the single 15mm screw, using the Phillips JIS #1 screwdriver.
- Remove the casing from the fan and battery component by pulling it straight up.

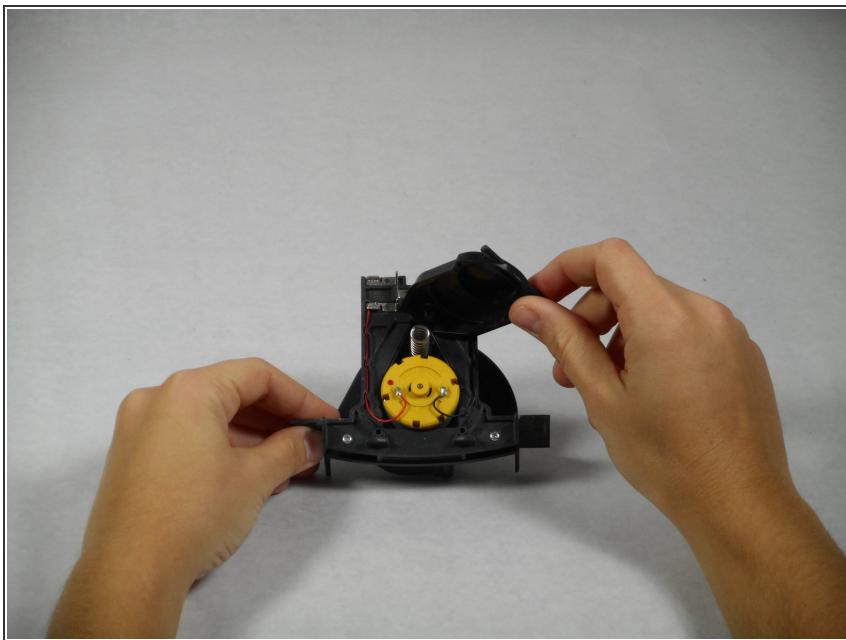
## Step 5

- Remove the small black button from the top of the battery.

ⓘ Save the spring and the button cover. The remainder of the fan assembly (yellow motor and the black housing) will need to be replaced as a unit.
