iRobot Roomba 595 Pet Series Side Brush Motor Replacement

This tutorial will show users how to properly change the side motor on their iRobot Roomba 595 Pet Series

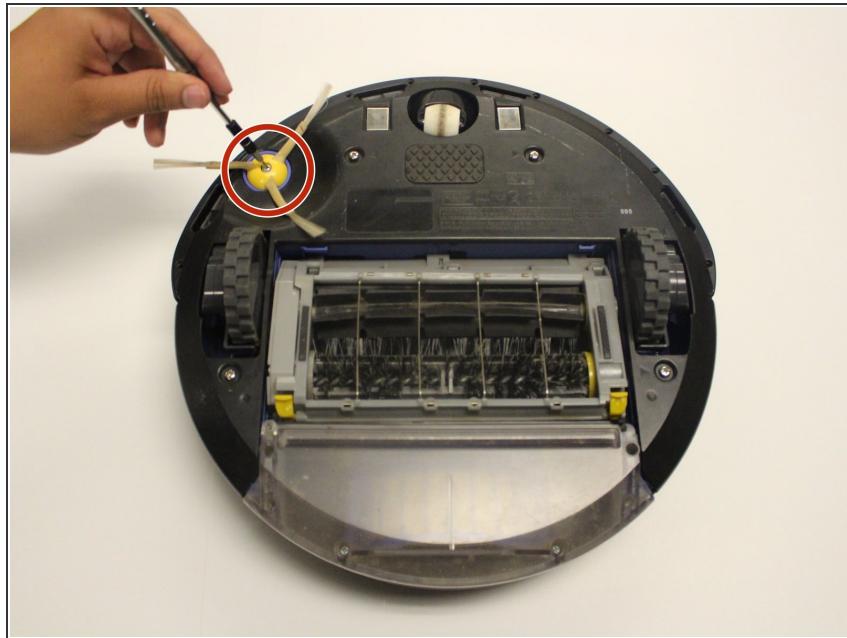
Step 1 — Secondary Brush

- Flip the Roomba upside down. Using the Phillips #0 screwdriver, carefully remove the 5 mm screw holding the brush in place.

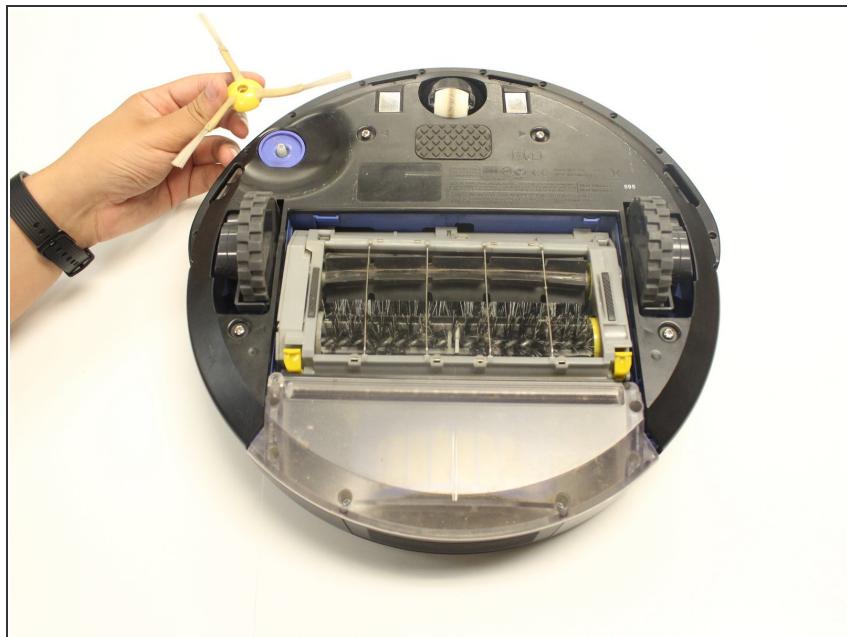
Step 2

- Gently pull the brush up and remove it from the device.

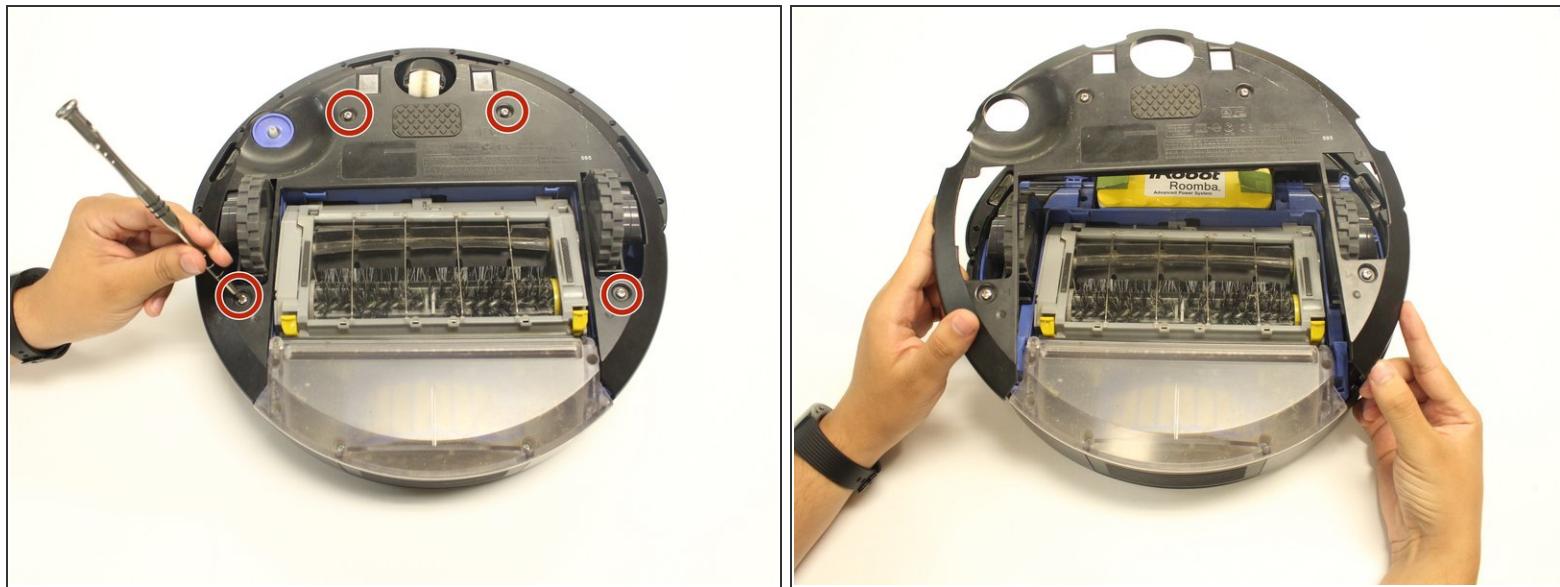
Step 3 — Side Brush Motor

- Unscrew the four 10mm screws on the underside of the Roomba with a Phillips #1 screwdriver.
- Lift the external underside cover accordingly.

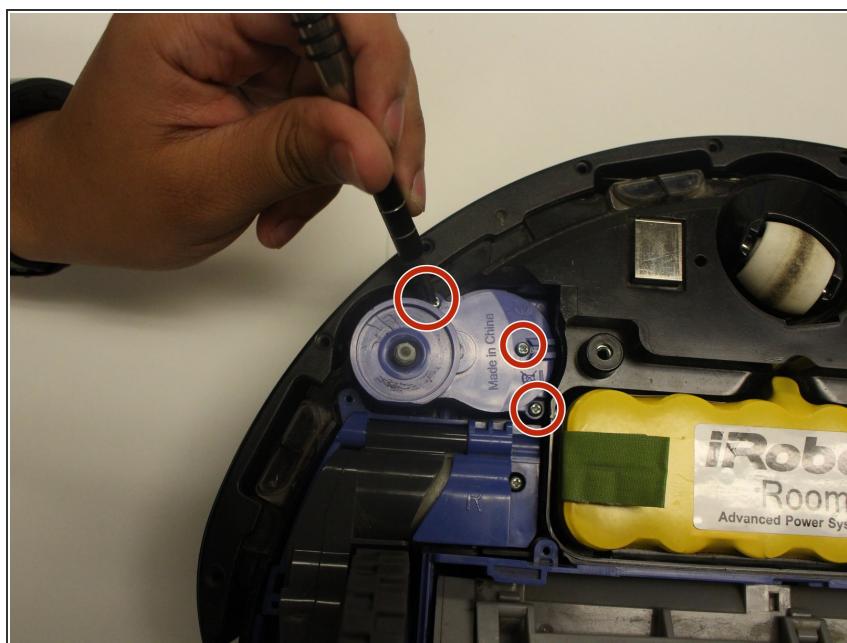
Step 4

- Use the Phillips #0 screwdriver bit to remove the three 15mm screws.

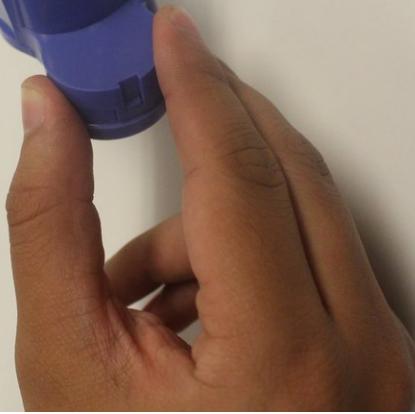
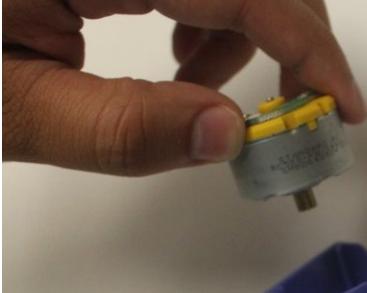
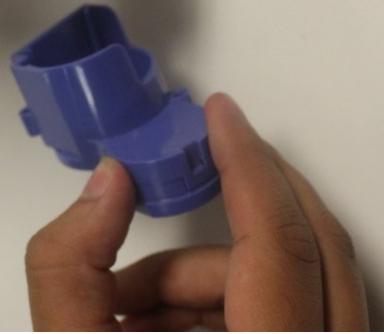
Step 5

- Remove the motor from the blue casing.
