iRobot Roomba 860 Side Wheel Assembly Replacement

This guide provides instructions to remove the side wheel assembly if the iRobot Roomba 860 is unable to move or the wheels no longer spin

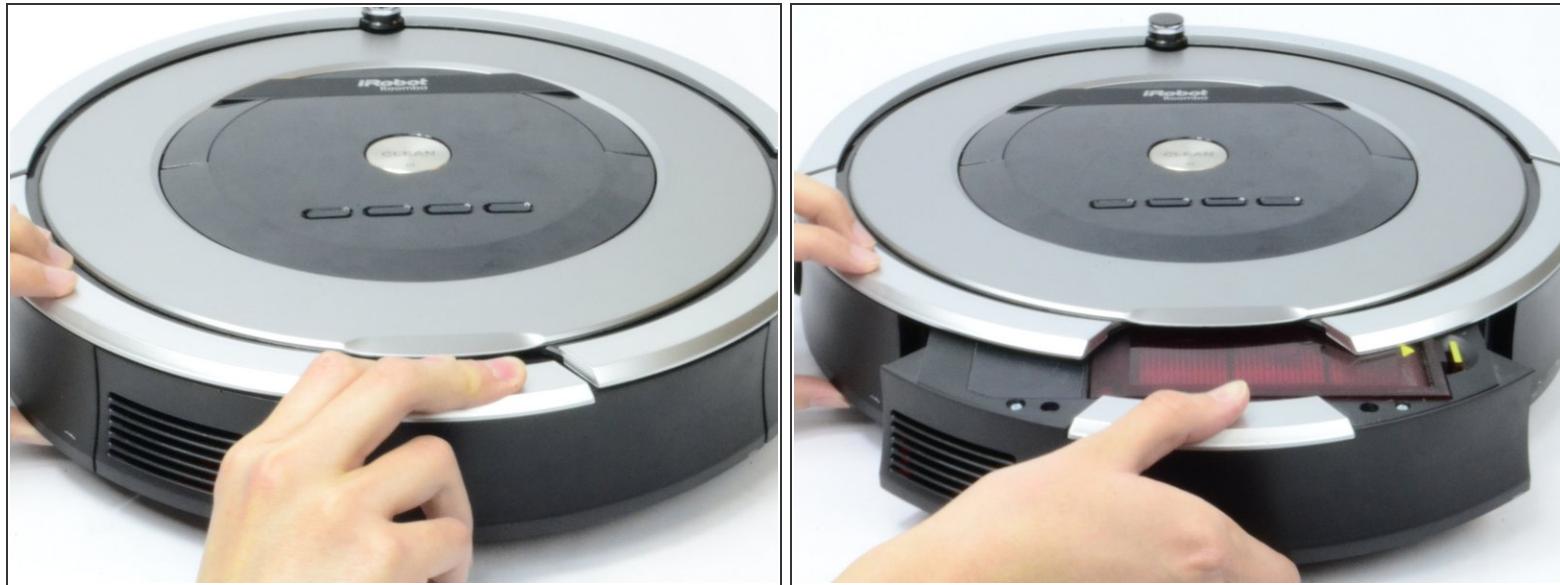
Step 1 — Debris Extractors

- To remove the debris extractor, first begin by removing and emptying the trash bin.
- Push down and pull out on the silver button located on the top of the Roomba in the back.
- The trash bin should then slide out.
